# Citroën C3 (HB) - Waterbinnendringing achterlicht | HELLA

**C3 Pluriel (HB)**

## **Waterbinnendringing achterlicht**

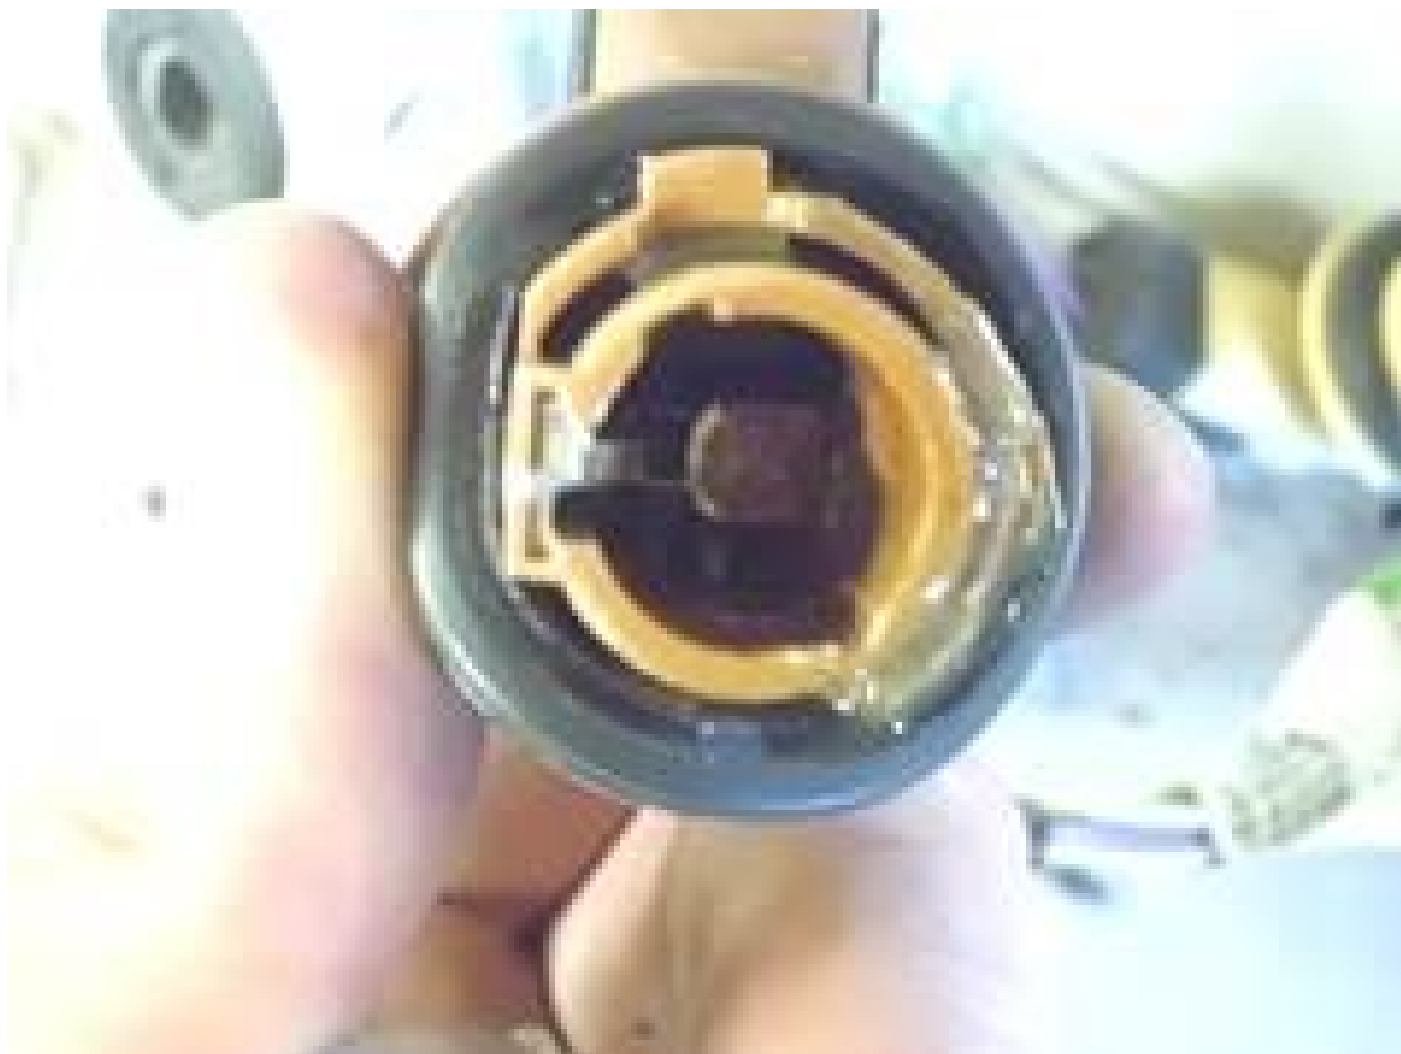
Figure 4

Vervolgens de lamp zijwaarts losklikken (afbeelding 3), verwijderen en de fittingen van de gloeilampen eruit draaien. Hierbij op verontreinigingen en corrosie letten (afbeelding 4).

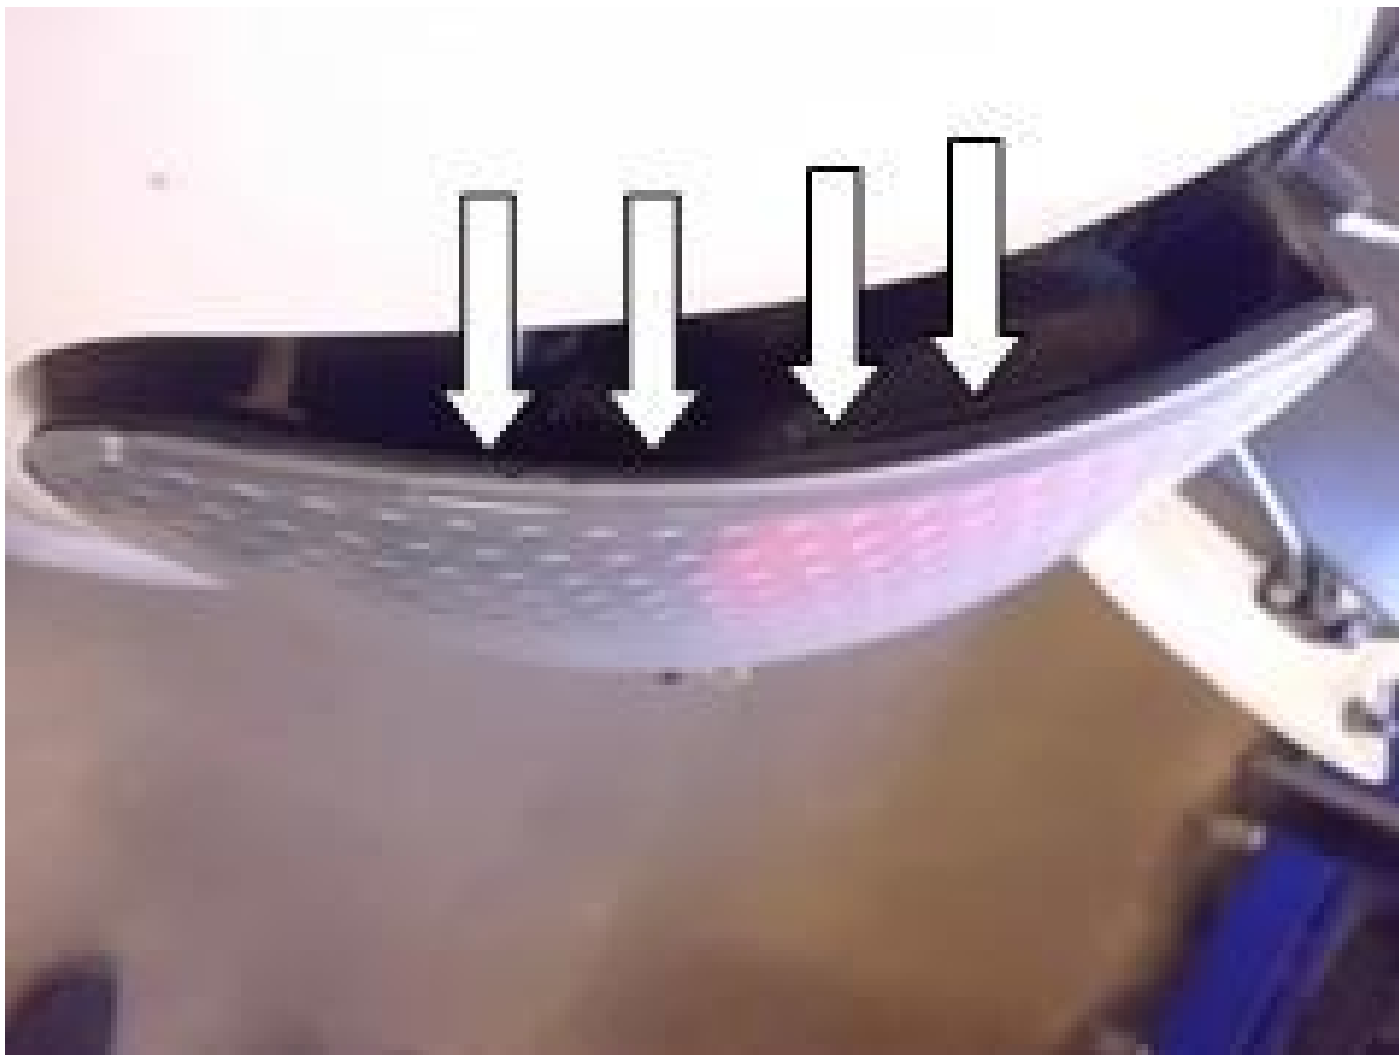
Figure 5

In de meeste gevallen is een defecte lasnaad van het kunststof (boven de lamp) verantwoordelijk voor de binnendringing van water (afbeelding 5).
