# Citroën C3 Pluriel — Infiltração de água na luz traseira | HELLA

## C3 Pluriel (HB)

### Water entering rear combination lamp

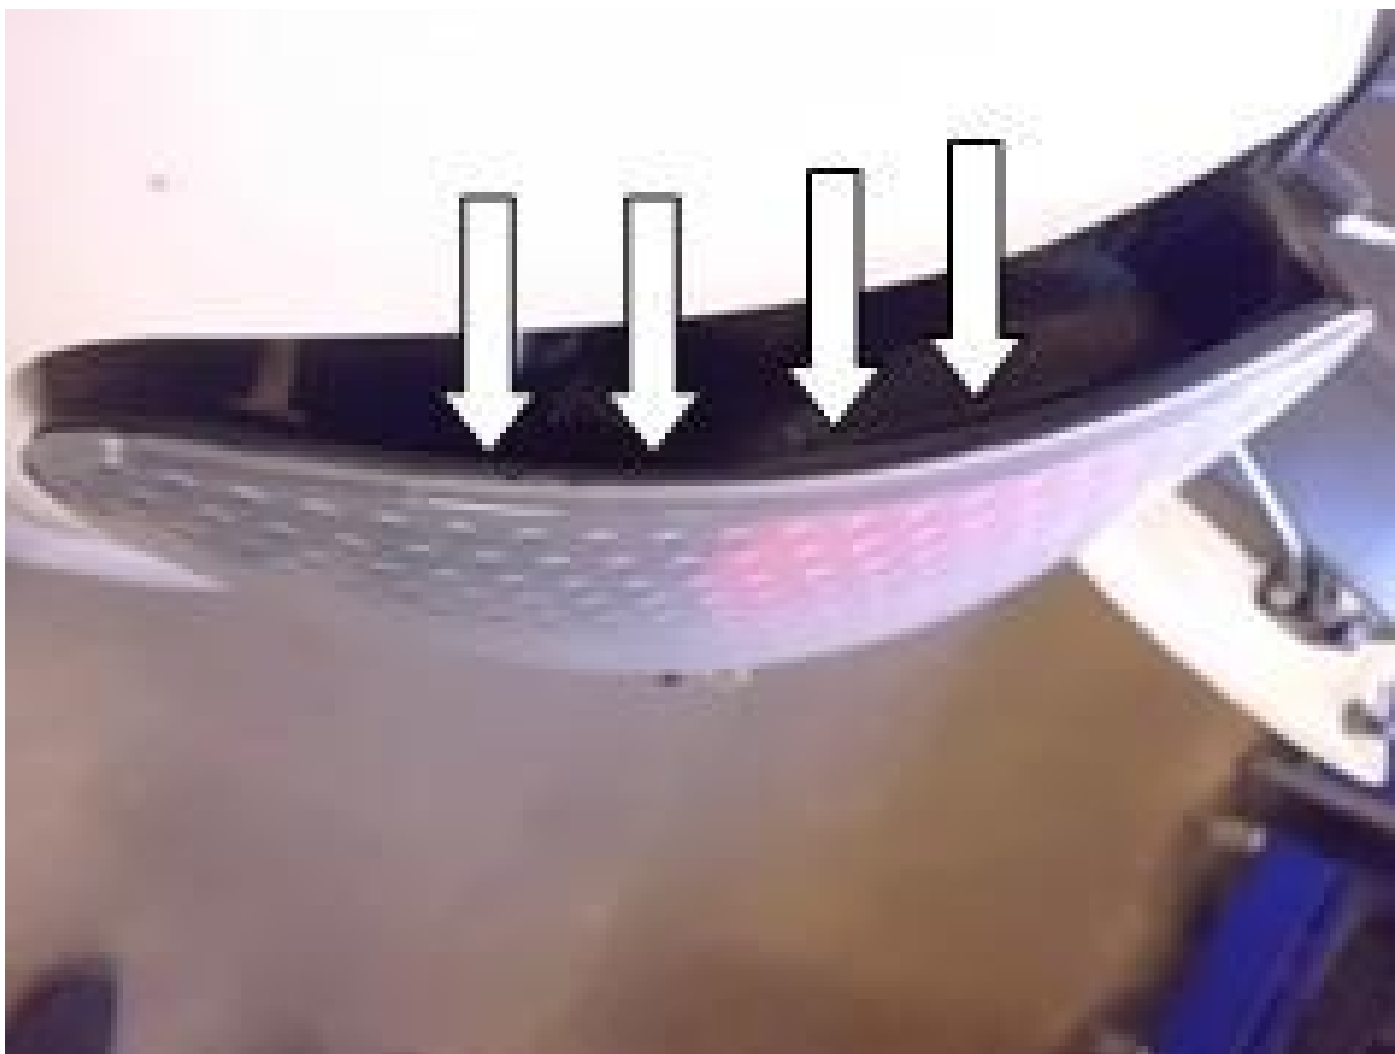
Figure 5

**Citroën C3 Pluriel (HB) Infiltração de água na luz traseira** Nos veículos supracitados, uma infiltração de água (Figura 1) pode implicar a falha das funções das luzes de marcha-atrás. Para um diagnóstico correto, deve-se desmontar a luz de marcha-atrás. Para isso, deve-se desenroscar os dois parafusos (Figura 2). Em seguida, deve-se desencaixar o farol lateralmente (Figura 3) e desenroscar os alojamentos das lâmpadas incandescentes. Prestar atenção a sinais de sujidade e corrosão (Figura 4). Na maioria dos casos, a infiltração de água deve-se a uma costura de solda com defeito (Figura 5) do plástico (acima do farol). **Figura 1 Figura 2 Figura 3 Figura 4 Figura 5**
