# **Mercedes Classe E (W211) — Código de erro C0249F/C2258 | HELLA**

**E-Class (W211)**

**Model year 2002-2005**

**All models with electro-hydraulic brake system (SBC)**

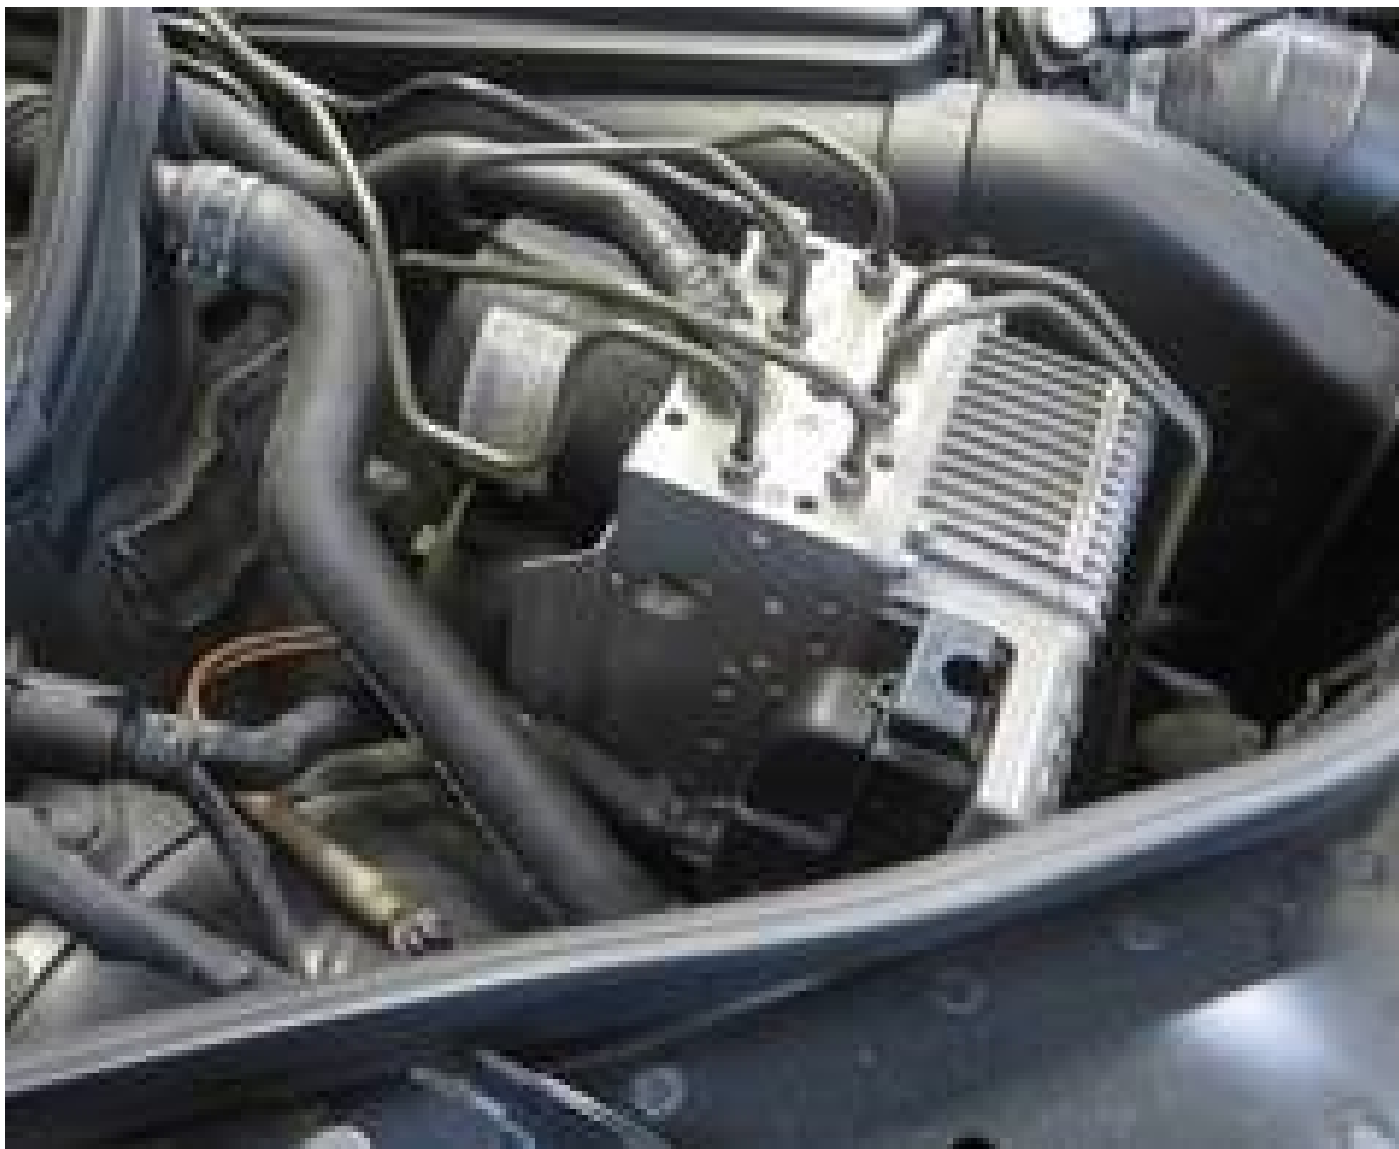
If these error codes are read out of the ABS control unit from the vehicles specified above, a possible cause for this could be that the service life specification of the ABS control unit and hydraulic unit has been reached.

These error codes must not necessarily lead to the replacement of the hydraulic fluid SCB ( figure).

In order to be able to rule out other causes, first check the periphery of the brake system. The ABS hydraulic unit must be replaced only after there are no more electric and mechanical error to be diagnosed.
