# VW Golf - Excessive engine temperature | HELLA

VW

Golf / Golf Estate

Starting from model year 1997

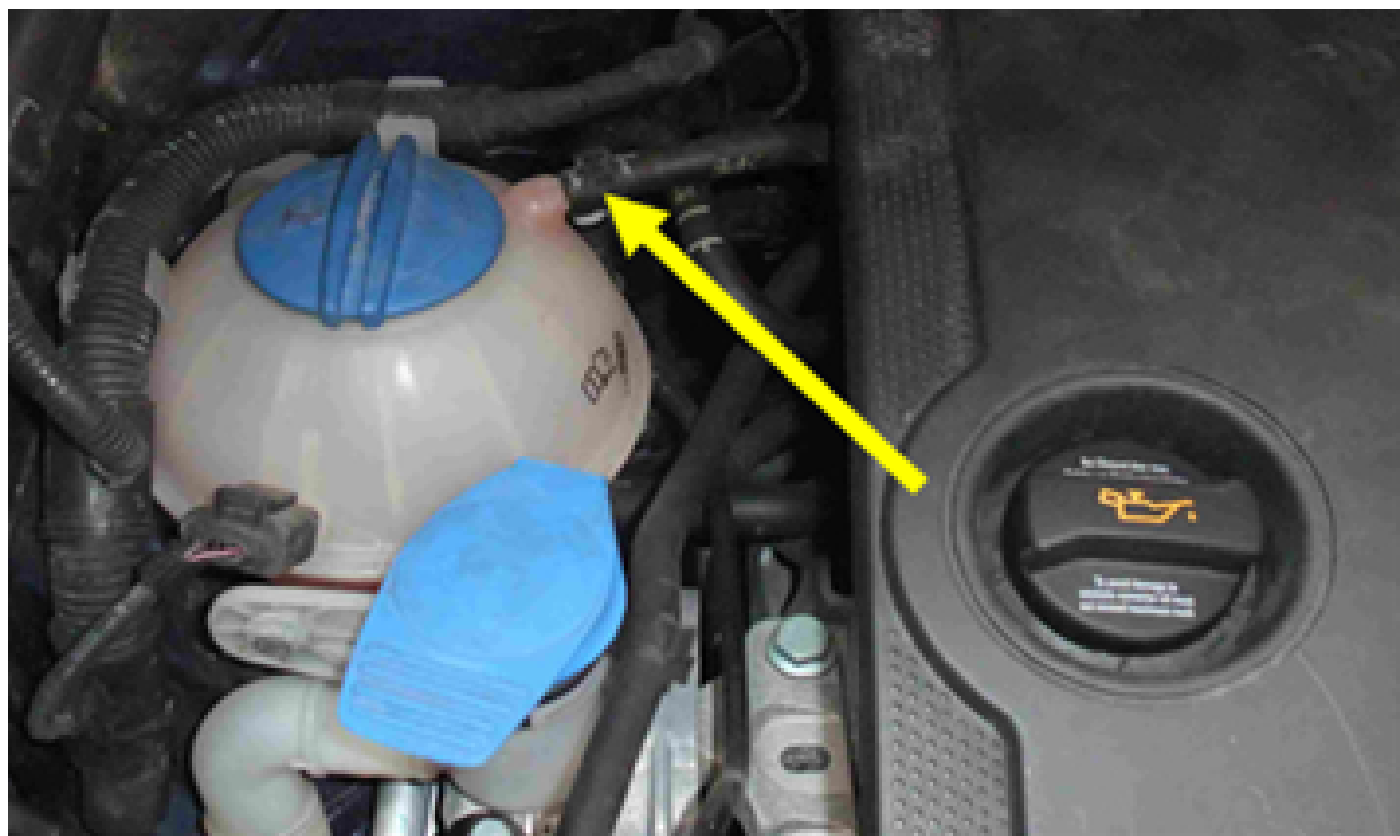
Additionally, remove the coolant return line from the coolant expansion tank (see figure below). If the coolant is not flowing, replace the coolant pump.
