VW Touareg - Faulty particle filter regeneration | HELLA

VW Touareg

Model 7P5 / Diesel TDI

Faulty particle filter regeneration

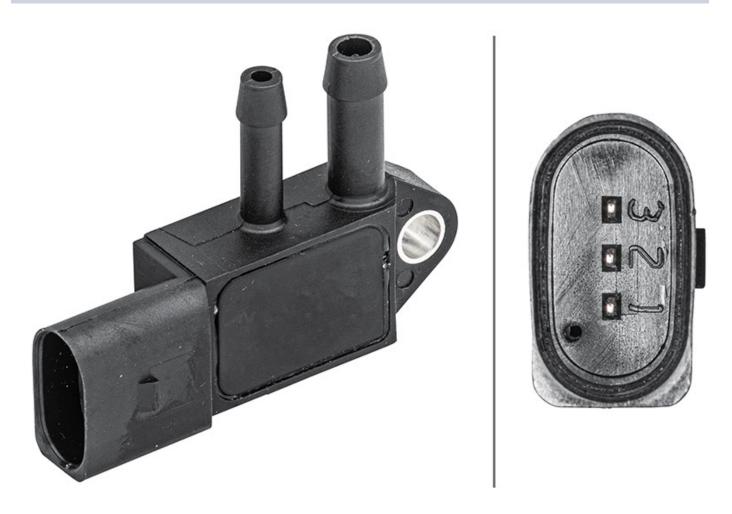
If the above-mentioned problem is identified, one possible cause may be a defective exhaust differential pressure sensor.

First perform a visual inspection of the plug connections/sensor hoses to check for contamination and damage and, if necessary, clean them with suitable cleaning agents. Alternatively, if damage has occurred, replace these parts in accordance with vehicle manufacturer's instructions.

If no other kind of malfunctioning is detected, the exhaust differential pressure sensor is to be replaced.
