# BMW - noises coming from the front end of the vehicle when driving on uneven surfaces

| Data sheet | |
|---|---|
| Vehicle model | 520 d G31 |
| Symptoms | Noises coming from the front end of the vehicle when driving on uneven surfaces |

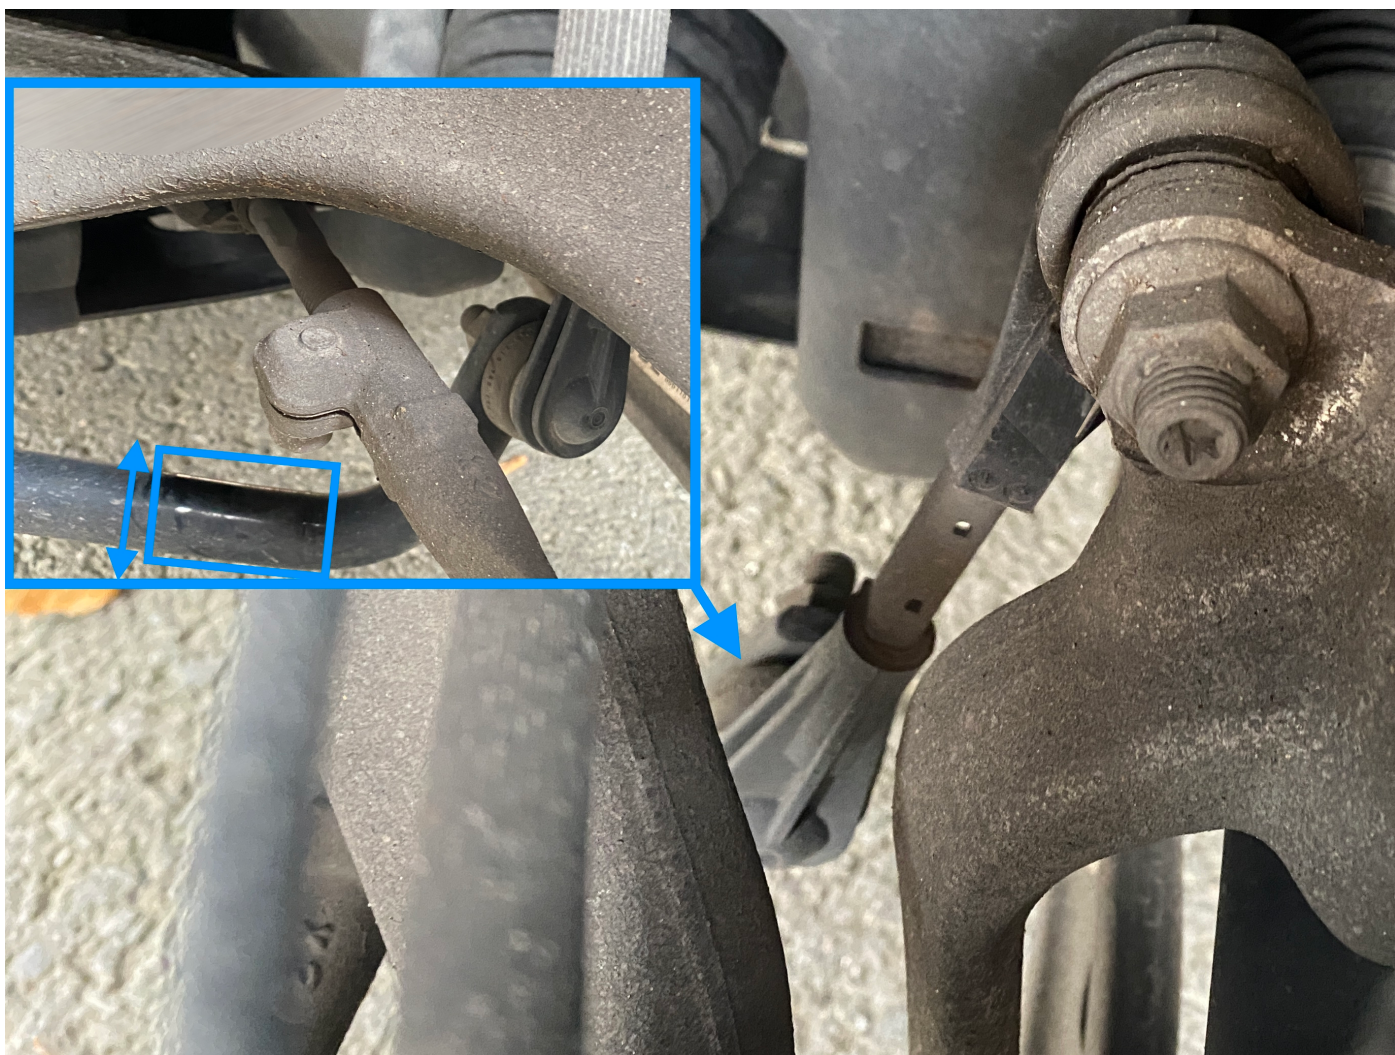
Should the above-mentioned defect apply, special attention is to be paid to the stabiliser link (anti-roll bar link) on the front axle.

Worn ball joints cause play, which, under load changes and during suspension compression, lead to the noise symptoms described.

So as to troubleshoot the fault, the vehicle must be raised on a lifting platform so that the front axle is completely unloaded. The stabiliser link must then be checked in its mounted state. To run this check, the stabiliser must be gripped directly in the marked area and moved by pressing it up

and down (see Figure 1). If you can feel any play or reproduce the noise, this suggests that the stabiliser link is worn. The check should always be carried out on both sides, as both anti-roll bar links can cause similar symptoms.

If, during the diagnostic check, excessive play or a distinct noise is detected, the affected stabiliser link must be replaced. After replacement, all fastening points must be tightened to the specified torque in accordance with the manufacturer's instructions. Finally, a test drive should be carried out to check whether the noise issue has been rectified.
