## Mini F56 - water ingress in the vehicle interior

### Data sheet

## Moisture in the vehicle interior caused by condensation draining from the air-conditioning system

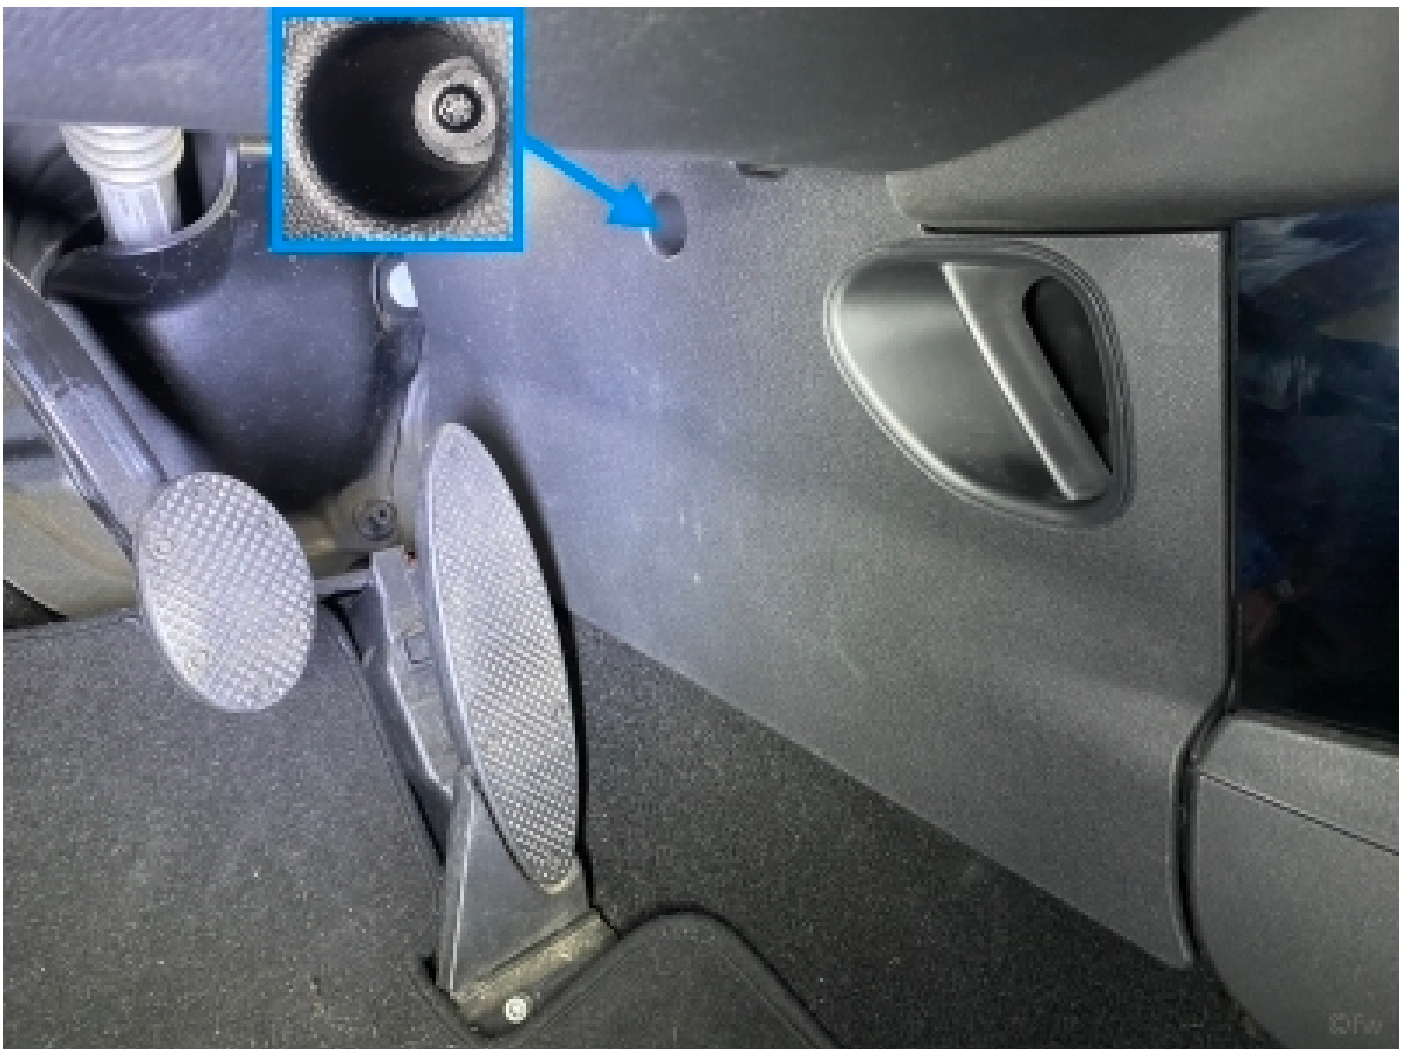
The side panelling (Fig. 1) in the footwell must be removed to carry out the necessary checks. In order to do this, the fastening screw has to be undone and the panelling removed from the brackets. The carpet can be pressed down slightly on the side underneath the air-conditioning unit in order to check it. The rubber seal of the water drain must fit all the way round the air-conditioning unit (Fig. 2) and have no kinks in it.
