# **Nissan X-Trail (T31) - Leak from the fuel level sensor | HELLA**

**X-Trail (T31)**

**Engine: 2.5 i 16V**

## **Leak from the fuel level sensor**

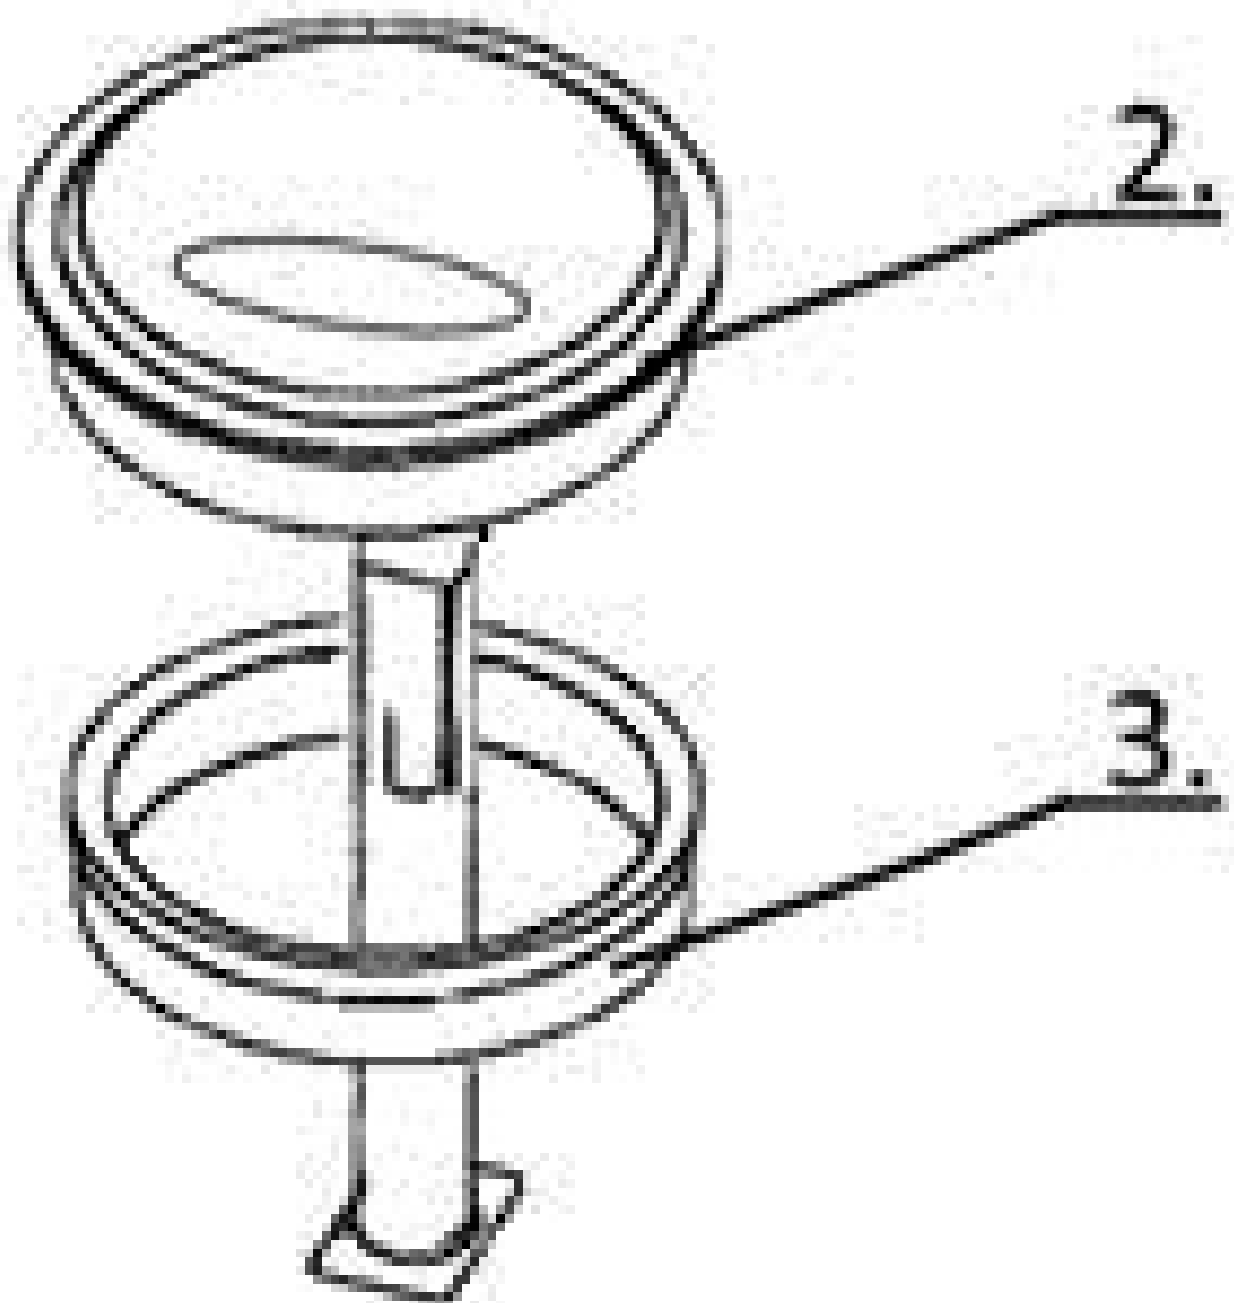
In most cases, the problem mentioned above only occurs when the tank is full.

The cause in such a case is inadequate sealing of the gas tank sensor because of a faulty seal.

Replace the defective gasket (Diagram - position 3) with a new one in accordance with the vehicle manufacturer's specifications.

- Gasket 1734279900 (Diagram - position 3)

- Circlip 17343JG00A (Diagram - position 1)

- Fuel level sensor unit 25060JG00A (Diagram - position 2)
