# Saab 9-3 - Loss of coolant | HELLA

**9-3**

**Engine code: B284.**

## **Loss of coolant**

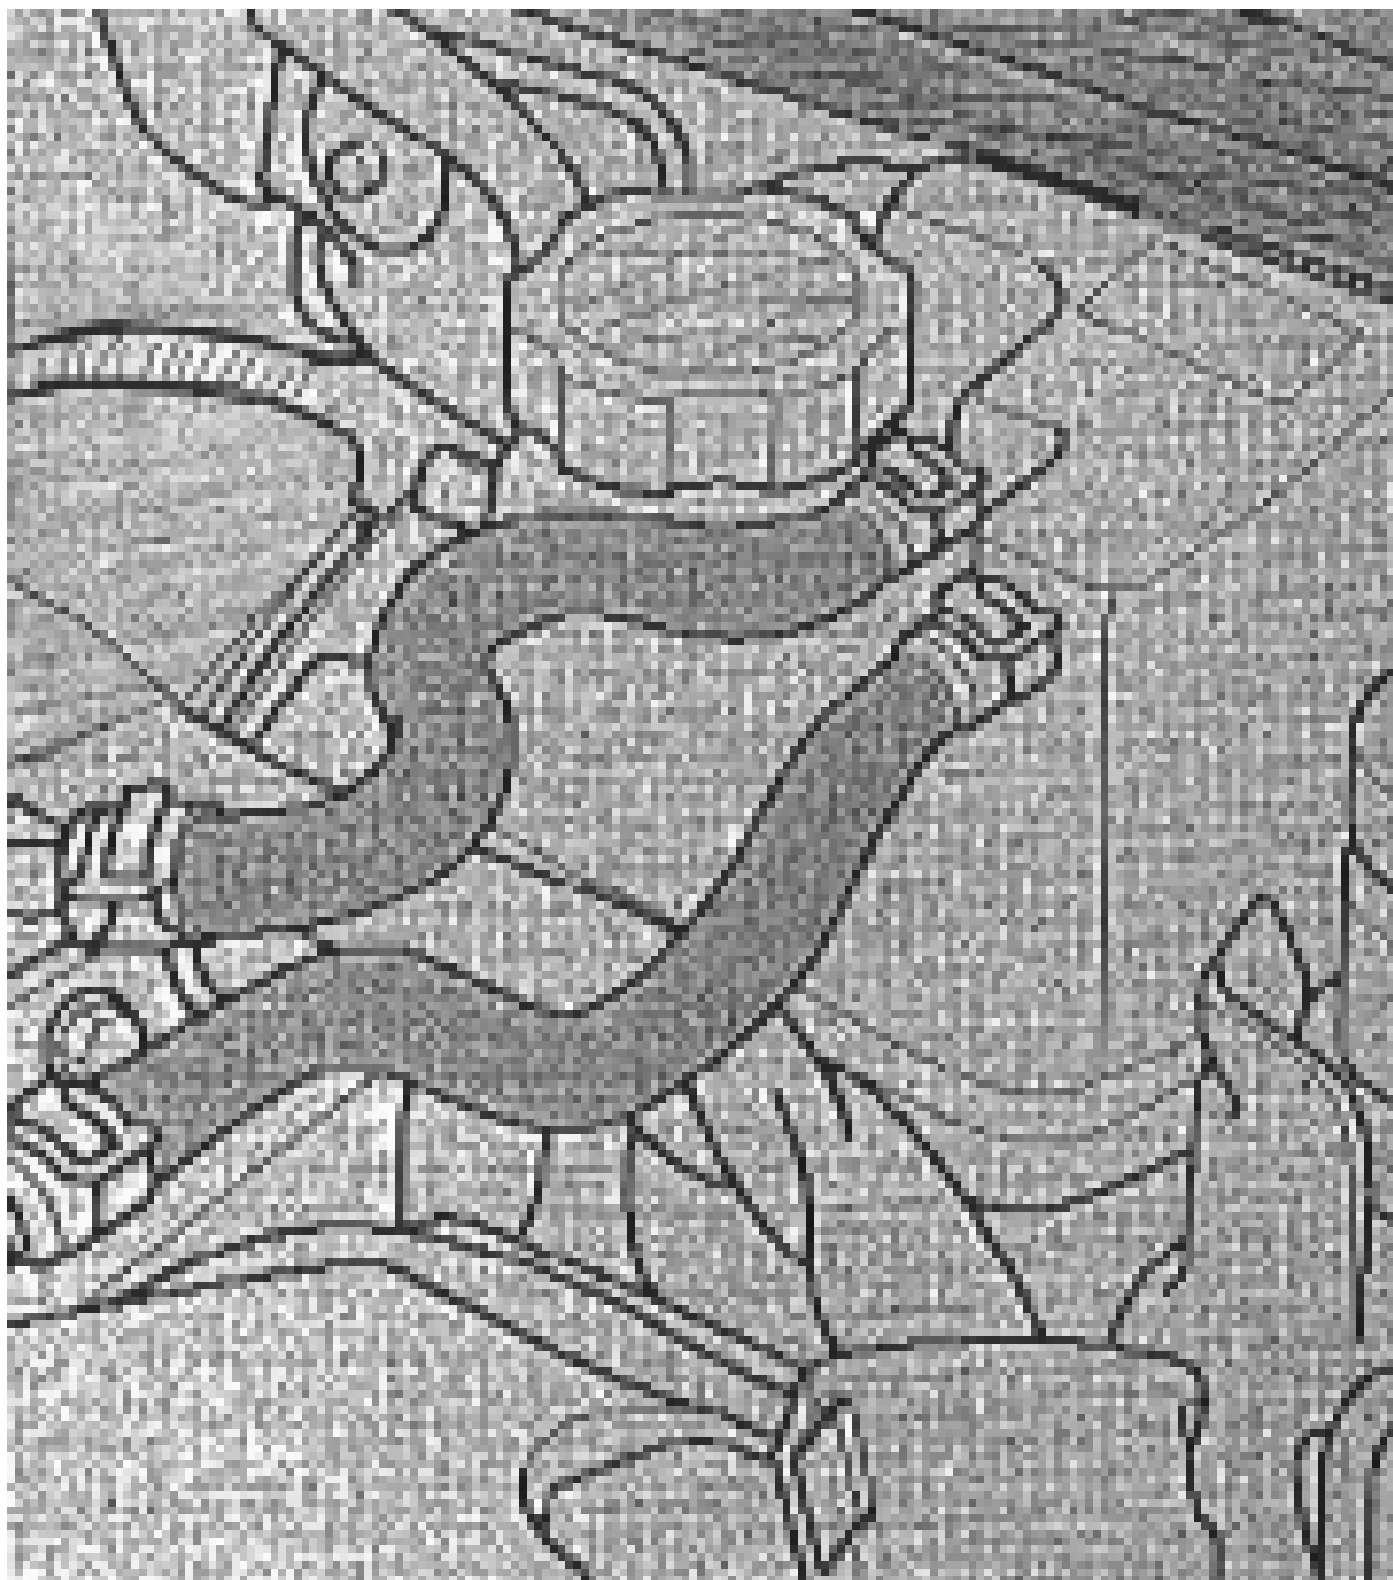
Figure 1

In the case of the above-mentioned vehicles, problems can arise because of loss of coolant. The cause of this can either be a defective coolant expansion tank or damaged engine coolant hoses on the coolant expansion tank.

The positioning of these components (Figure 1) is located very close to the turbo charger, which means that material fatigue can result because of the hot ambient temperature.

(Old layout)

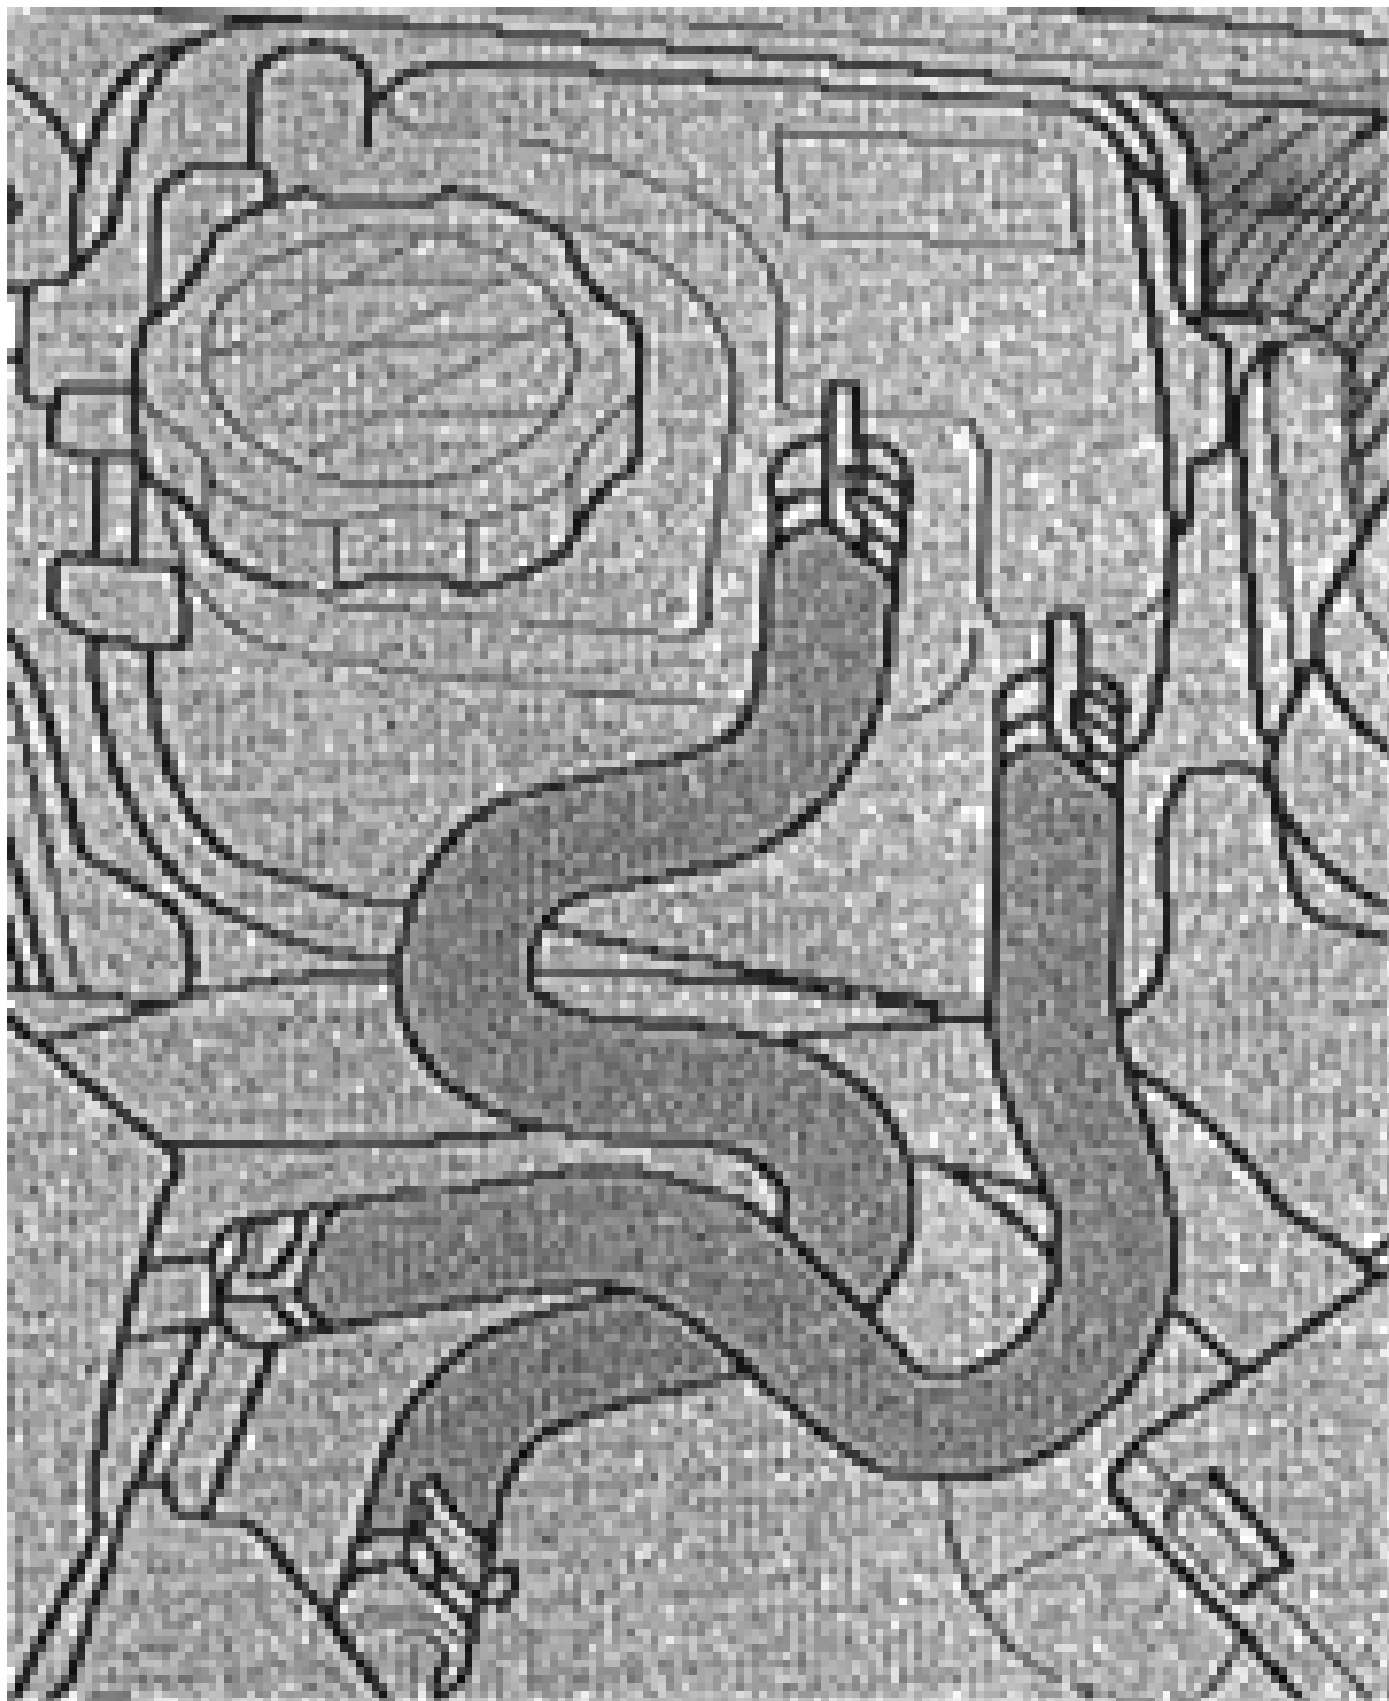
Figure 2

(Modified layout)

In order to remedy this, the coolant expansion tank is to be replaced and the hoses of the coolant expansion tank are also to be replaced / repositioned.

The car manufacturer provides modified coolant hoses for this specific purpose (See Figure 2).

Spare part no: 93 194 927

Spare part no:12 759 330
