## VW T6 - fuel loss

### Data sheet

| Vehicle model | Transporter T6 |
| Engine | 2.0 TDI |

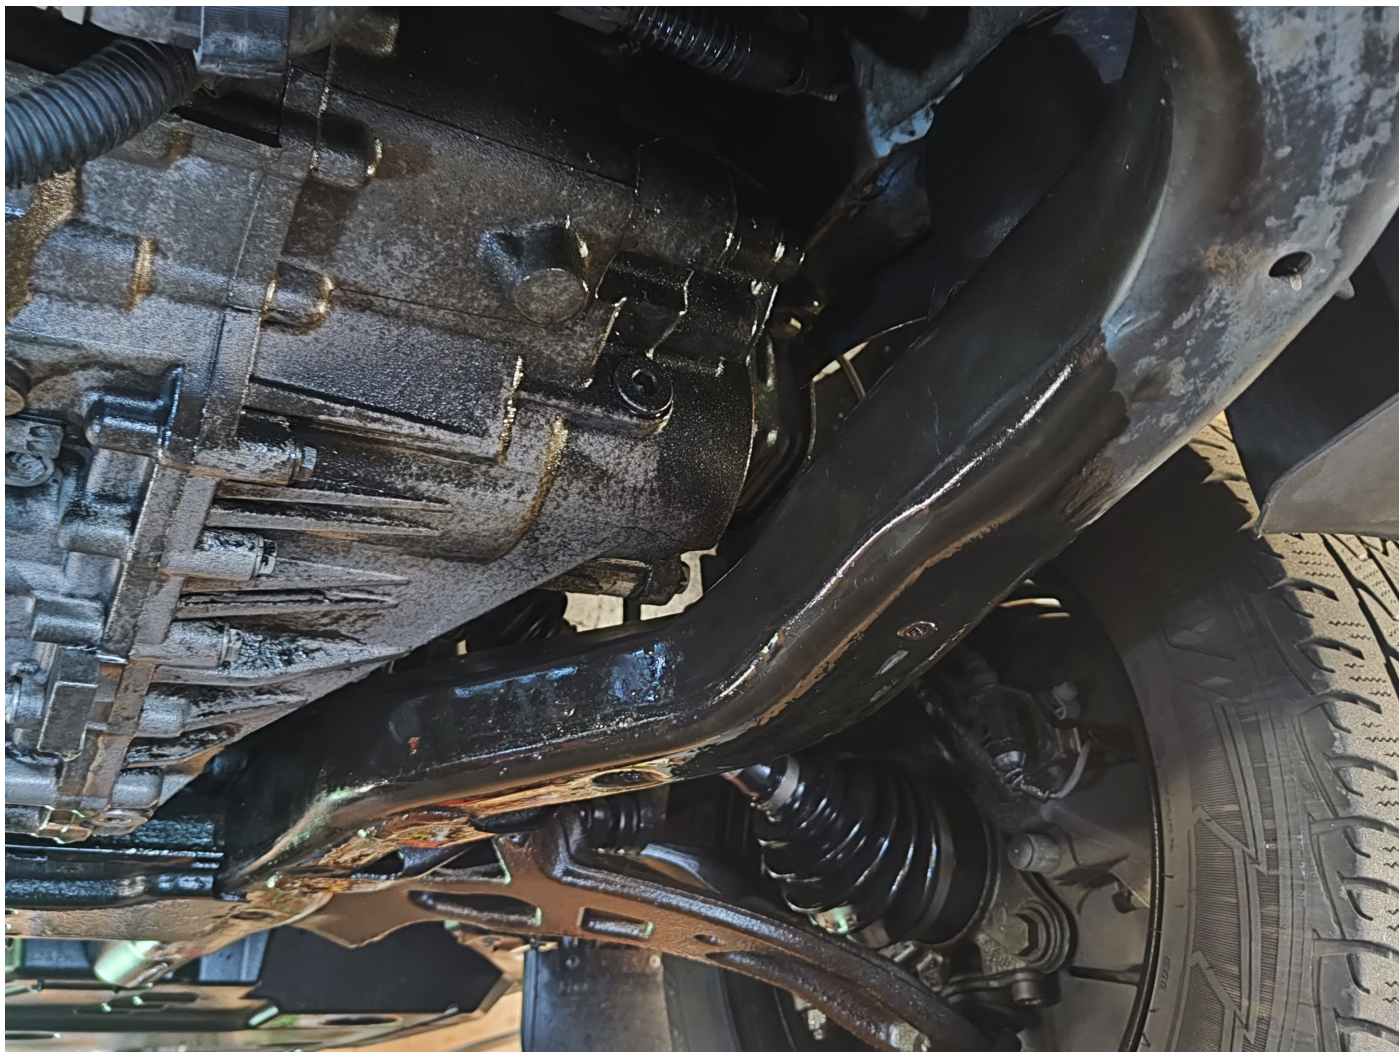
On the vehicle mentioned above, it can happen that a strong smell of diesel suddenly becomes very noticeable. Leaking fuel may also have accumulated in the engine compartment or under the vehicle. The cause of this is not always immediately recognisable. Firstly, the fuel lines and their connections in the engine compartment should be checked. If no leak is found, the fuel filter housing may be the cause of the diesel loss.

Fuel loss T6

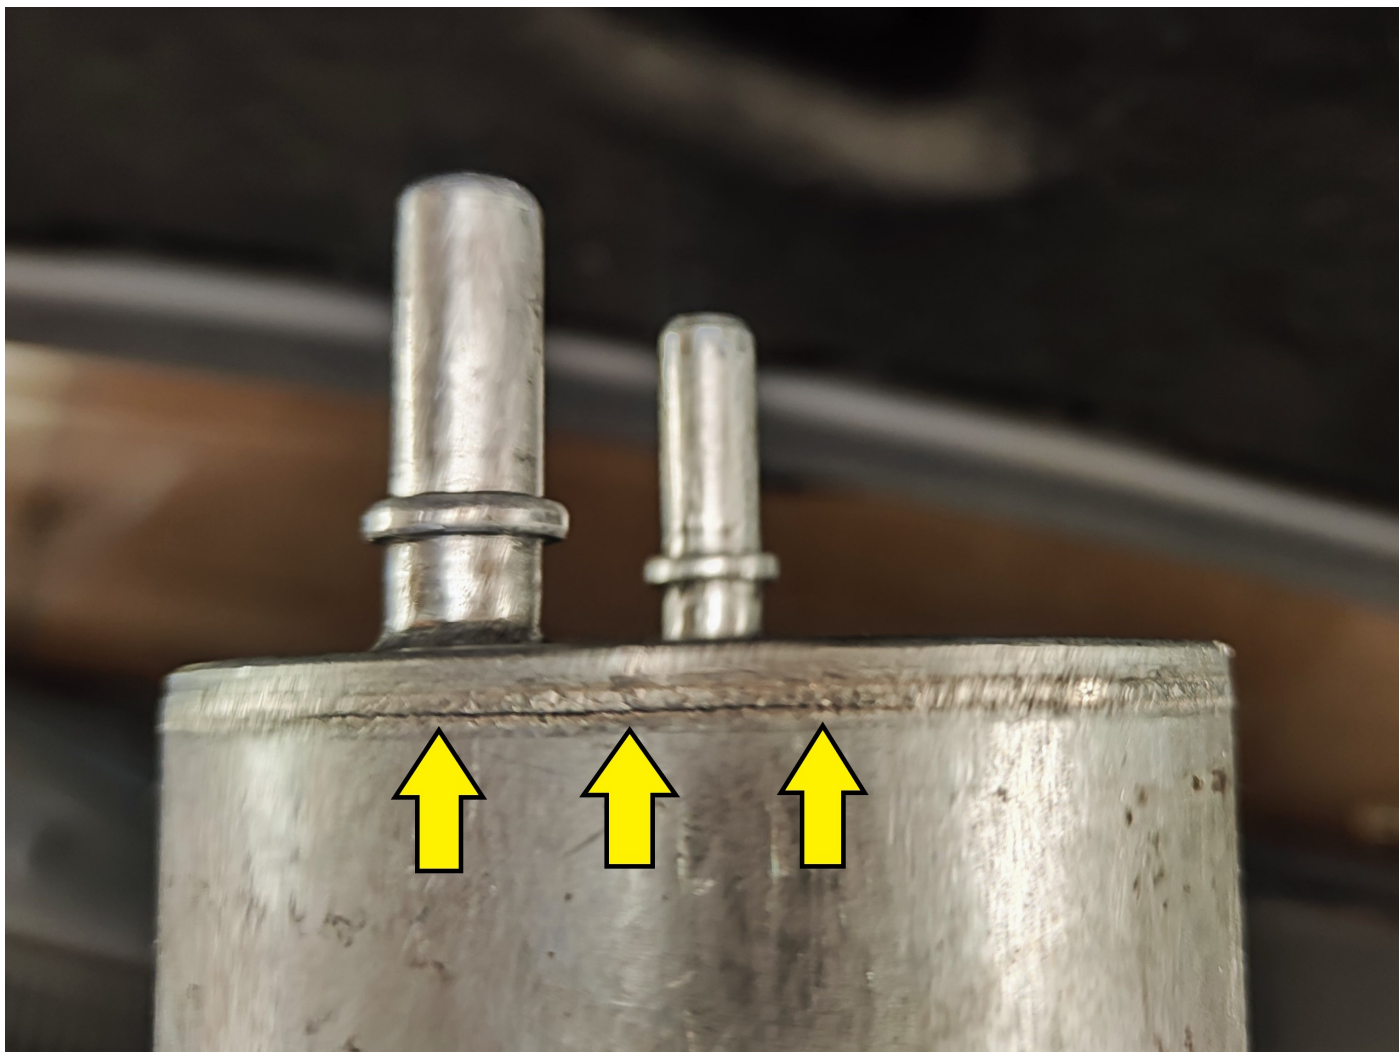
Fuel filter T6

If you now take a look at the upper area of the filter, in some cases a horizontal hairline crack can be seen, which is responsible for the leak.

In order to remedy the situation, the filter should be replaced and the fuel system bled in accordance with the vehicle manufacturer's instructions. We recommend cleaning the engine compartment as a final step of the repair.
