# Mazda Model 5 - Engine stalls | HELLA

**Model 5**

**2.0 diesel engine (RF Turbo) 105 kW**

## Engine stalls

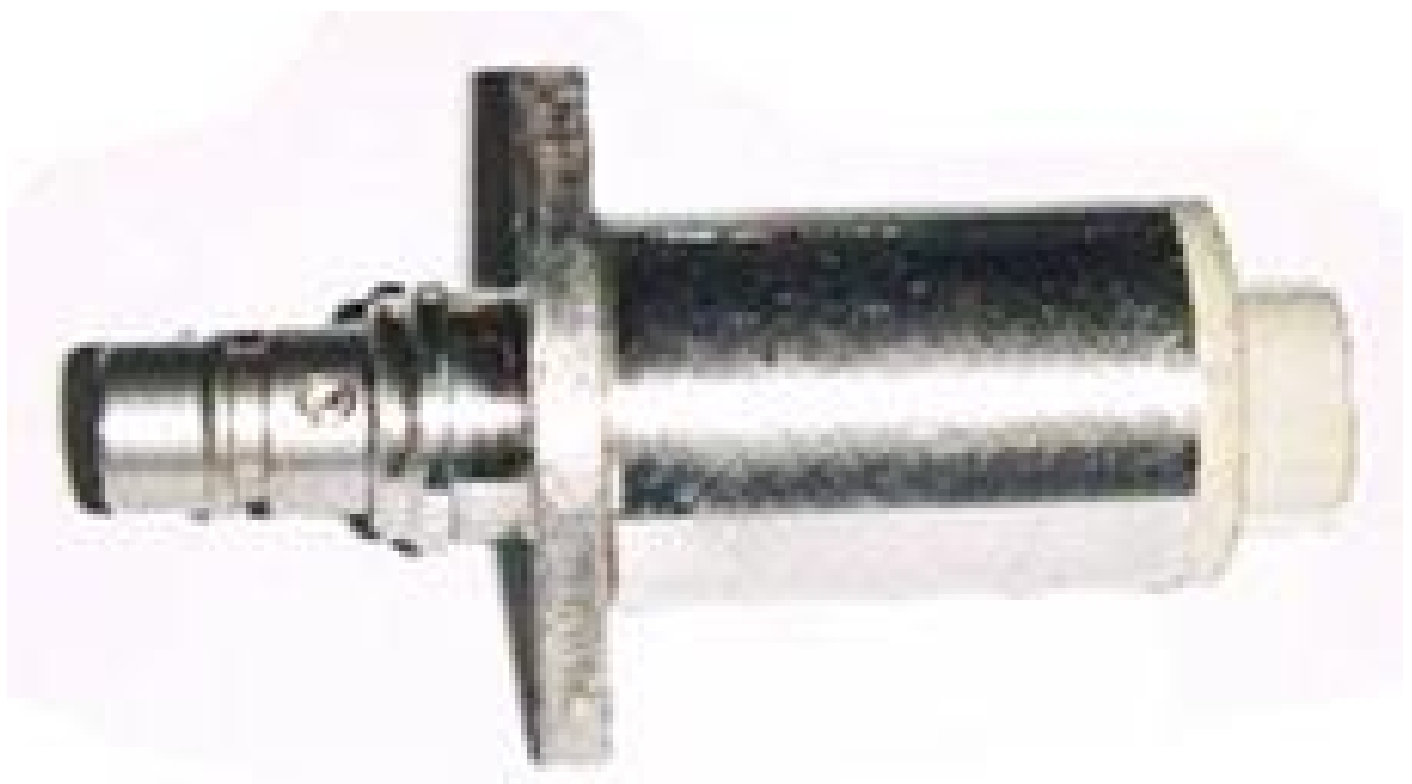
Figure 2

If a customer complains about the above problem, this could be caused by the fuel pressure control valve. Furthermore, occasional loss of power and poor engine cold starting performance may also be complained about. In this case, the control valve must be replaced (see Figure 1). It can be obtained under number 294009-0120. The valve is located on the rear housing part of the high pressure pump (Fig. 2).
