# **Mercedes-Benz A-Class - Rear combination lamp with reduced luminosity**

**A-Class**

Model years: 2004 - 2009

## **Rear combination lamp with reduced luminosity**

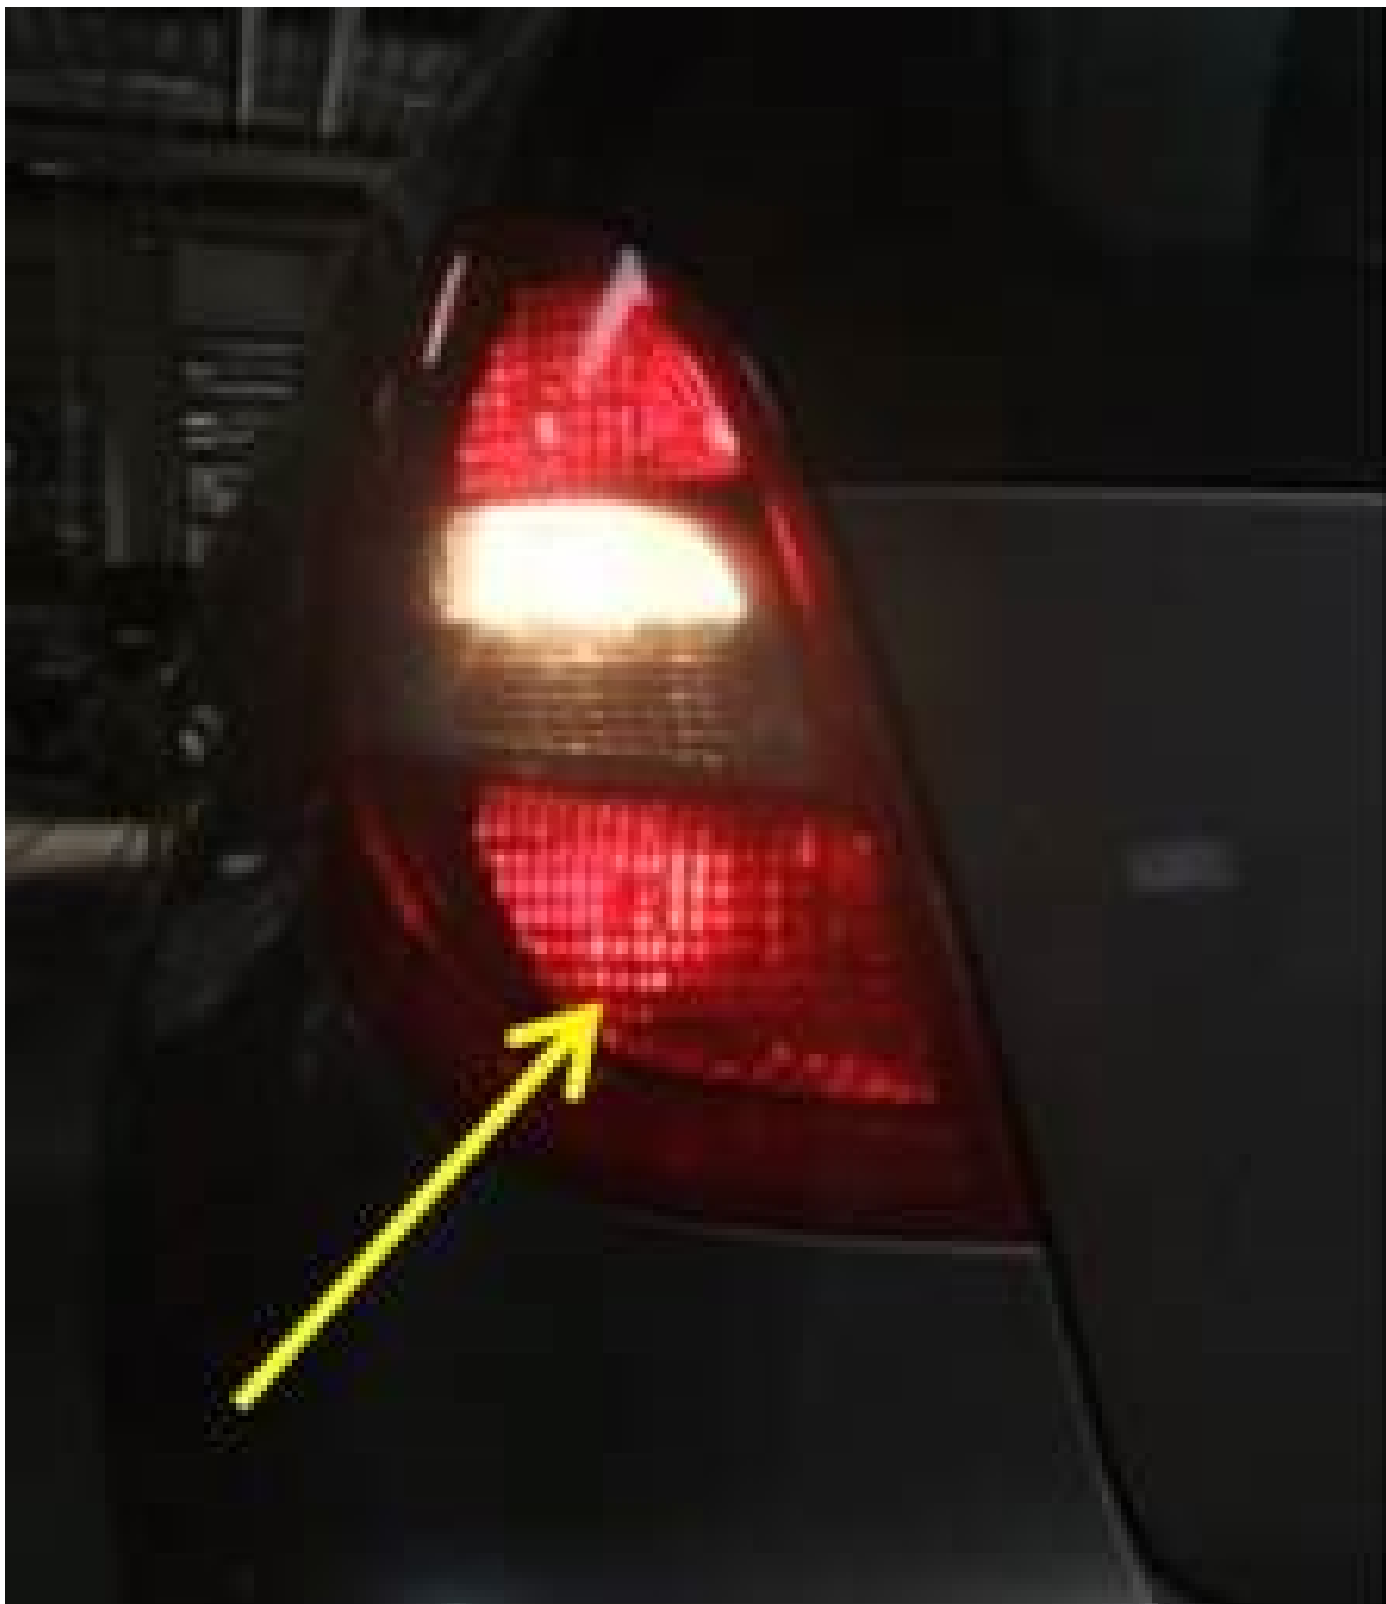
Fig.2

okay\_ after repair.

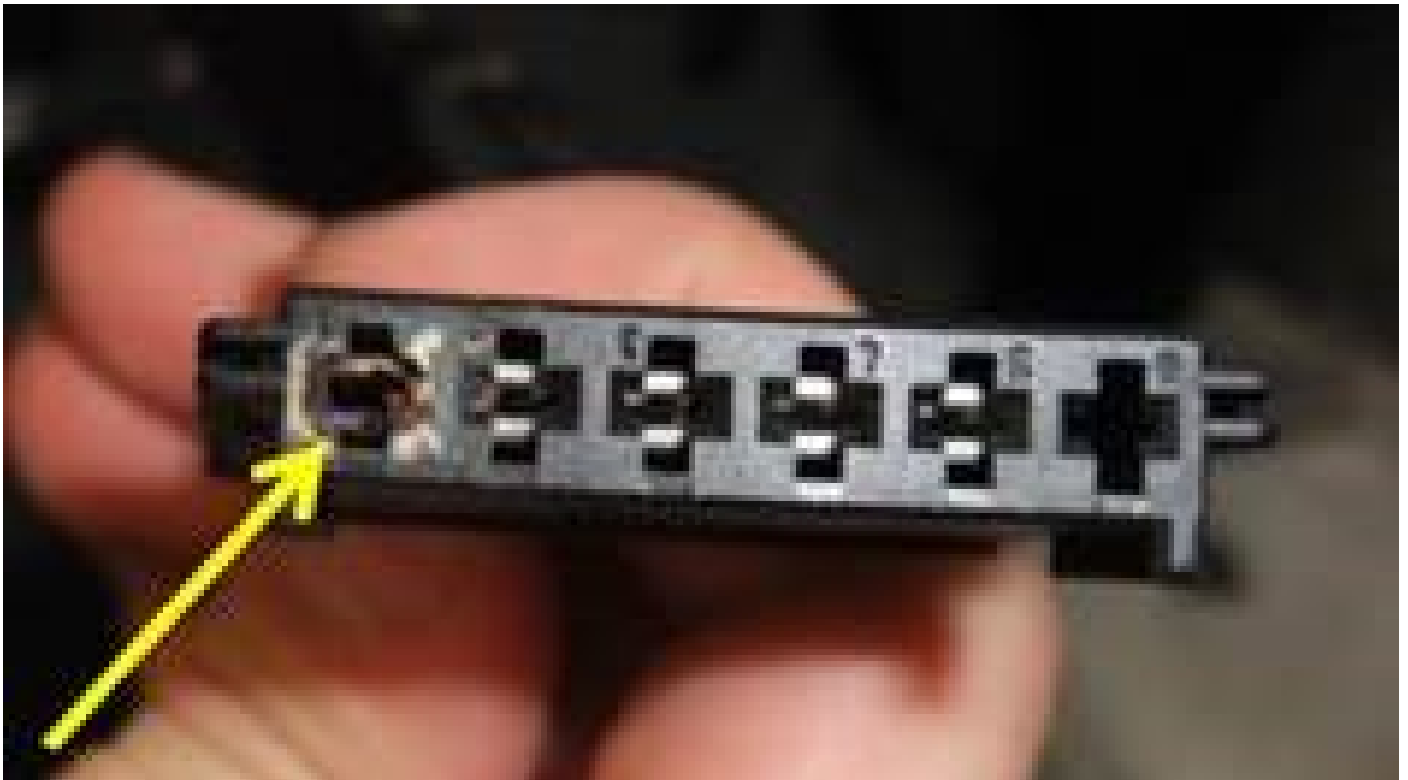
Fig.3

- Opening vehicle rear door.
  - Unclipping left and/or right cover (C-pillar) using e.g. a long wedge.
  - Opening cover of left and/or right storage compartment in trunk.
  - Removing first-aid kit and electric air pump from left storage compartment in trunk (left rear combination lamp).
  - Folding right storage compartment in trunk inside (right combination lamp).
  - Disconnecting electric plug connection.
  - Checking electric cables, plugs, contacts and the rear light for further damage,
- see charred plug socket. (Fig.3).

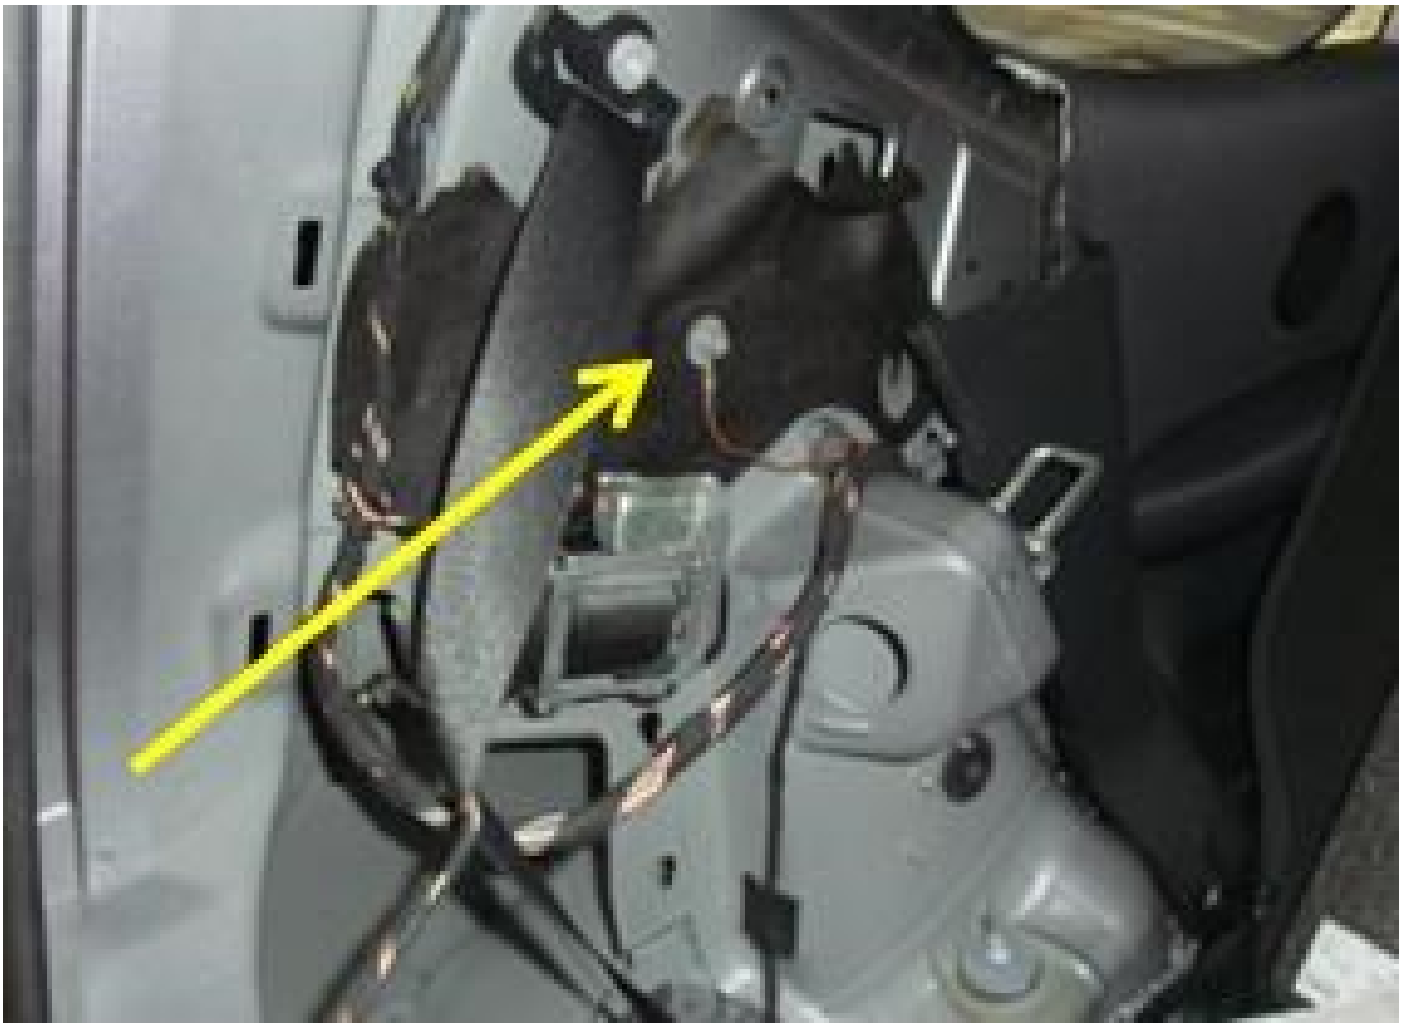
Fig.4

- Checking proper ground connection (corrosion/ transition connection) see Fig. 4.
