Mini F56 - Araç kabinine su girmesi

Moisture in the vehicle interior caused by condensation draining from the air-conditioning system

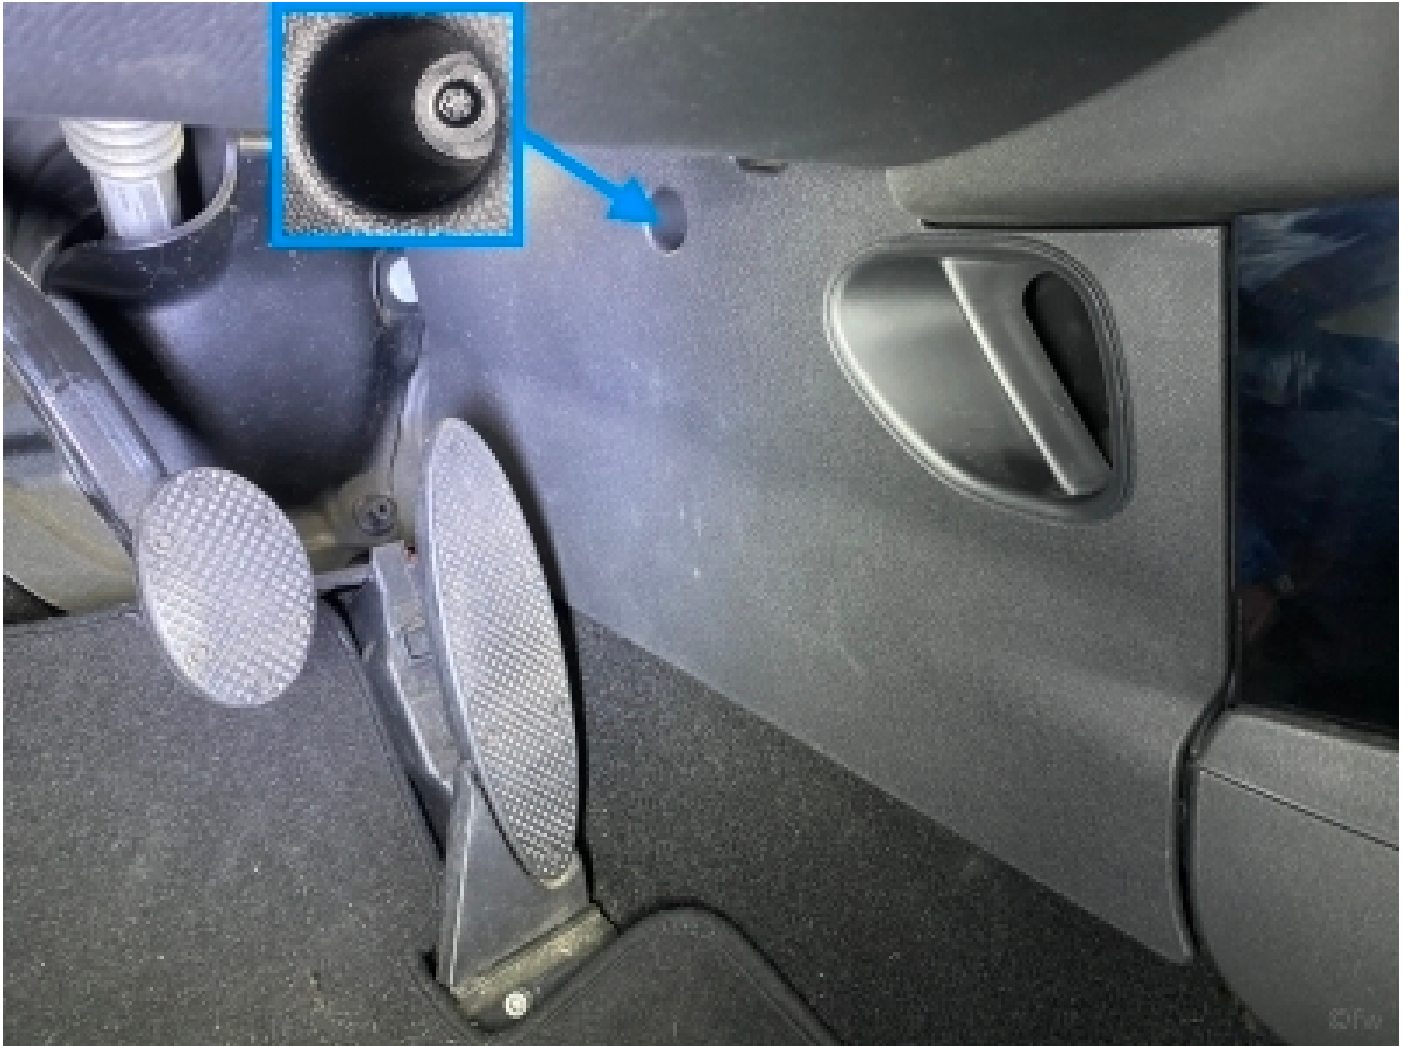
The side panelling (Fig. 1) in the footwell must be removed to carry out the necessary checks. In order to do this, the fastening screw has to be undone and the panelling removed from the brackets. The carpet can be pressed down slightly on the side underneath the air-conditioning unit in order to check it. The rubber seal of the water drain must fit all the way round the air-conditioning unit (Fig. 2) and have no kinks in it.

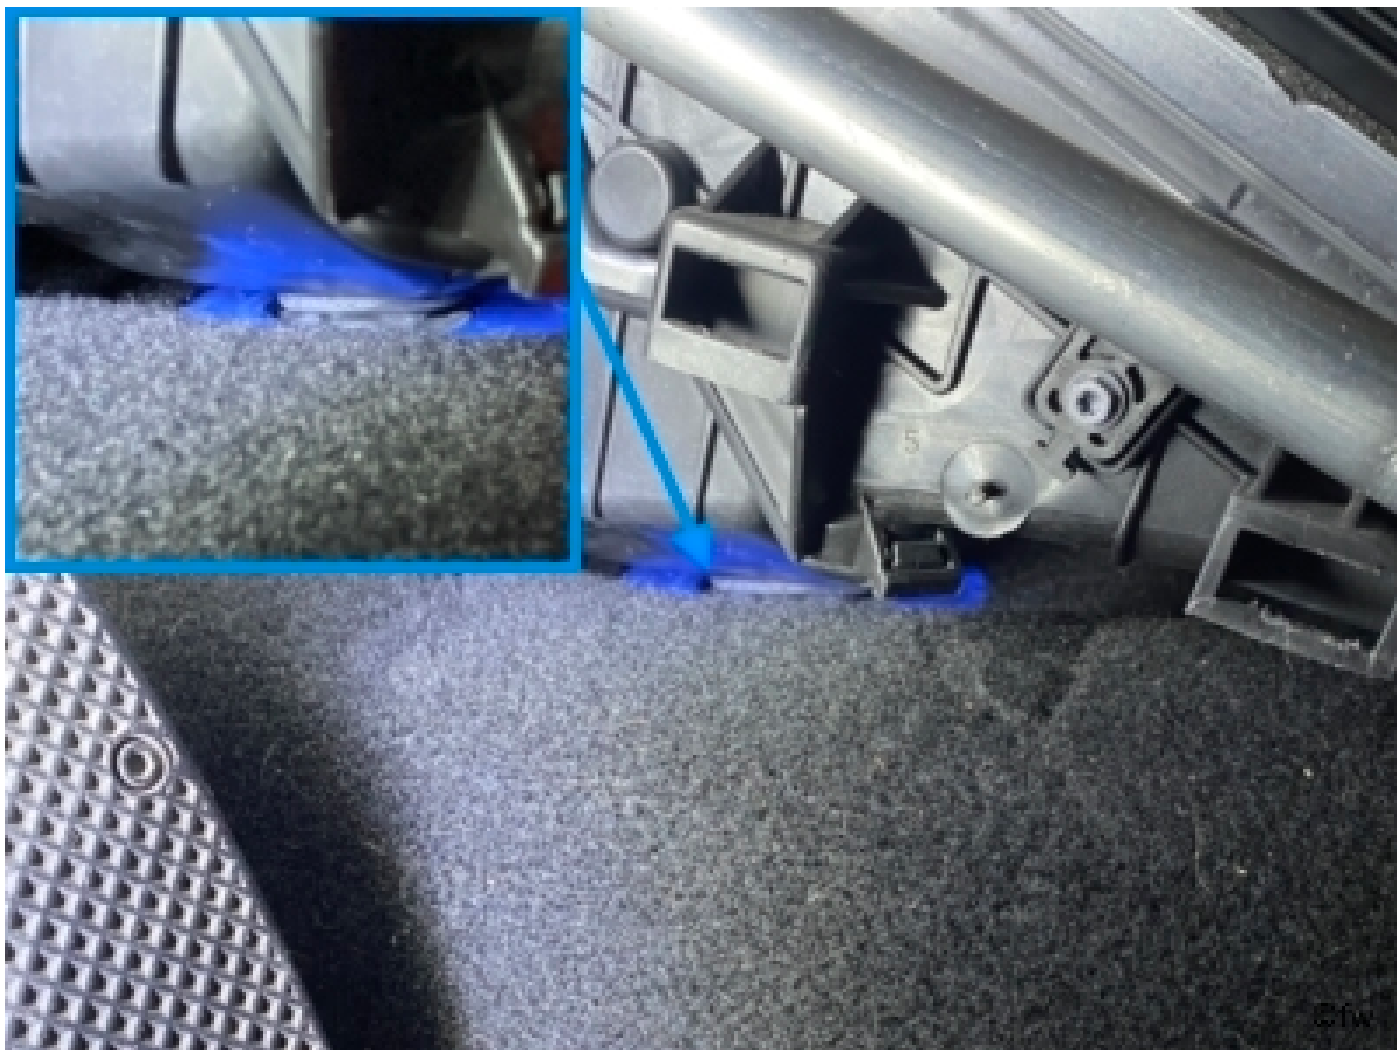
Deformation of the rubber seal means that condensation can no longer drain off properly. The water collects and is not drained off as intended, but enters the vehicle interior as a result of the deformed seal. The interior carpet absorbs the water, which can lead to unpleasant odours and, under certain circumstances, mould growth.

An endoscope is recommended for easier inspection. In the event of a fault, traces of water are usually visible on the side of the drain, indicating that the seal does not fit properly.

One test option is to set the air-conditioning system at maximum cooling capacity. In warm ambient temperatures, this causes condensation. In the event of a fault, this condensation would then run visibly past the seal and into the vehicle interior. If kinks or traces of water are visible, the condensation drain must be replaced. If mould is visible on the interior carpet, this should also be replaced.
