Mini F56 - Sinyal kornas# al###m#yor

Malfunction of the signal horn caused by faulty connecting cables in the steering wheel

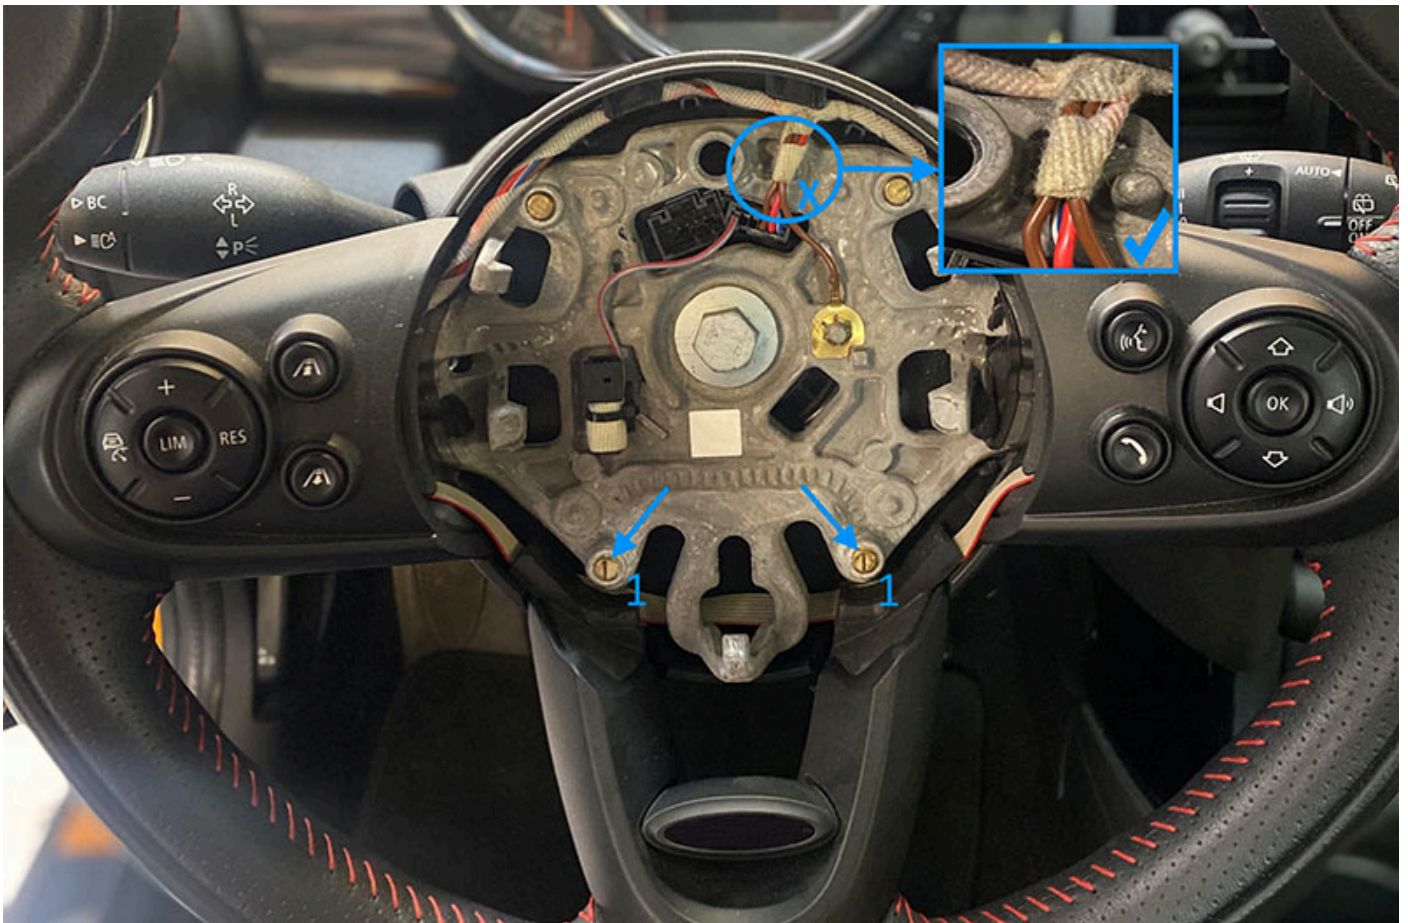
Incorrect routing of the connecting cables in the steering wheel or an unfavourable material pairing on the signal horn contacts between the steering wheel and the airbag unit may be responsible for this defect. Both problems can also occur simultaneously. An error memory entry that indicates a defect is not stored.

If the connecting cable is not laid correctly (see illustration), this has to be rectified. If the cable is visibly damaged, it must be replaced. If contamination is detected on the contact surfaces, a steering wheel with optimised contacts must be installed in accordance with the manufacturer's specifications. The problem has been identified by the vehicle manufacturer and rectified by means of a service solution using modified components.
