# **Nissan X-Trail (T31) - Leak from the fuel level sensor | HELLA**

**X-Trail (T31)**

**Engine: 2.5 i 16V**

## **Leak from the fuel level sensor**

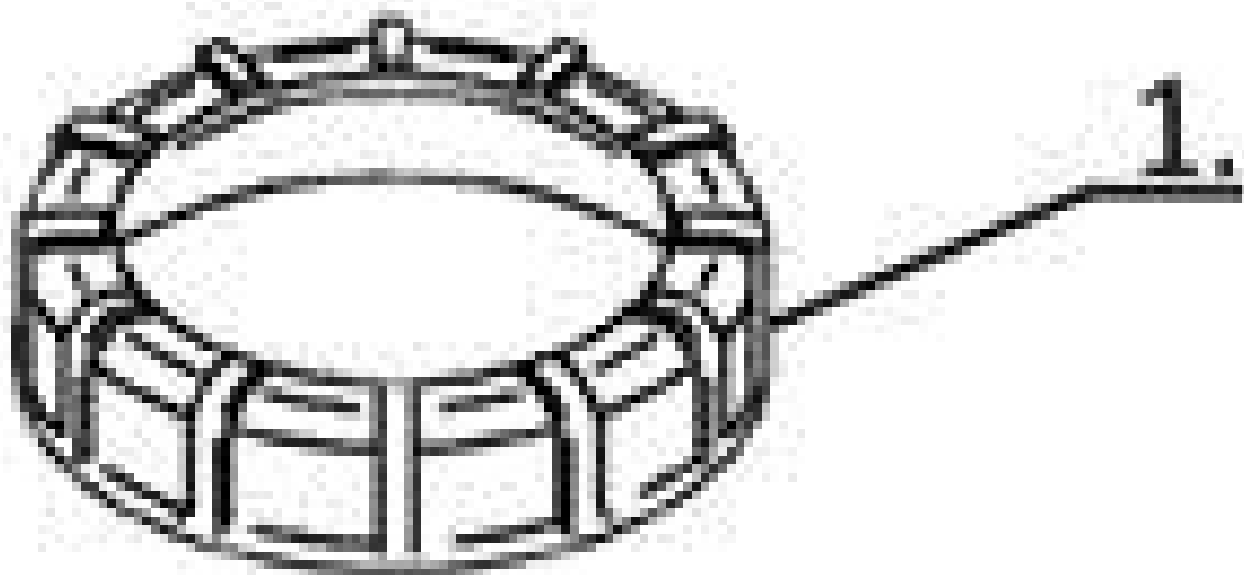
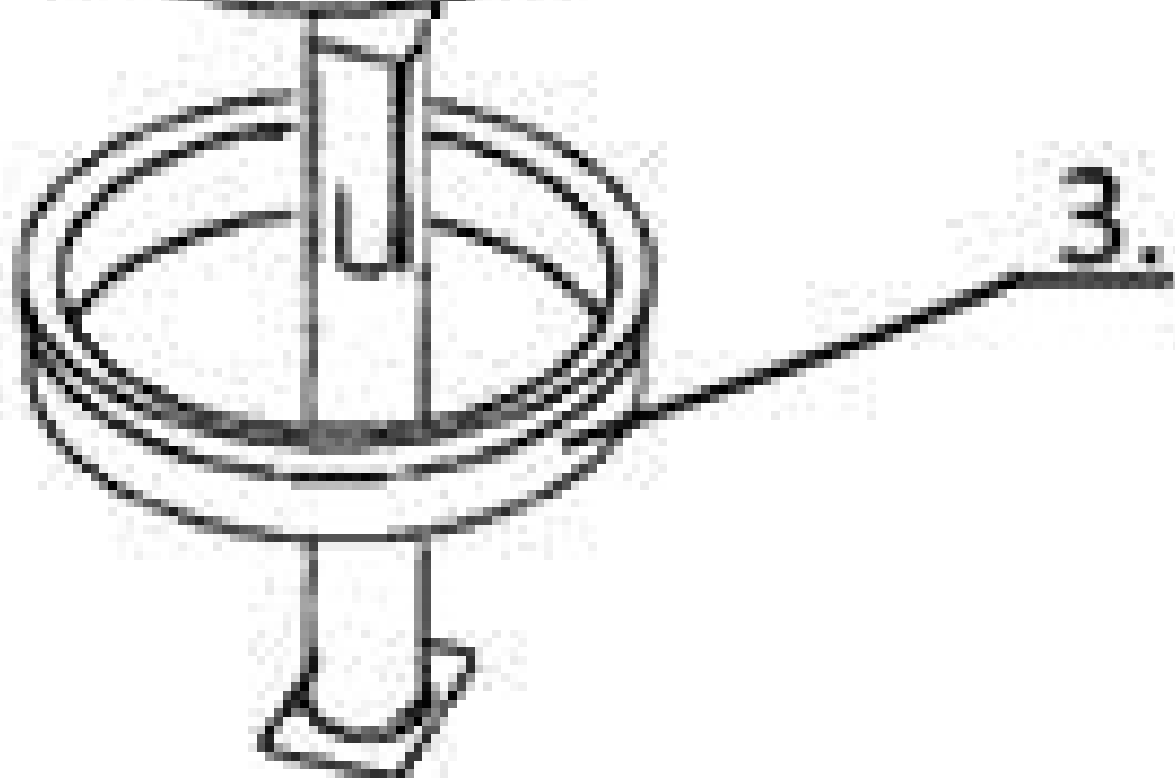
In most cases, the problem mentioned above only occurs when the tank is full.

The cause in such a case is inadequate sealing of the gas tank sensor because of a faulty seal.

Replace the defective gasket (Diagram - position 3) with a new one in accordance with the vehicle manufacturer's specifications.

Access to the mounting opening of the fuel level sensor unit is located below the rear seating area.

- Gasket 1734279900 (Diagram - position 3)

- Circlip 17343JG00A (Diagram - position 1)

- Fuel level sensor unit 25060JG00A (Diagram - position 2)
