BMW 2 Series Active Tourer - various system failures in conjunction with the multifunction steering wheel

Data sheet

Manufacturer	BMW
Vehicle model	2 Series Active Tourer (F45)
Engine	All
Year of manufacture	2014 - 2017
Symptoms	Failure of various systems in connection with problems on the multifunction steering wheel

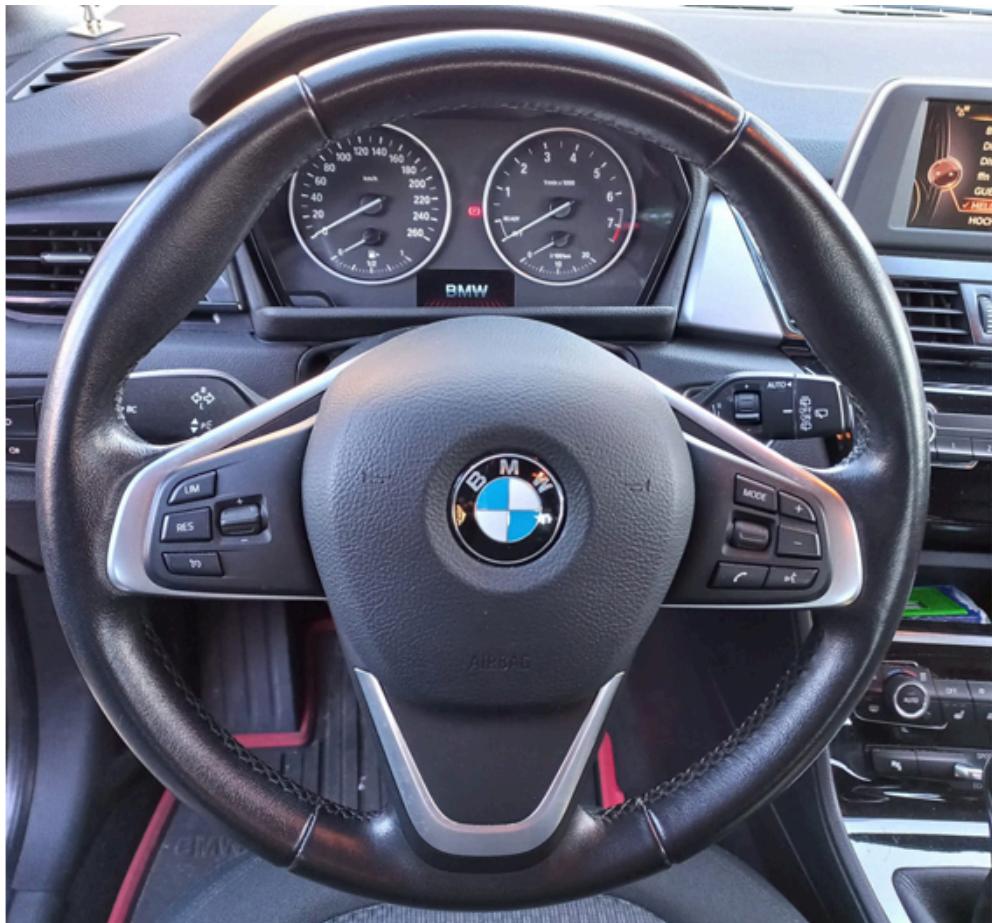
With the above-mentioned vehicle, various failures/malfunctions (cruise control, gear selector) may occur in conjunction with the multifunction steering wheel.

The error message "cruise control failed" may then appear in the instrument cluster. In addition, error code 030410 (MFL LIN slave) may be stored in the control unit.

This may be caused by poor contact between the steering wheel coil spring and the multiple connector on the steering wheel wiring harness.

In order to eliminate the problem, the coil spring and the steering wheel wiring harness must be replaced. As part of this job, it is recommended that you contact the vehicle manufacturer or an authorised BMW workshop.
