# BMW G31 520d - malfunctioning of instrument cluster

| Manufacturer | BMW |
| Vehicle model | G31 |
| Engine | 520d |

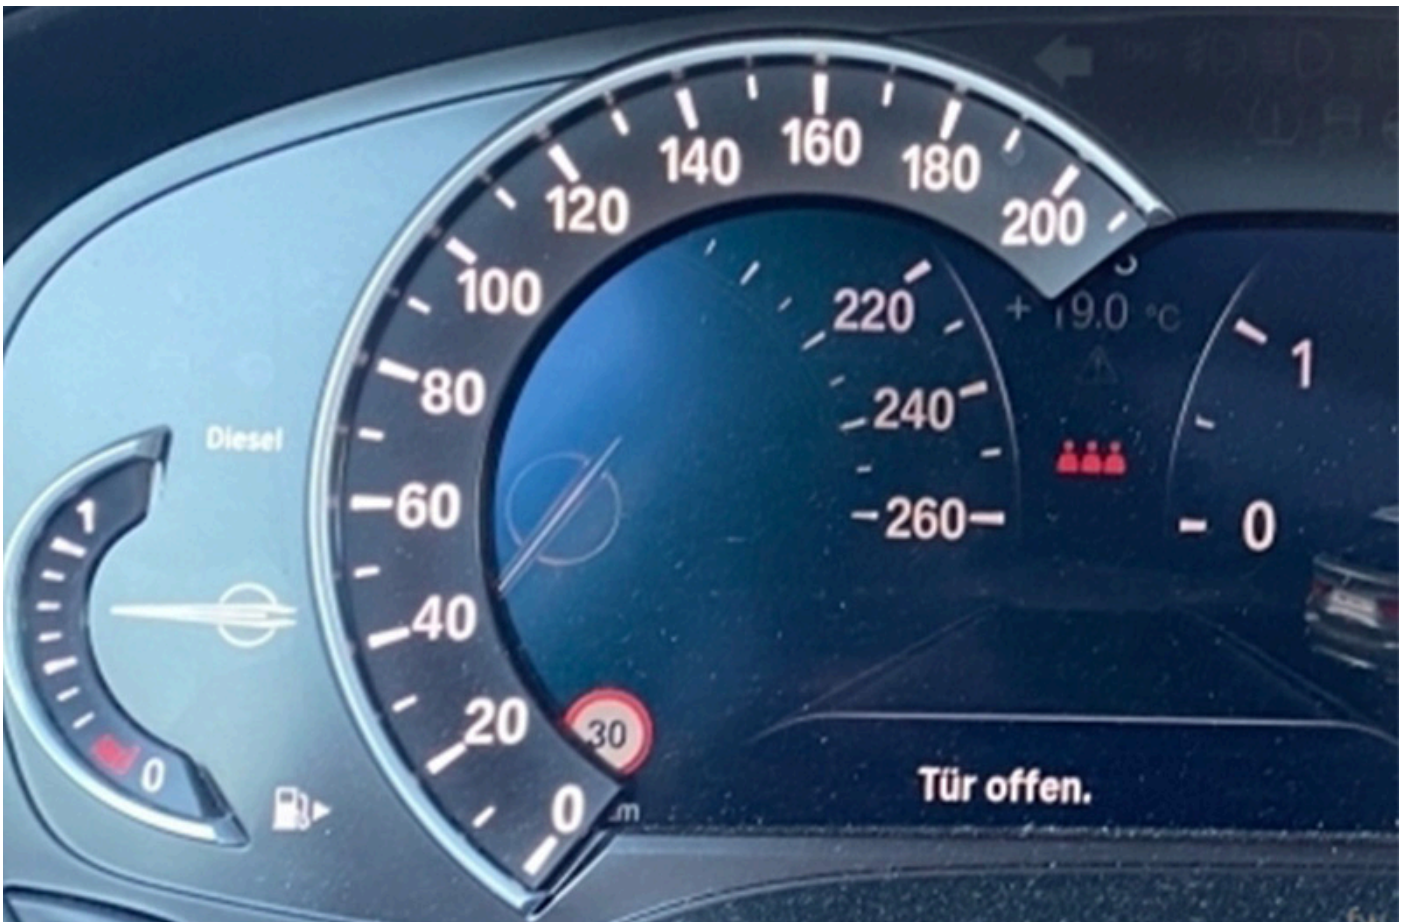
On the above-mentioned vehicle model, the display on the instrument cluster may sometimes be offset. This fault occurs after the vehicle has been stationary for a longer period of time and can be rectified for a while again after switching the ignition off/on. This defect may recur at irregular intervals.

If the above-mentioned defect should occur, it may be related to a software error in the instrument cluster. A firmware update of the instrument cluster electronics can help here. In such a case, the software version has to be checked and also updated if necessary. A software update can be carried out, for example, via Hella-Gutmann macsRemote Services or by using a pass-through-capable diagnostic device from the mega macs series. Furthermore, registered access to the vehicle manufacturer's online portal is required.
