# Mercedes C-Class - ESP/ABS pilot lamp lights up | HELLA

**Mercedes**

**C-Klasse (W 203)**

## **ESP/ABS pilot lamp lights up**

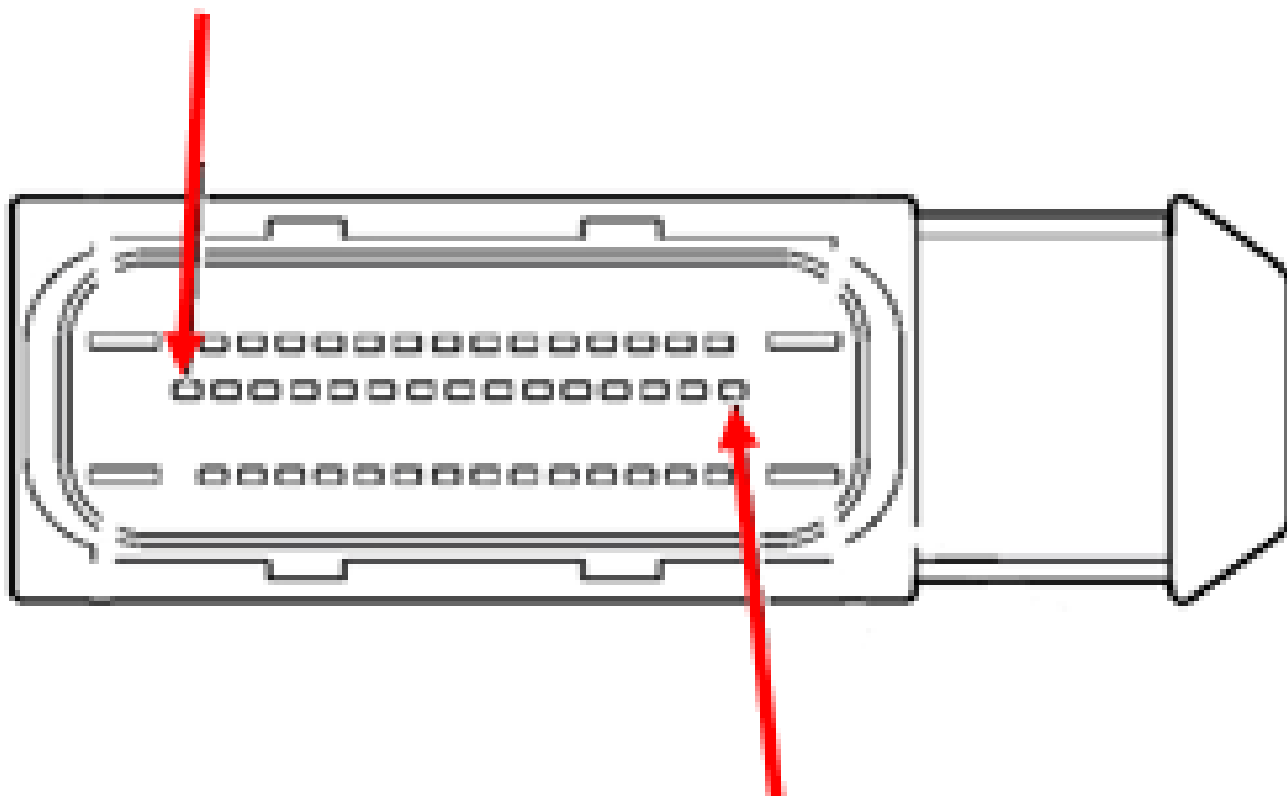
If a customer complains about the above error, this could be caused by a corroded plug connection. Error codes C1140 (steering wheel angle sensor, incorrect signal) and C1145 (ABS wheel speed sensor VR, interruption) may occur.

1. Check connector pins 18, 19 and 20 (all three on the brake pressure sensor) of the plug connection on the ABS/ESP control unit (see Fig.); clean and dry if necessary. The control unit is located in the left side of the engine compartment in the control unit box behind the spring dome.
2. If damage is already severe, use the repair kit to replace the pins.
3. Treat the plug connection with electronic spray or grease before contacting.
4. Check the wiring harness of the brake pressure sensor for continuity. Max. resistance is 0.5 Ohm.
