## Mini F56 - signal horn not functioning

## Malfunction of the signal horn caused by faulty connecting cables in the steering wheel

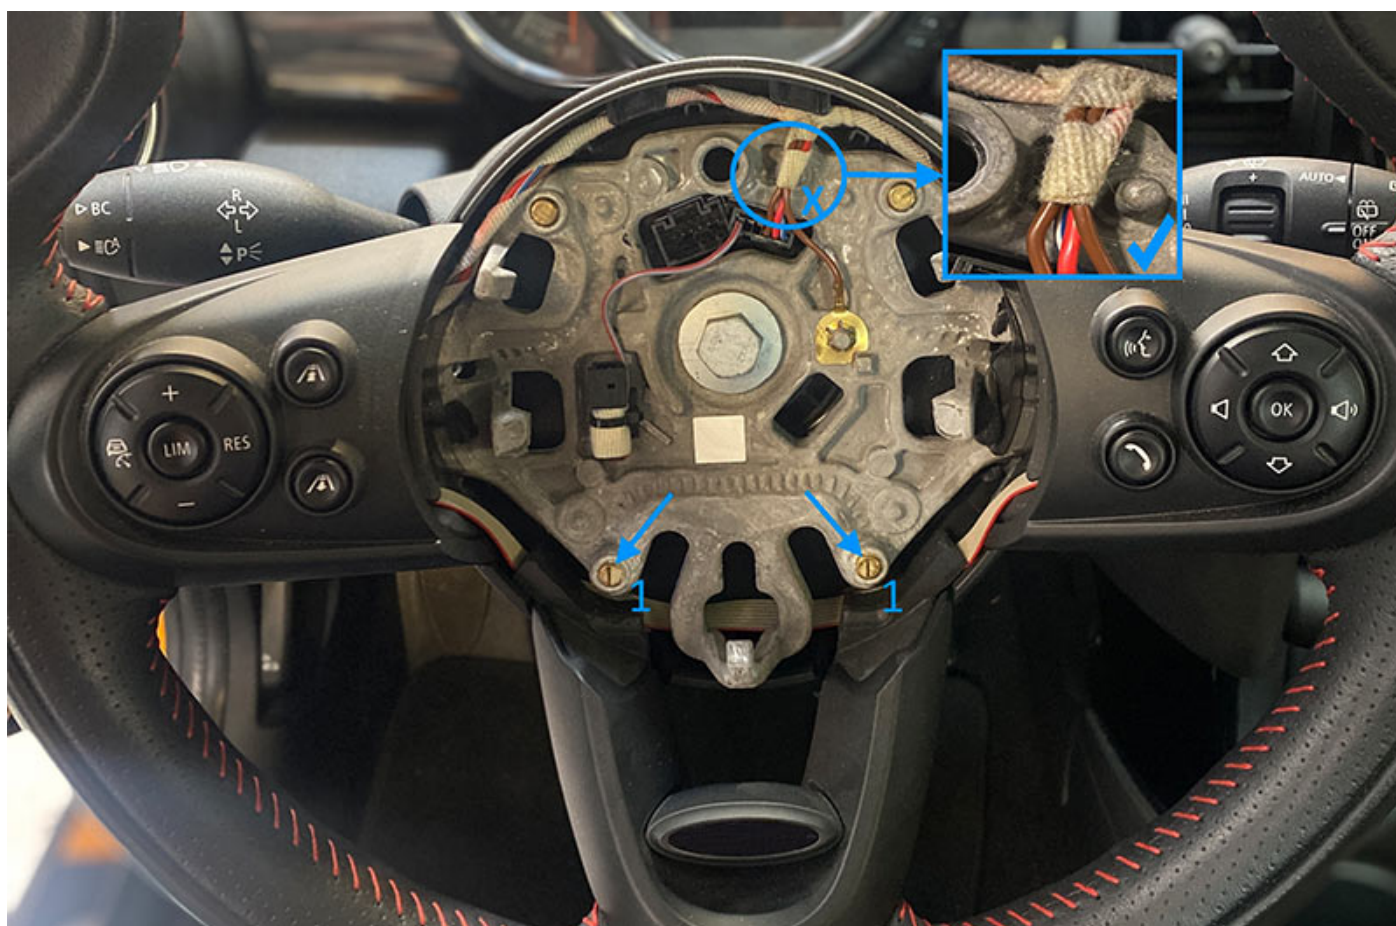
Incorrect routing of the connecting cables in the steering wheel or an unfavourable material pairing on the signal horn contacts between the steering wheel and the airbag unit may be responsible for this defect. Both problems can also occur simultaneously. An error memory entry that indicates a defect is not stored.

If the connecting cable is not laid correctly (see illustration), this has to be rectified. If the cable is visibly damaged, it must be replaced. If contamination is detected on the contact surfaces, a steering wheel with optimised contacts must be installed in accordance with the manufacturer's specifications. The problem has been identified by the vehicle manufacturer and rectified by means of a service solution using modified components.
