# **Nissan X-Trail (T31) - Leak from the fuel level sensor | HELLA**

**X-Trail (T31)**

**Engine: 2.5 i 16V**

## **Leak from the fuel level sensor**

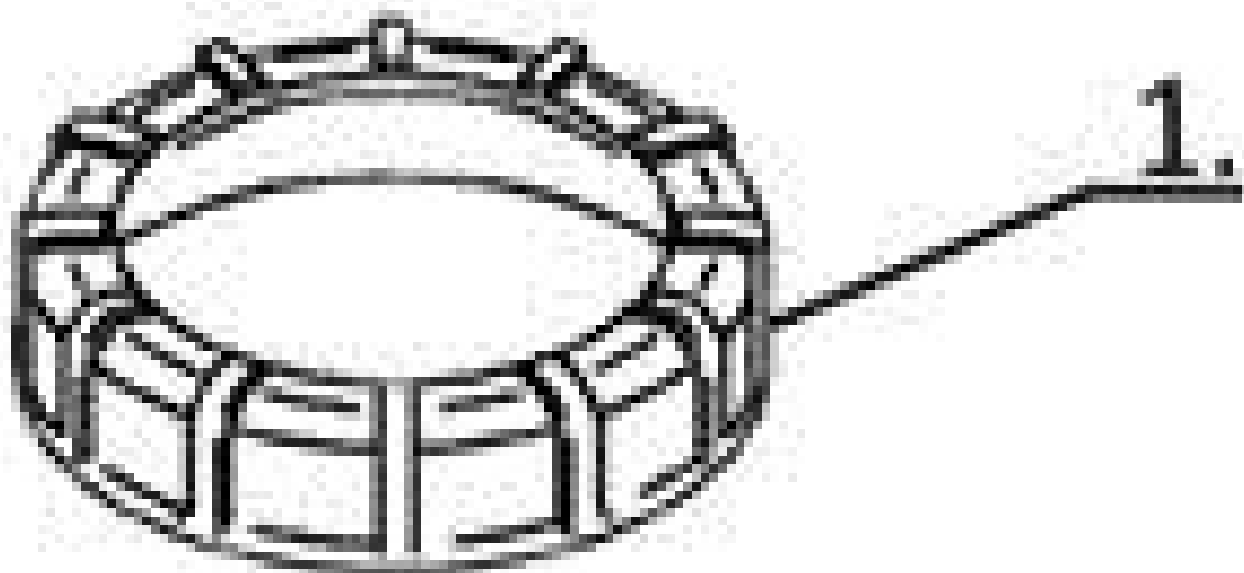
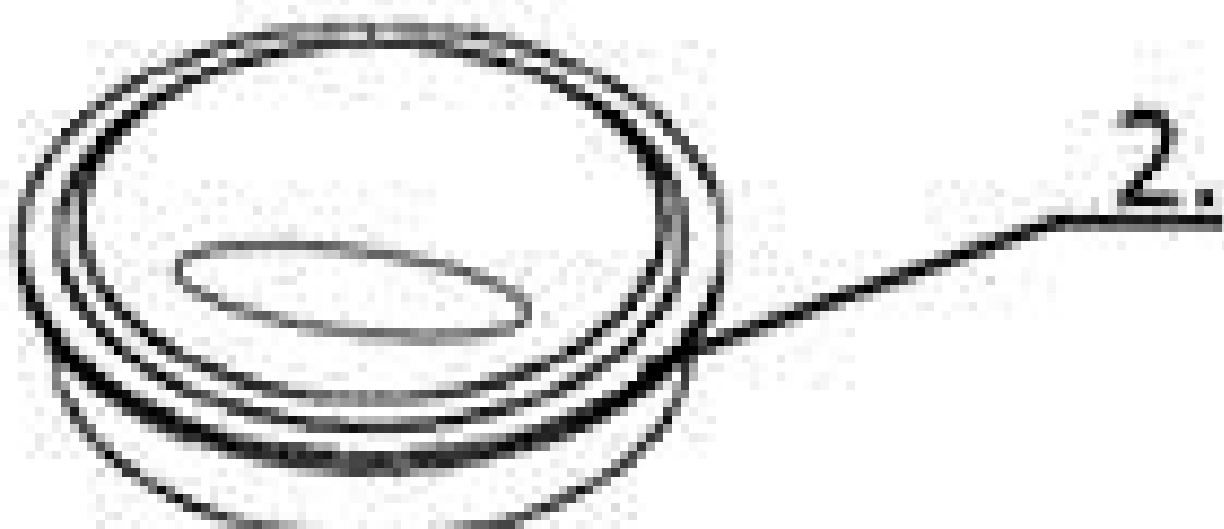
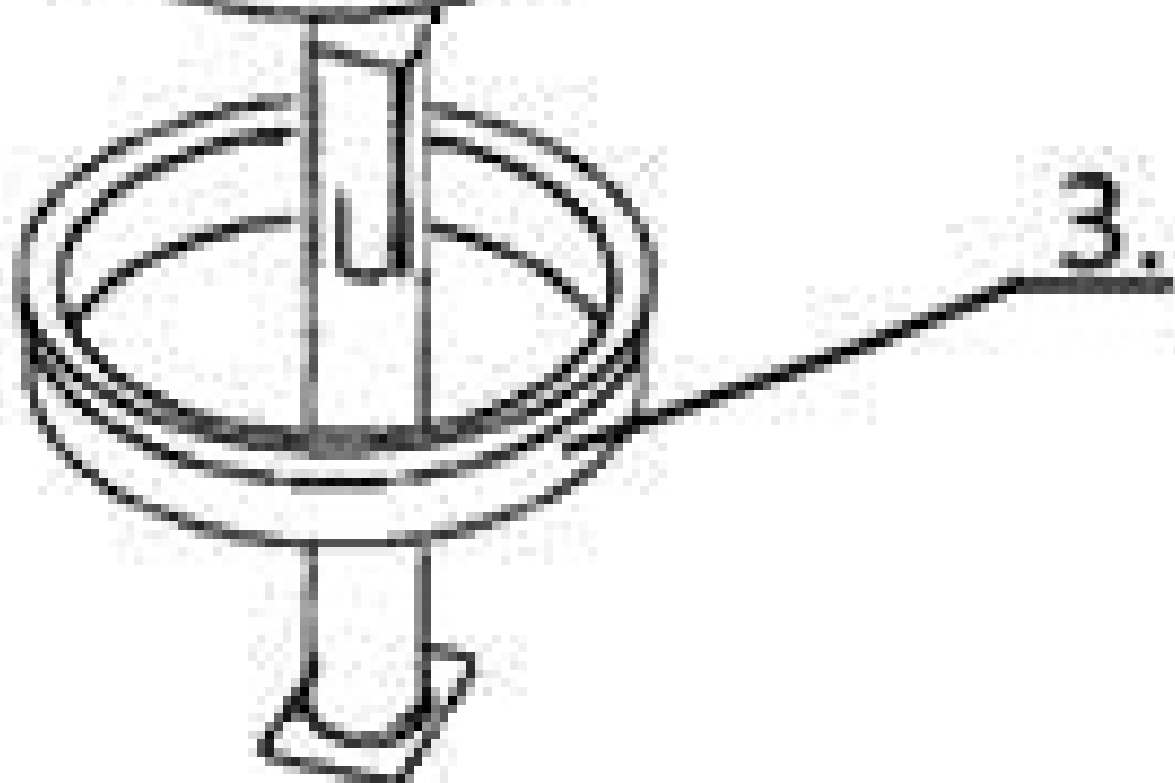
In most cases, the problem mentioned above only occurs when the tank is full.

The cause in such a case is inadequate sealing of the gas tank sensor because of a faulty seal.

Replace the defective gasket (Diagram - position 3) with a new one in accordance with the vehicle manufacturer's specifications.

Access to the mounting opening of the fuel level sensor unit is located below the rear seating area.

- Gasket 1734279900 (Diagram - position 3)

- Circlip 17343JG00A (Diagram - position 1)

- Fuel level sensor unit 25060JG00A (Diagram - position 2)
