# **Peugeot 307 - Poor acceleration performance | HELLA**

**307 HDI**

**Engine code: 9HZ (DV6TED4)**

**Poor acceleration performance**

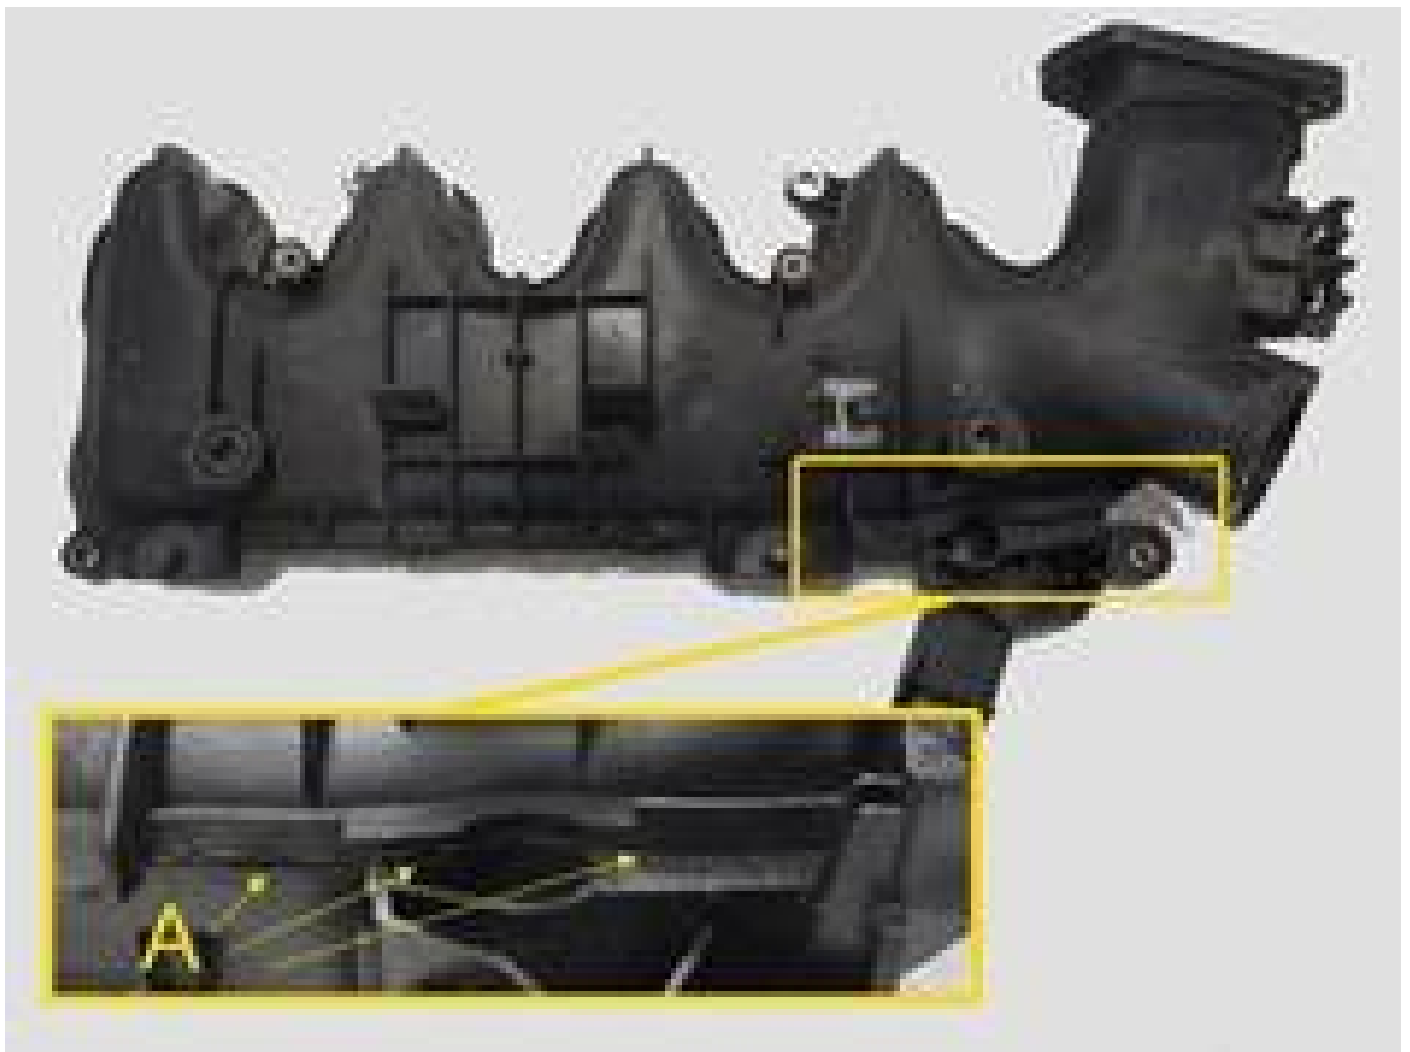
The intake manifold consists of two plastic housing halves bonded together. A leaky bonded joint (A) causes air to escape as boost pressure increases, while also making a distinctive noise. Depending on the size of the leak, the following fault entries may occur in the engine control unit.

P0100 - Air-mass sensor malfunction

P3008 - Air flow too strong

If a leak is detected, the intake manifold must be completely replaced. It cannot be repaired. Replacing the intake manifold requires removing the high-pressure fuel lines for the injection valves (injectors).

In order to avoid leaks later, carefully remove and re-install the lines.
