## Peugeot 307cc- engine cuts out

## Anti-lock braking system (ABS) error message present, engine switches off and cannot be restarted

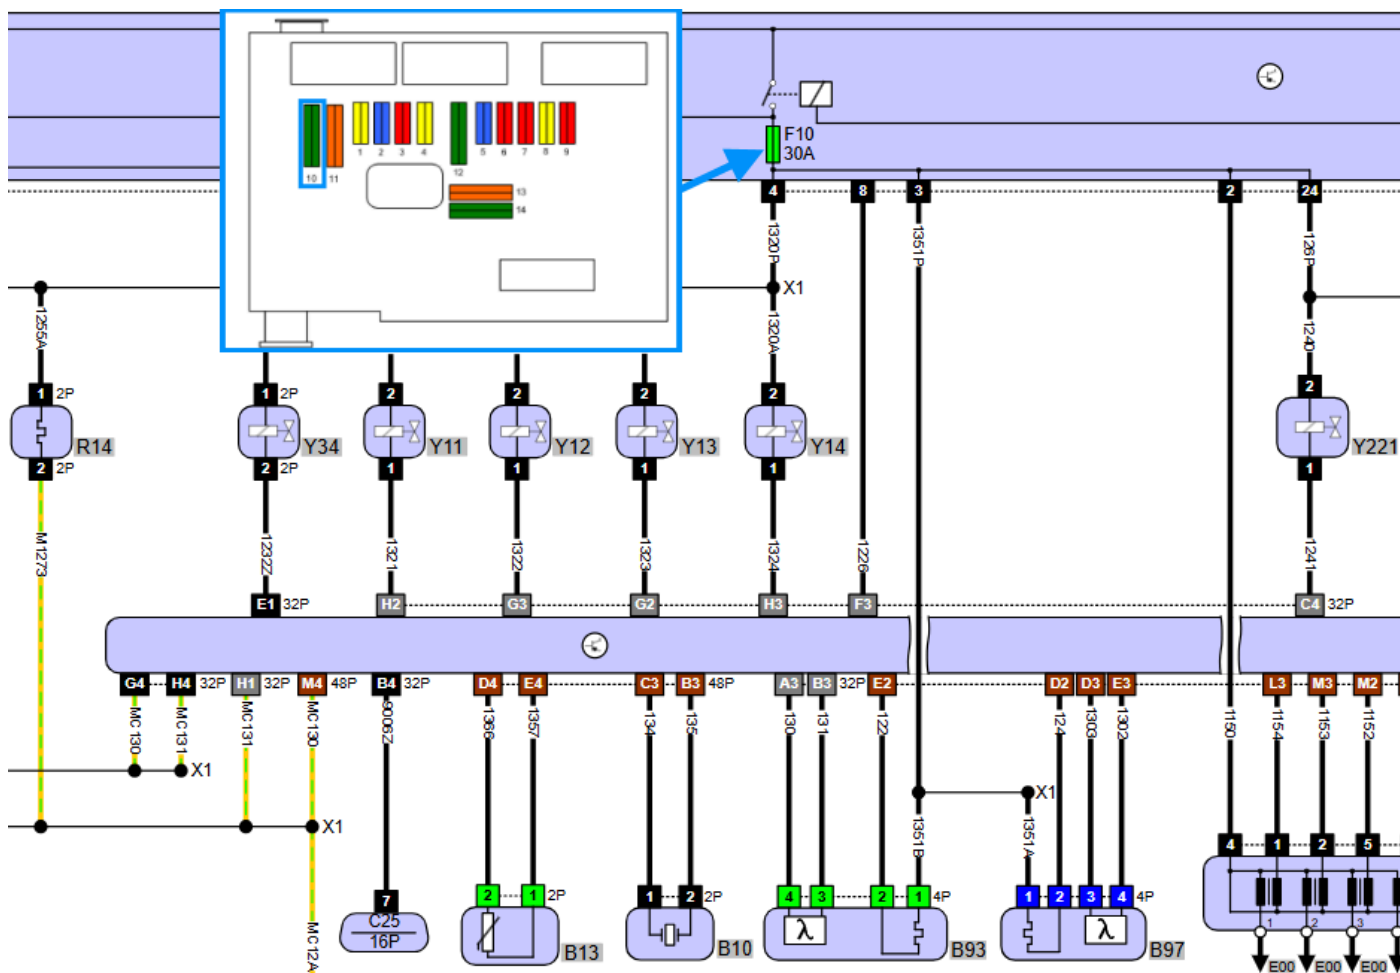
The fuses should be carefully checked as the first troubleshooting step. Pay particular attention to fuse F10 (30A) in the fuse and relay box in the engine compartment. The fuse must be removed and visually inspected for defects. If there are no obvious defects on the fusible wire, a continuity test can be carried out with a suitable measuring device for a more precise check. If the fuse is visually defective or measurements are out-of-spec, a possible cause may be a defective heating element on one of the two lambda sensors.

In order to check whether the lambda sensors are responsible for tripping the fuse, a circuit breaker with 30 A can be temporarily inserted in the slot of fuse F10 for troubleshooting purposes. This circuit breaker trips in the event of a short circuit and can then be switched on again. After inserting the circuit breaker, the plug connections of the sensors are disconnected one after the other. Each time the plug connection is disconnected, the engine has to be started and, if necessary, a test drive carried out to check whether the short circuit is still present. If the circuit breaker no longer trips, the fault is in the previously disconnected component.
