## Tesla Y - water ingress in interior fan

## Water ingress on passenger side, interior fan noise

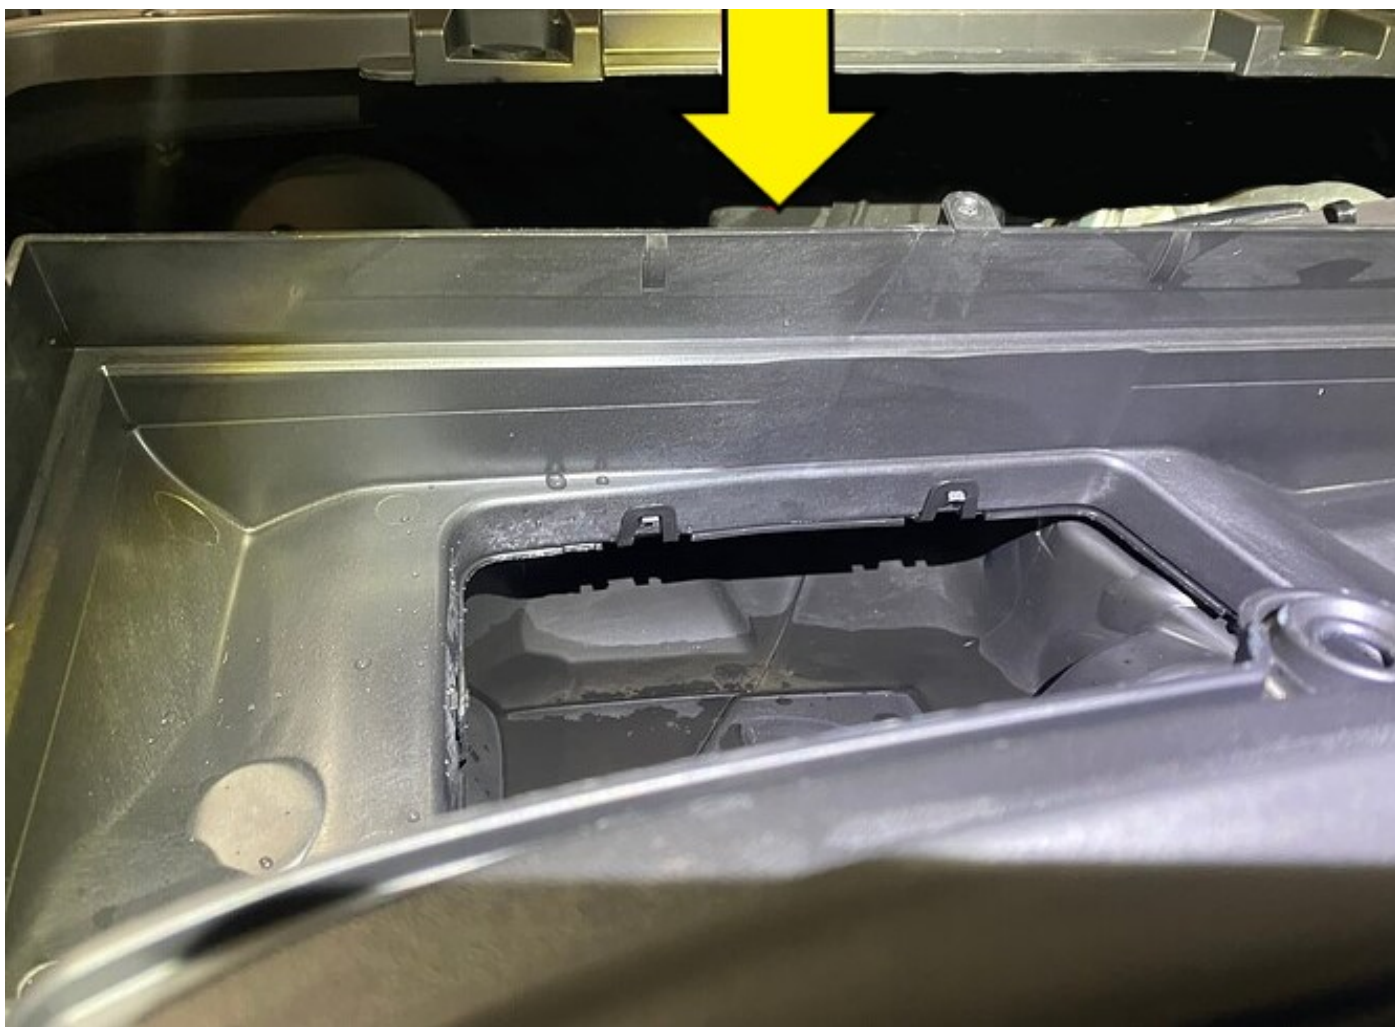
In order to confirm the cause, the cabin air filters should be removed. These can be reached from the engine compartment (underneath the water box cover). A seal should be visible above the vent box. If it is only loosely attached or shows no real contact pressure, water will enter the vehicle interior via the ventilation housing and the ventilation shafts when it rains.

Sealing the ventilation box of the cabin air filter

Remedy or repair measures are to be carried out in accordance with the vehicle manufacturer's instructions.
