# VW Sharan - ESP lamp lights up | HELLA

**Sharan**

**Model year: until 2008**

## **ESP lamp lights up**

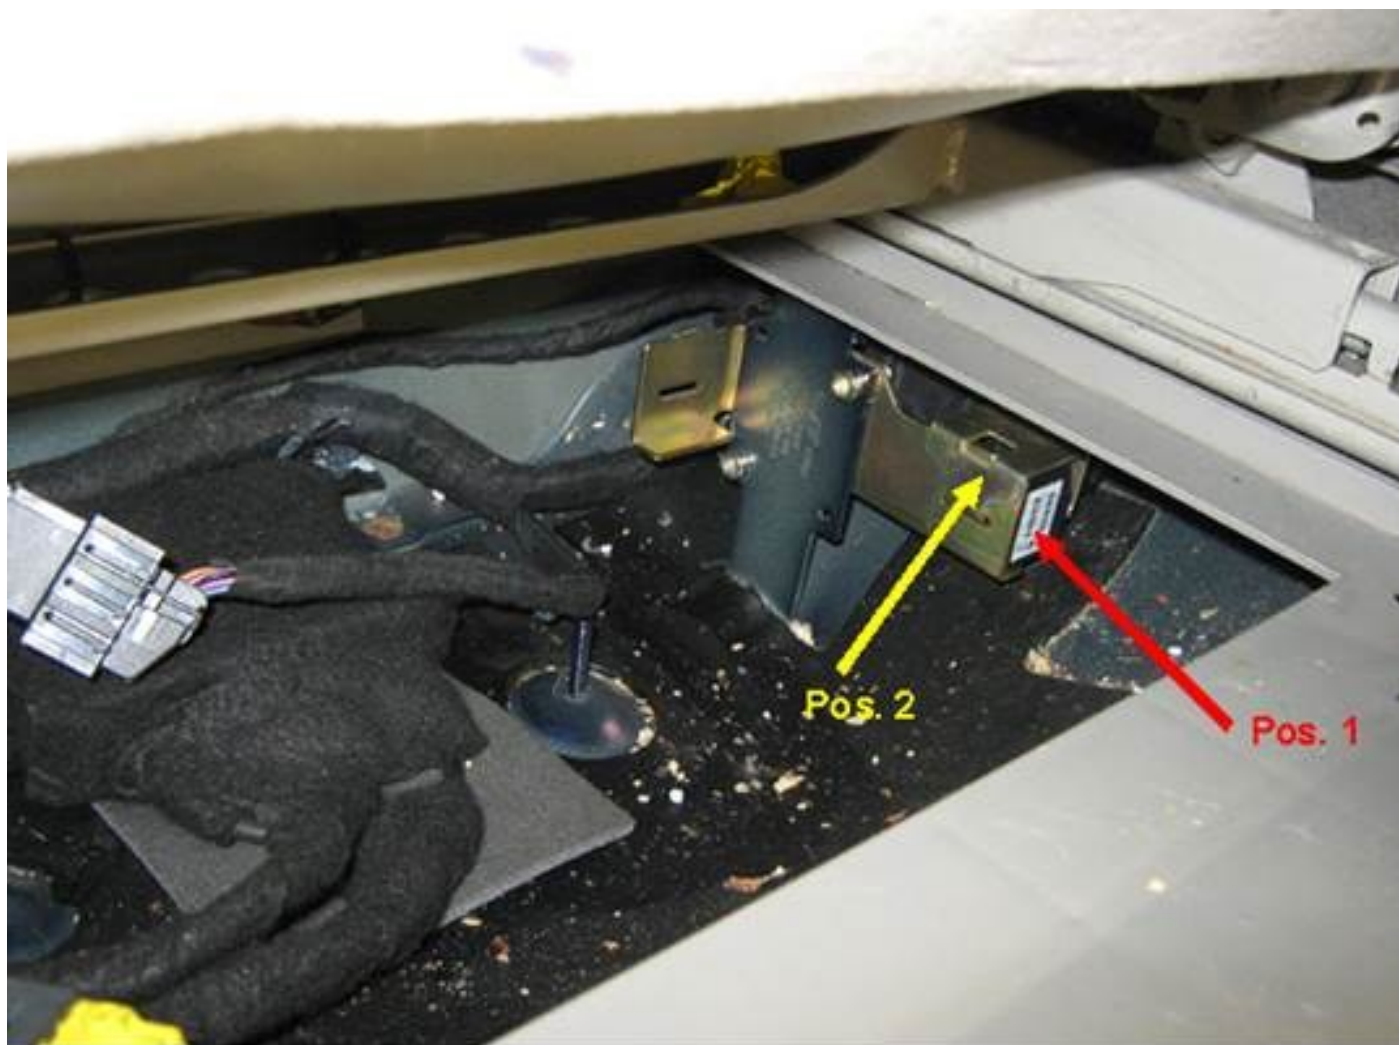
Figure 1

If the ESP warning lamp lights up sporadically or permanently in the above vehicles, this may be caused by a faulty lateral acceleration sensor.

The lateral acceleration sensor (G200) is located under the driver's seat. It can be designed as a combination sensor (rotation rate + lateral acceleration) or as a single sensor. The single sensor is located below the right seat rail (Figure 1, Pos. 1).

- Loosen the clamp of the sensor (Figure 1, Pos. 2)
- Unlock and disconnect the sensor plug
- Remove the sensor
- Install the new sensor and connect the plug
- Calibrate or zero the sensor using a diagnostic instrument
- Clear the fault memory
- Carry out a test drive

Note: The fault memory can often be cleared only after the zeroing the new sensor.
