## VW T6 - fuel loss

## Vehicle smells of diesel - fuel loss

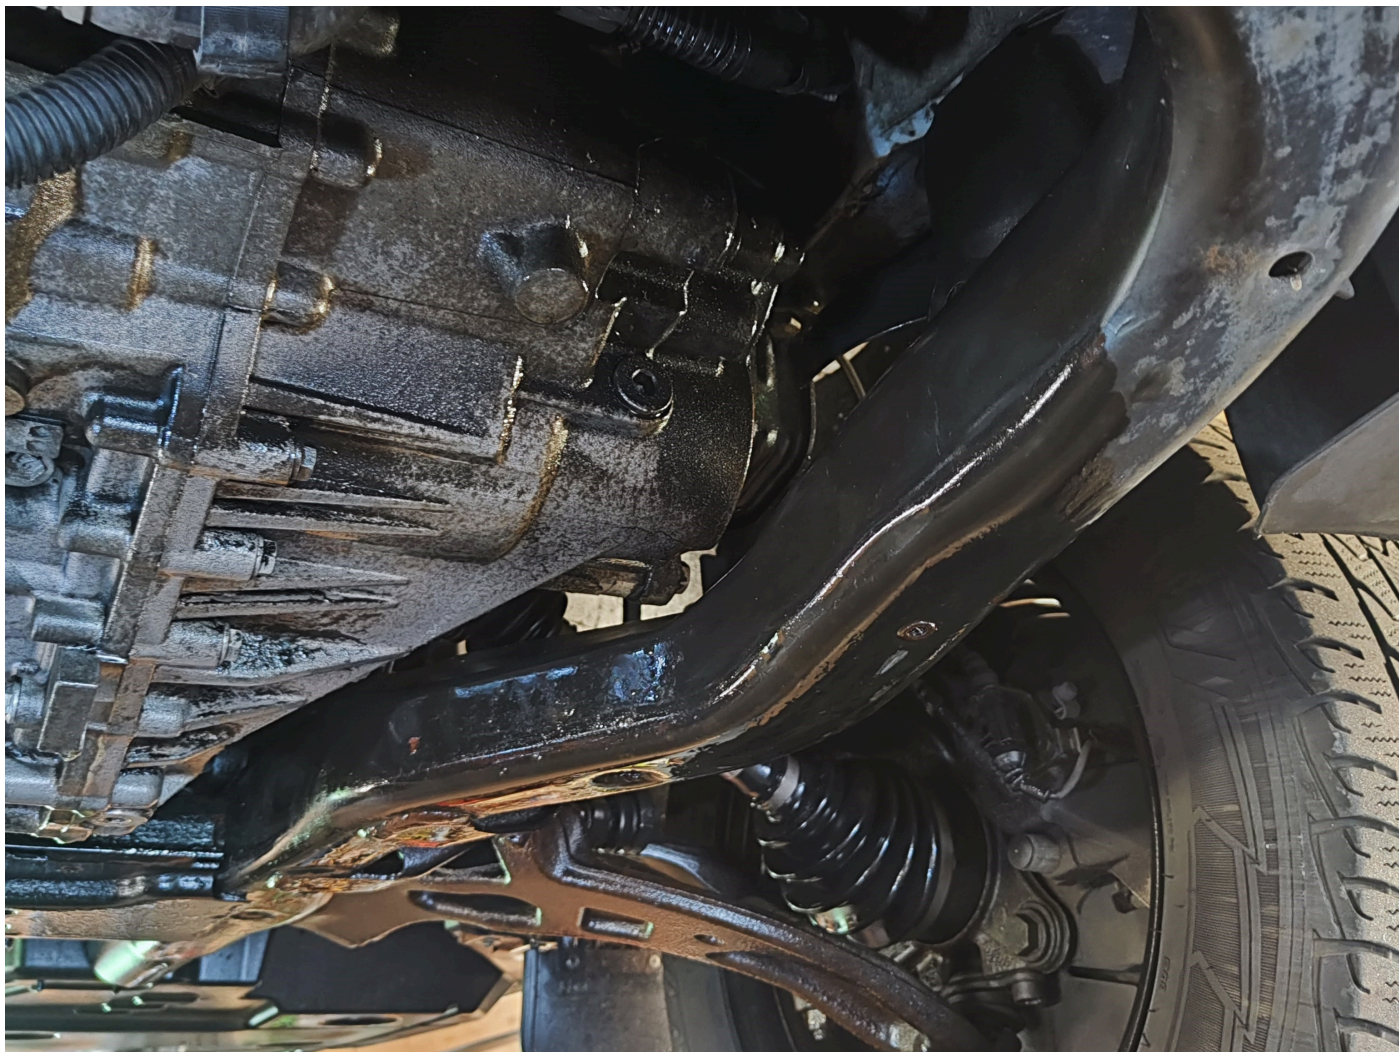
On the vehicle mentioned above, it can happen that a strong smell of diesel suddenly becomes very noticeable. Leaking fuel may also have accumulated in the engine compartment or under the vehicle. The cause of this is not always immediately recognisable. Firstly, the fuel lines and their connections in the engine compartment should be checked. If no leak is found, the fuel filter housing may be the cause of the diesel loss.

Fuel loss T6

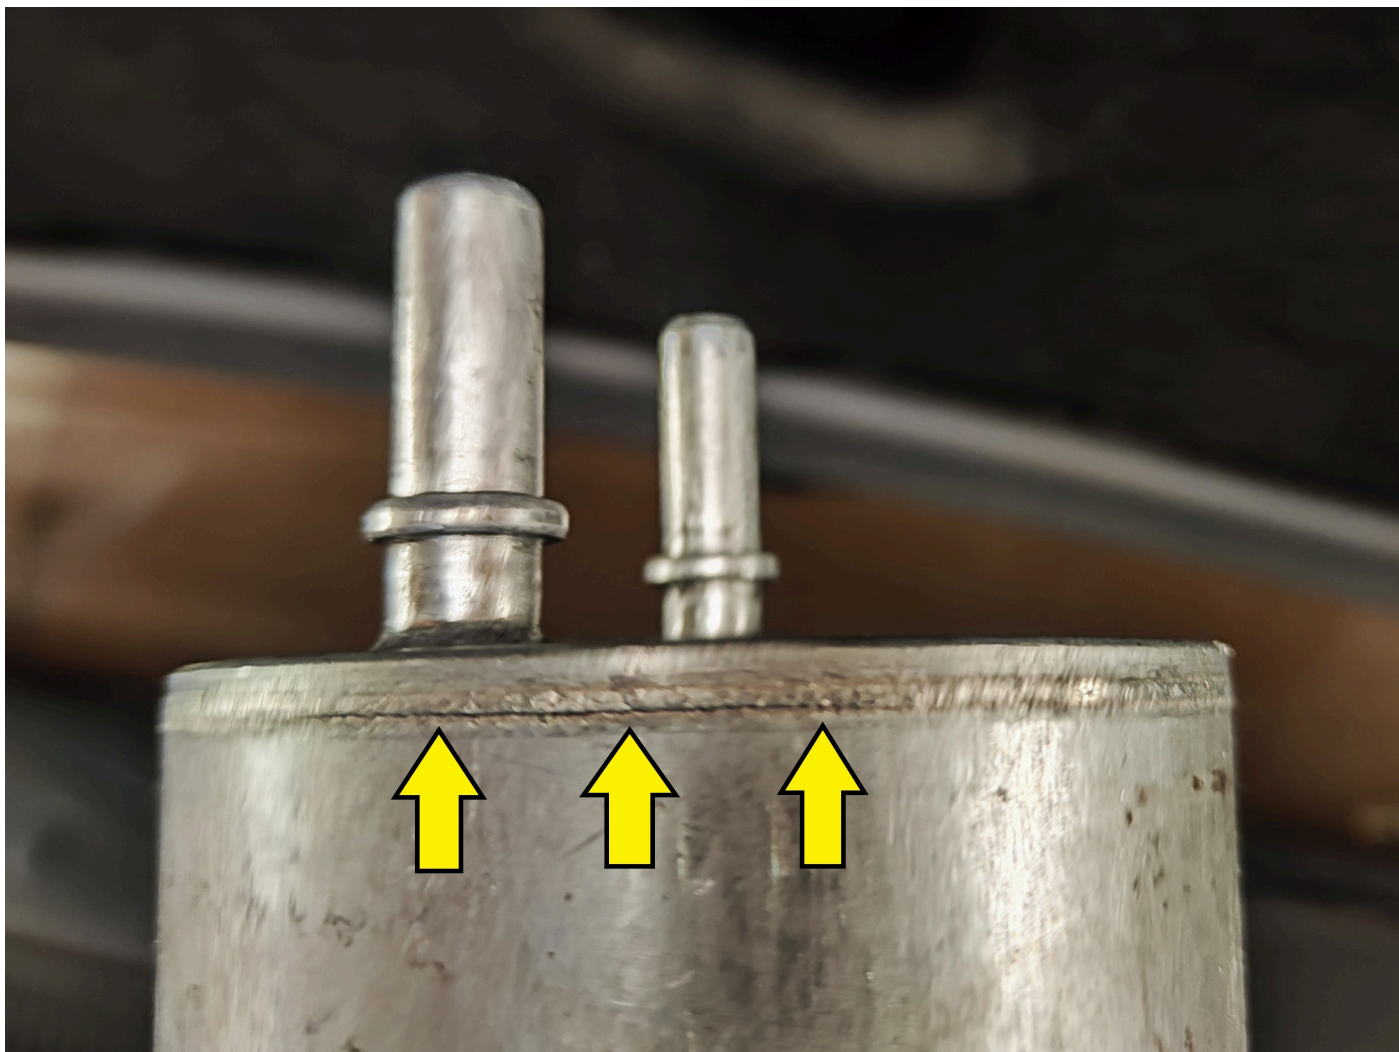
If you now take a look at the upper area of the filter, in some cases a horizontal hairline crack can be seen, which is responsible for the leak.

Fuel filter T6

In order to remedy the situation, the filter should be replaced and the fuel system bled in accordance with the vehicle manufacturer's instructions. We recommend cleaning the engine compartment as a final step of the repair.
