Vauxhall Astra K - power steering failure

Data sheet

Manufacturer	Vauxhall
Vehicle model	Astra K
Engine	1.4 16V Turbo (B14XFT)
Year of manufacture	2019
Symptoms	Power steering failure

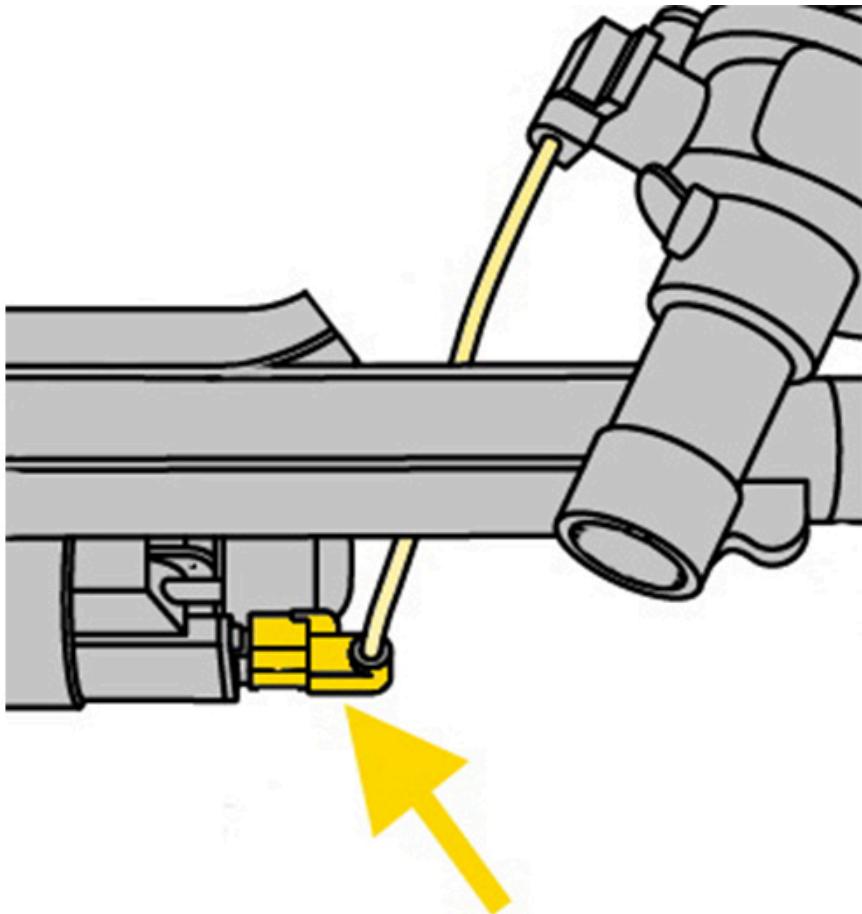
The following problem is observed in the vehicles mentioned above: Vehicle steering sluggish.

The reason for this is an insufficient plug connection between the steering angle sensor and the wiring harness (see figure).

First disconnect the plug connection and check for dirt and damage; if necessary, clean and repair it according to the manufacturer's instructions. Then reconnect the connectors, making sure that the plug connection is correctly seated.

Subsequently run a fault code query and go for a test drive to check the measure.
