# Volkswagen Up/Seat Mii - engine start impaired: Error code 4629

## Data sheet

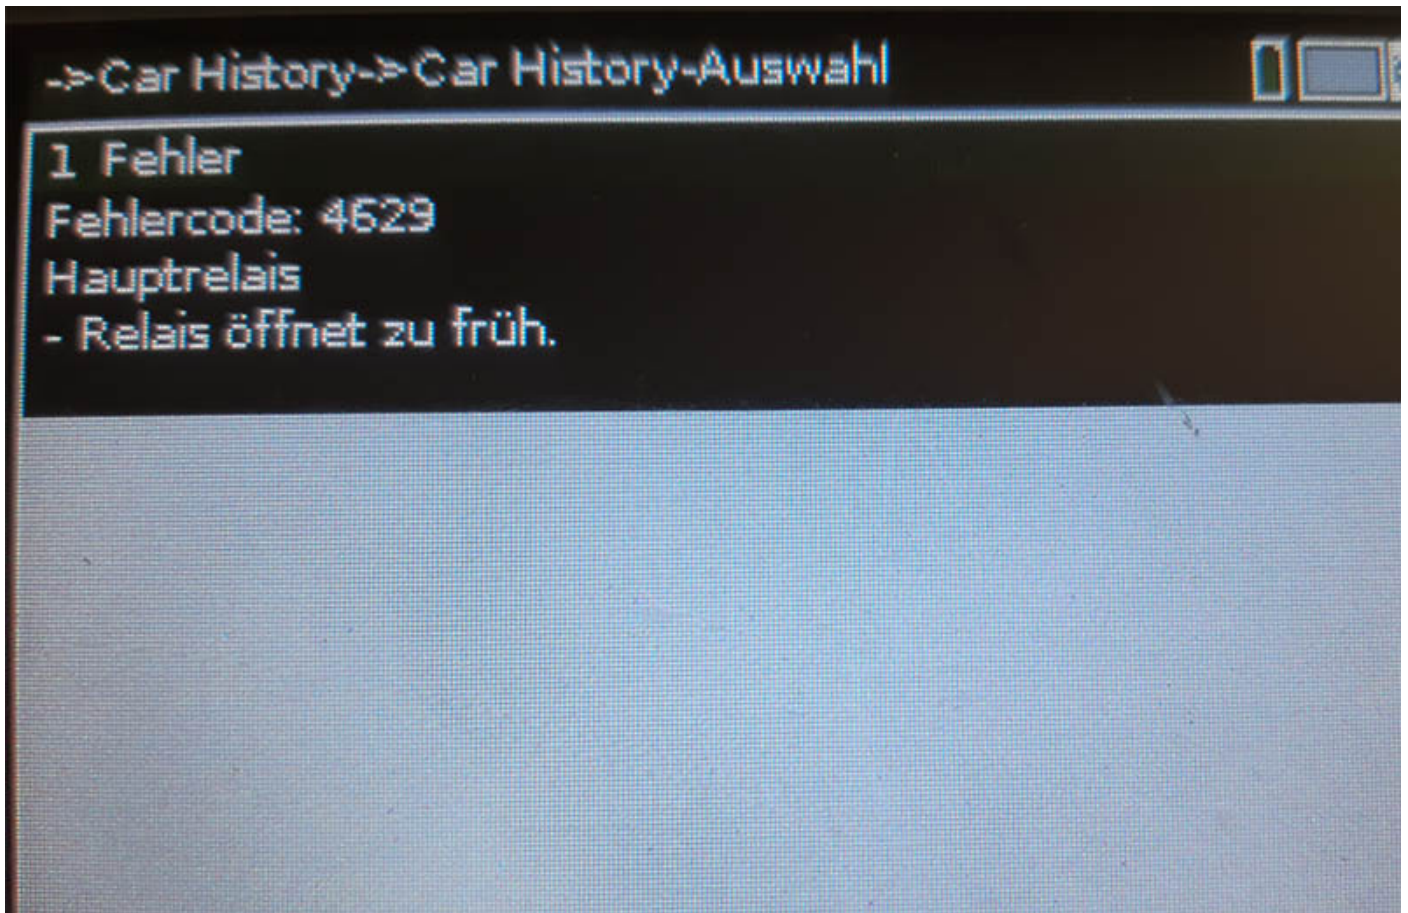
The first step is reading out the error memory. Error code 4629 (main relay opens too early) may be stored. ([Fig. 1](#)) This leads to the assumption that a relay is faulty. The relays can be reached relatively easily after removing the left cover on the dashboard. ([Fig. 2](#)) The position of the main relay(s) should be identified using a relay plan ([Fig. 3](#)). One of the relays controls the fuel pump. If the relay is defective, this would explain why the engine does not start.

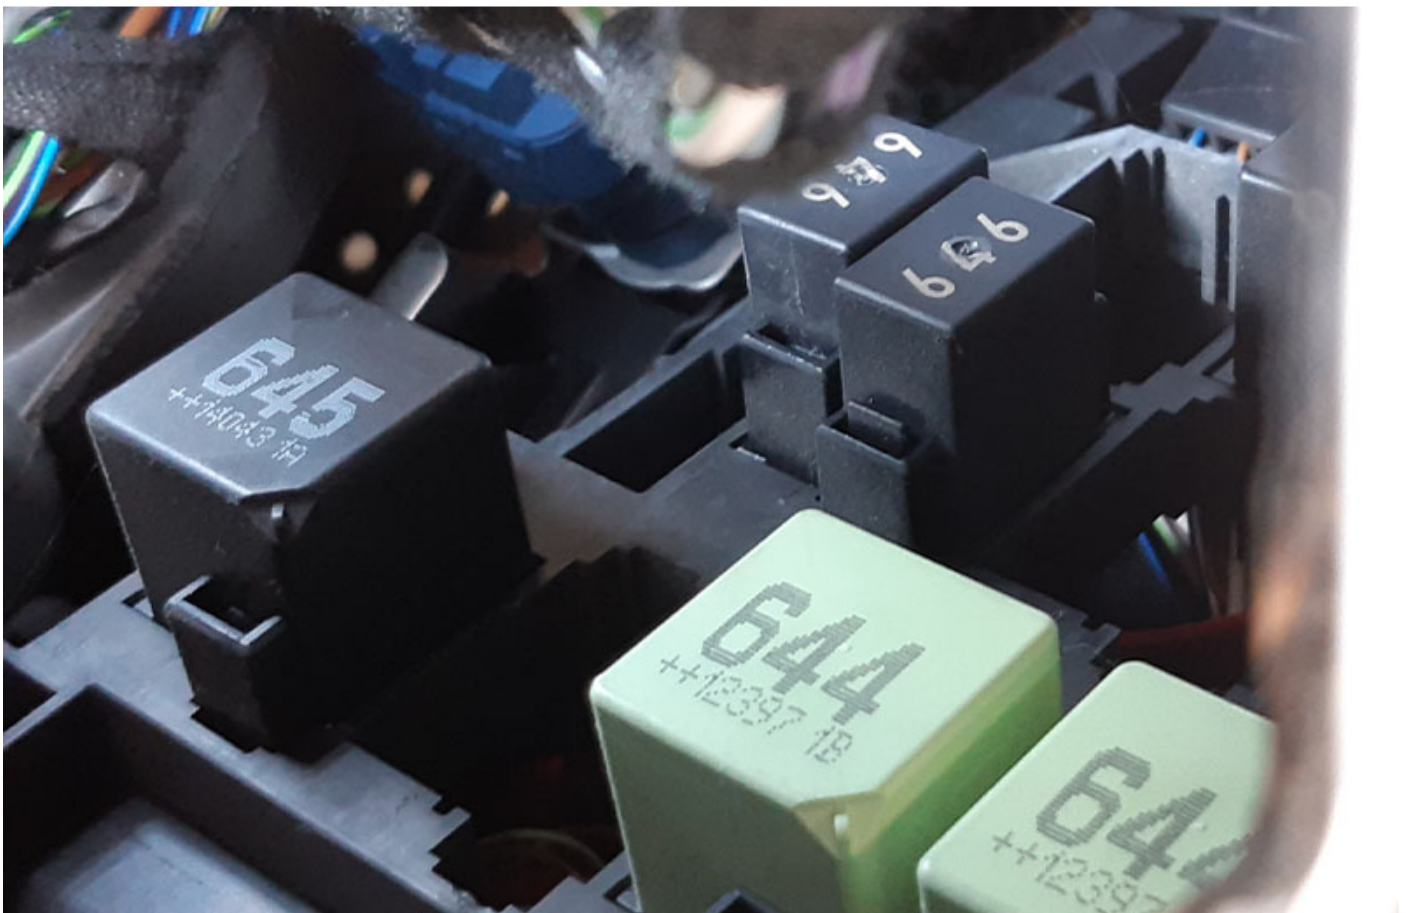
## Relays

A weak battery may be another cause of the problem. During the starting process, the vehicle electrical system voltage drops below the threshold at which the fuel pump relay closes.

The engine will therefore only start when the vehicle electrical system voltage rises again. In this case, replacing the vehicle battery is a sufficient remedy.

A software update may be considered as a last measure.
