# **BMW i3 (I01) - Interrupted radio reception | HELLA**

**i3 (I01)**

**Model year: 2013**

## **Interrupted radio reception**

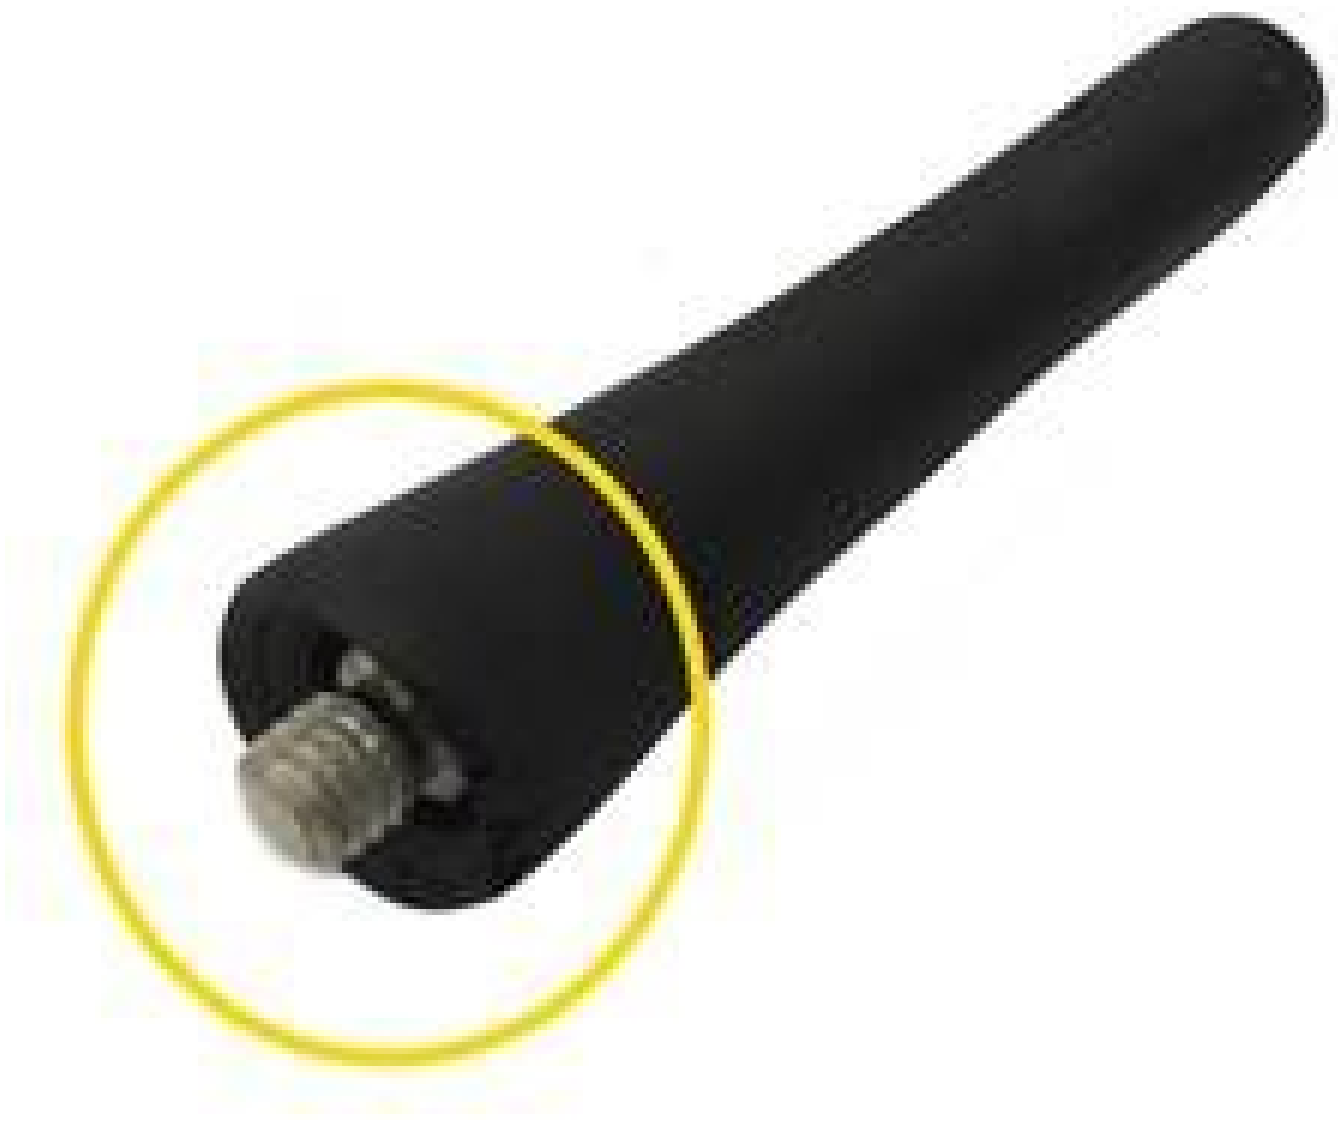
-Antenna rod OE No. 65209355718

On closer inspection of the roof antenna unit, it was discovered that the antenna rod was damaged (a cracked or broken threaded rod), a situation which could lead to the above-mentioned problem.

- Disassemble the antenna rod
- Check the thread on the antenna rod (see photo) and also the thread in the roof antenna unit for damage and repair or replace if necessary.
- Mount the new antenna rod
- Check functioning of the radio
