## Mazda CX5 (KE) - Fault code P0299 boost pressure too low

| Vehicle model | CX5 (KE) |
| Engine | 2.2 CDI Skyactiv-D |

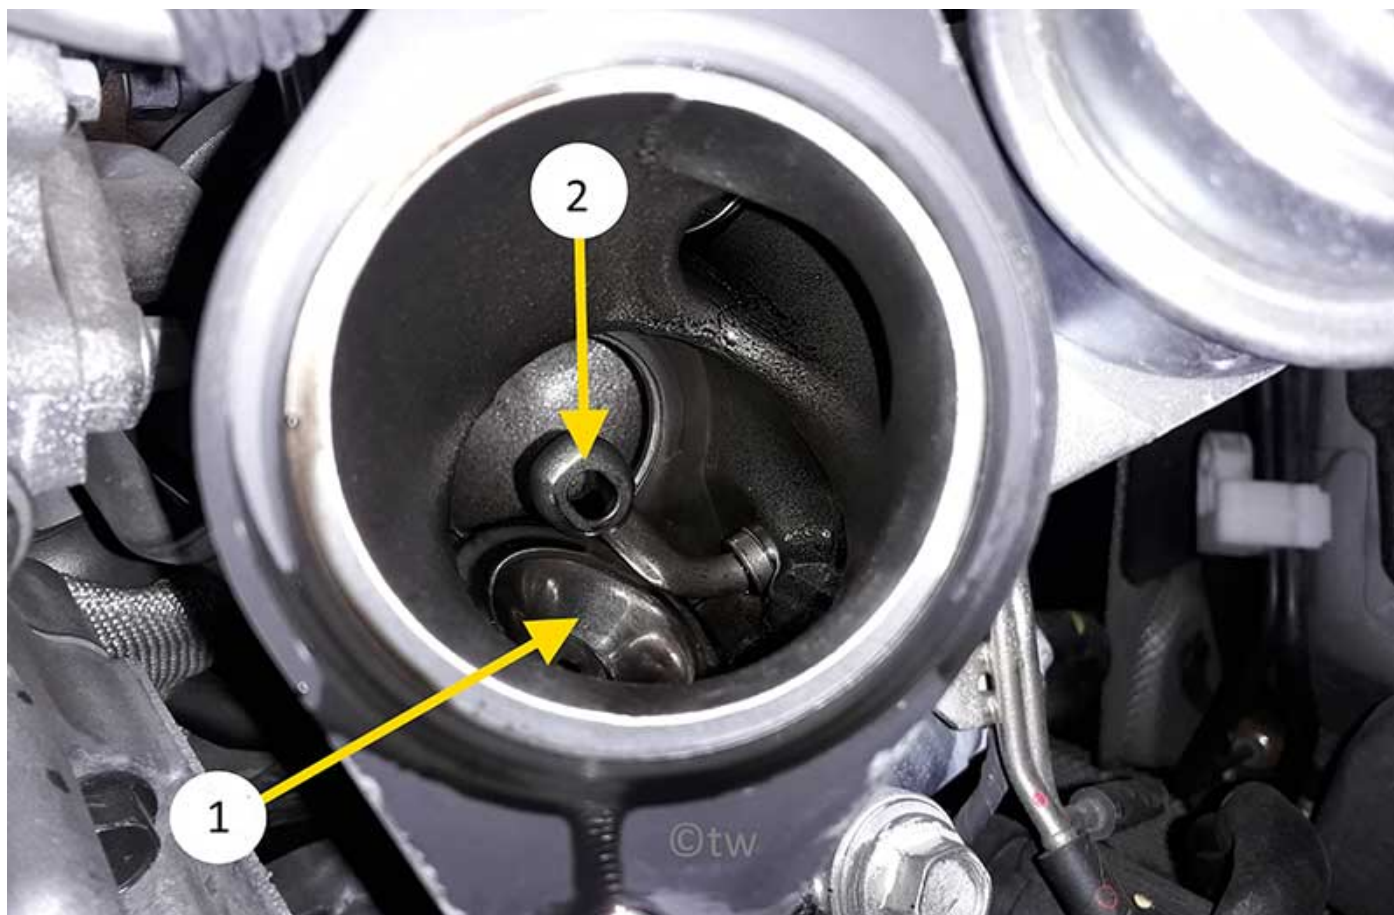
If the fault mentioned above is detected, it may also be related to a defective bypass flap on the small turbocharger. A mechanical defect ensures that the flap does not close properly and thus cannot build up sufficient boost pressure. In this case, the charge air hoses on the turbocharger should be removed and the flap control visually inspected. In our case study, the flap (1) had already completely detached from the lever (2). (Picture)

In a repair case, the complete turbocharger unit must be removed and replaced. The vehicle manufacturer does not offer the option of repairing the bypass flap's operating device.
