Vauxhall Astra K - Noises in the area of the C-pillar | HELLA

Noises in the area of the C-pillar

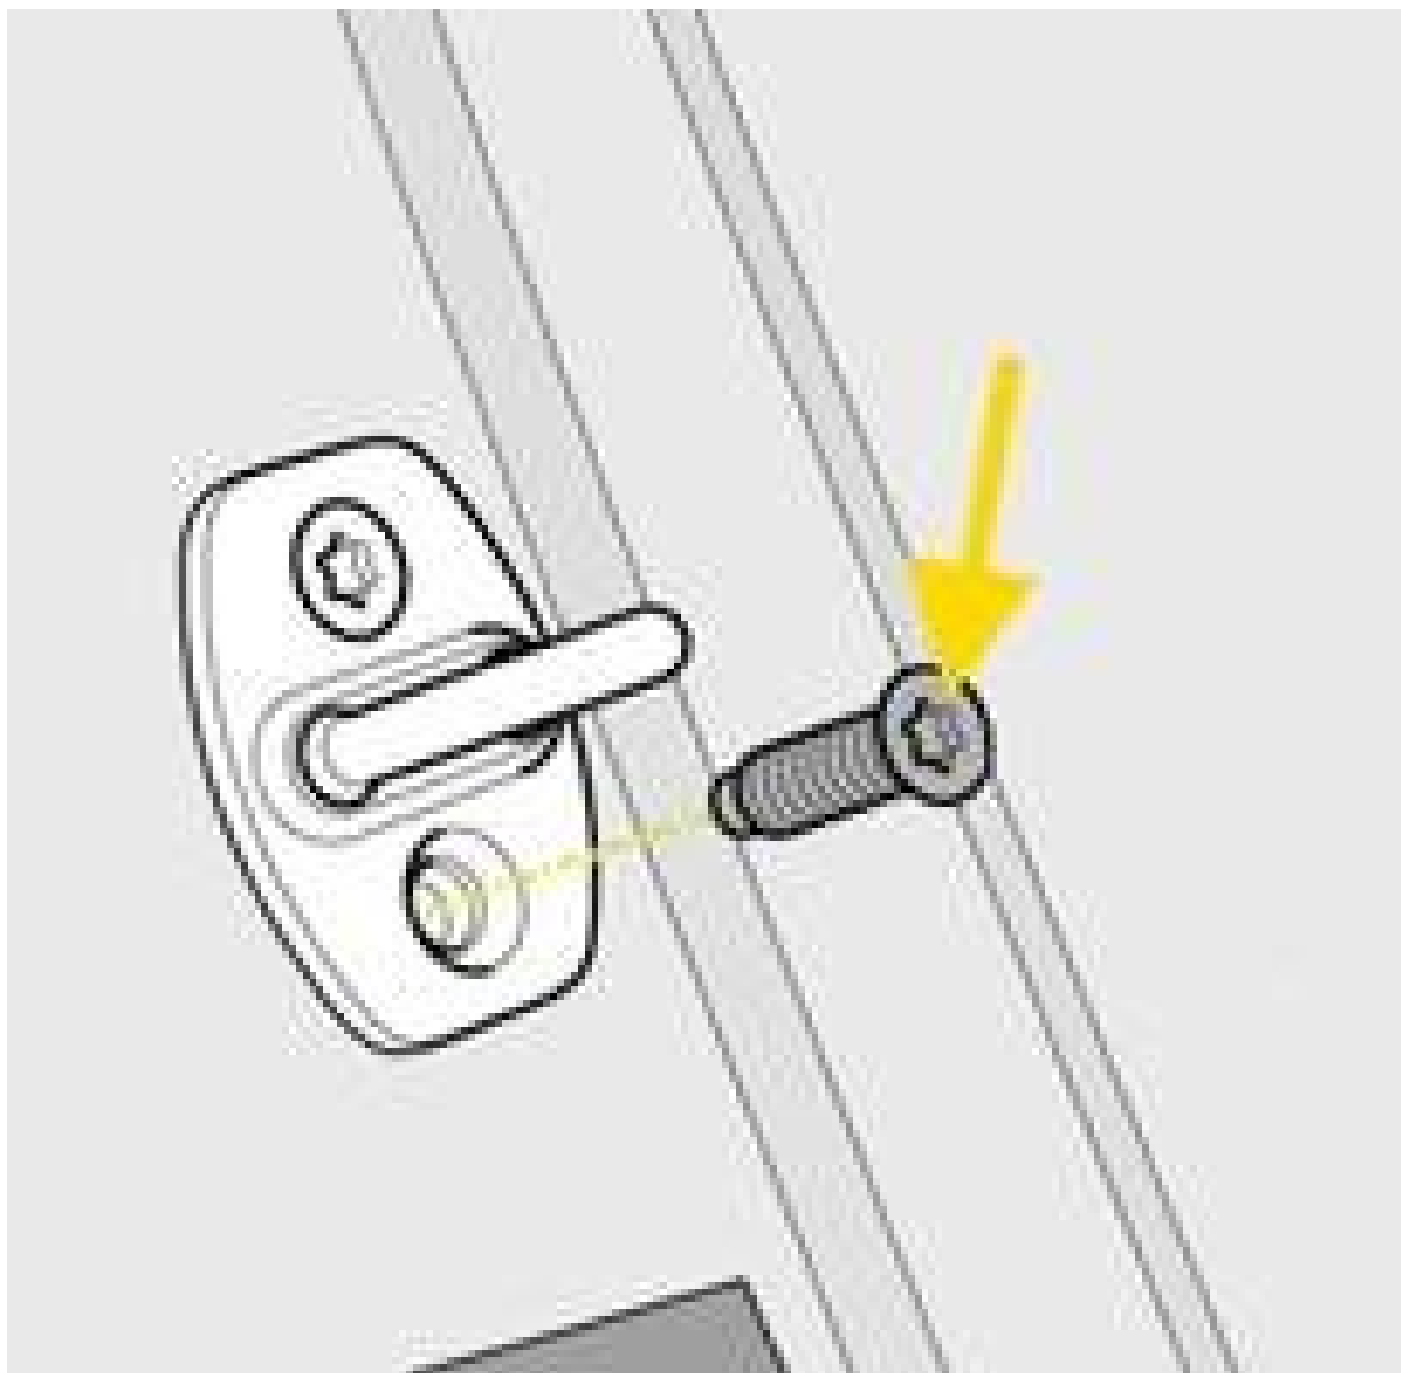
Figure 1

When checking the door lock mechanism, it emerges that the lower fixing screw (figure 1) of the door locking plate has been made too long. This results in contact between the screw tip and the inner sheet metal of the right C-pillar (can also affect the left C-pillar).

- Disassemble the fixing screw (figure 1)
- Shorten the screw by approx. 1.5 mm at the screw tip (figure 2)
- Install the fixing screw and tighten to the torque specified by the vehicle manufacturer
- Repeat this measure on the left side if necessary (locking plate of the left C-pillar)
