Vauxhall Insignia - rasping noise from the engine compartment when load is changed

Data sheet	
Manufacturer	Vauxhall
Vehicle model	Insignia A
Engine	1.6i 16 V
Engine code	A16 LET
Year of manufacture	2009 - 2013
Symptoms	Engine noises when accelerator released

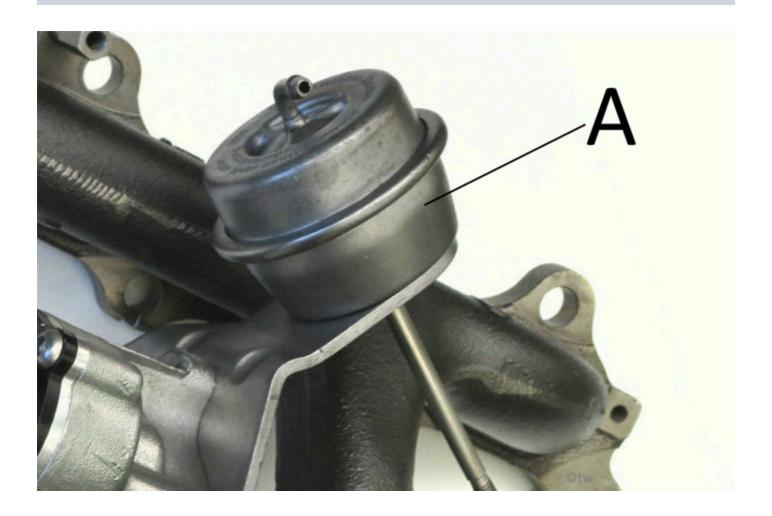
When throttle is released: rasping noise from the engine compartment

If the above-mentioned defect is detected, it may be related to a defect in the vacuum system responsible for controlling the turbocharger.

The vacuum box on the turbocharger actuator (A) is connected to a vacuum tank via vacuum lines and valves. Leaks caused by ageing or component defects can lead to faulty controlling, which triggers the rasping sound.

In such a case, the vacuum system should be tested with an installed vacuum hand pump.

If the test shows that the vacuum is leaking of its own accord, the defective components are to be replaced.
