Volkswagen Up/Seat Mii - engine start impaired: Error code 4629

Data sheet	
Manufacturer	Seat/Volkswagen
Vehicle model	Mii/Up
Engine	All models
Year of manufacture	2012 - 2019
Symptoms	Engine start impaired

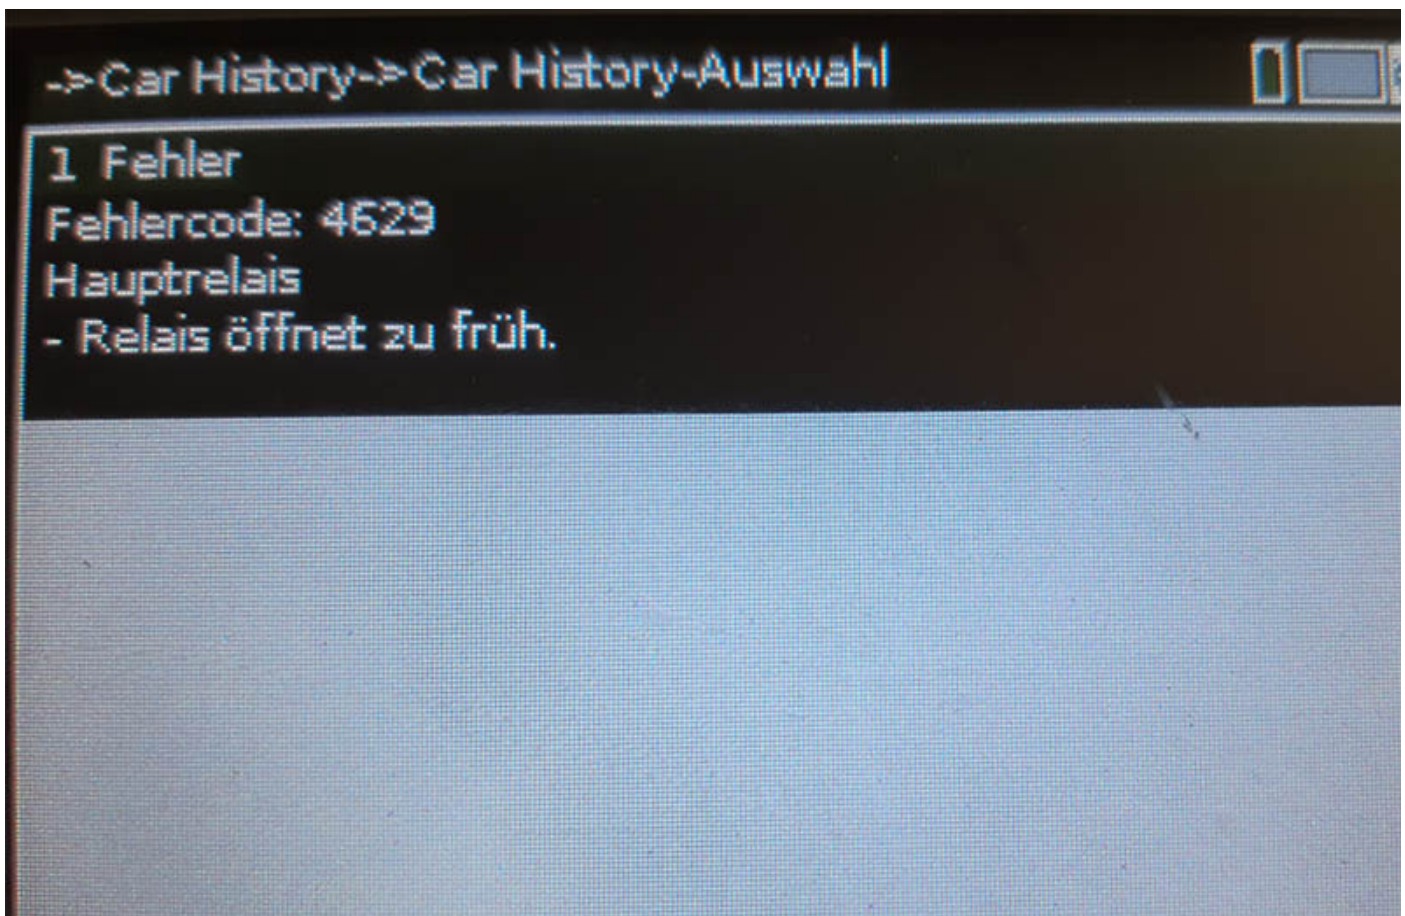
The first step is reading out the error memory. Error code 4629 (main relay opens too early) may be stored. ([Fig. 1](#)) This leads to the assumption that a relay is faulty. The relays can be reached relatively easily after removing the left cover on the dashboard. ([Fig. 2](#)) The position of the main relay(s) should be identified using a relay plan ([Fig. 3](#)). One of the relays controls the fuel pump. If the relay is defective, this would explain why the engine does not start.
