Jaguar S-Type - Ticking Sounds From Instrument Panel Area | HELLA

S-Type (X200)

Model Year: 1999 - 2008

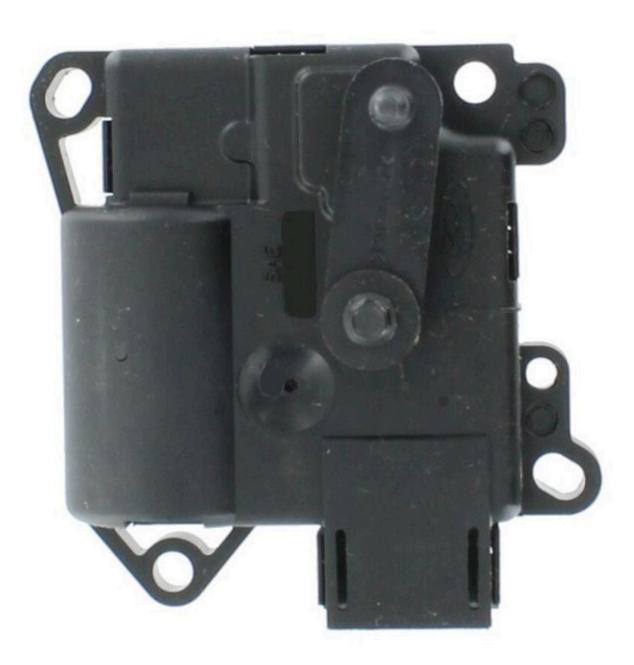
In the vehicles listed above, ticking noises can arise from the instrument panel or the instrument cluster area.

The potential cause for this is one or more actuator motors of the heating/air-conditioning system.

- Exactly locate the source of the noise
- If required, carry out an actuator test
- Replace the affected actuator motors
- Read out/clear the error memory
- Program the actuator motors
