Porsche 911 - Uneven abrasion and increased wear on disc brake pads

Model series 911

Type 964, 933, 996

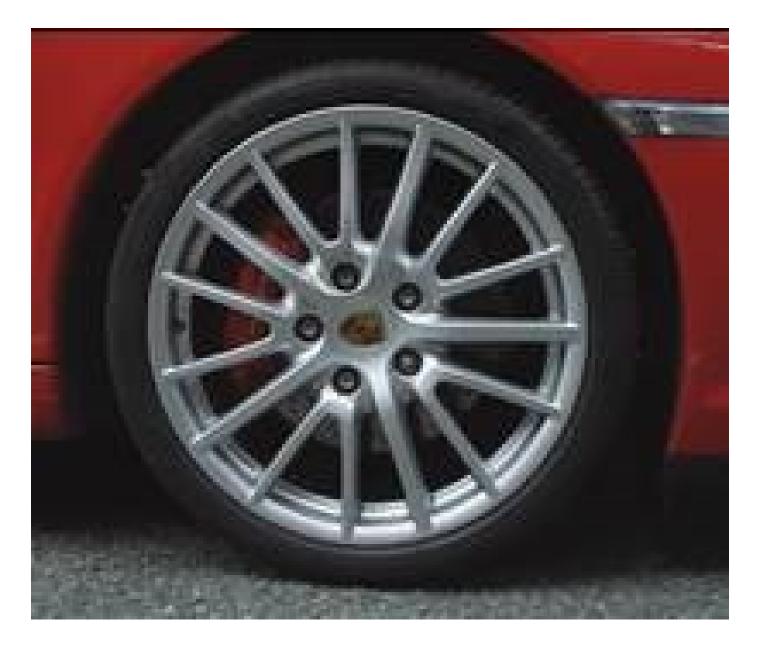
Uneven abrasion and increased wear on disc brake pads.

More difficult brake pad installation.

If the brake pads on the front or rear axle can only be inserted with great difficulty on the vehicle models listed above, then this may be caused by a brake caliper guide plate deformed by creeping corrosion and dirt. This dirt leads to the brake pads seizing in the guides, thereby resulting in high wear, uneven abrasion, squealing and increased temperatures on the wheel brakes.

The following work should be carried out:

- Properly clean the brake caliper, remove and clean the guide plates if necessary.
- Check the guide plates for damage and replace them if necessary.
- Clean and grease the contact surfaces of the guide plates.

We recommend using HELLA metal-free permanent lubricant for this.
