# Opel Astra-G, Opel Zafira, Vectra-B - Irregular engine running | HELLA

**All models with X18XE1 engine**

Vehicle occasionally stalls; impaired idle speed control

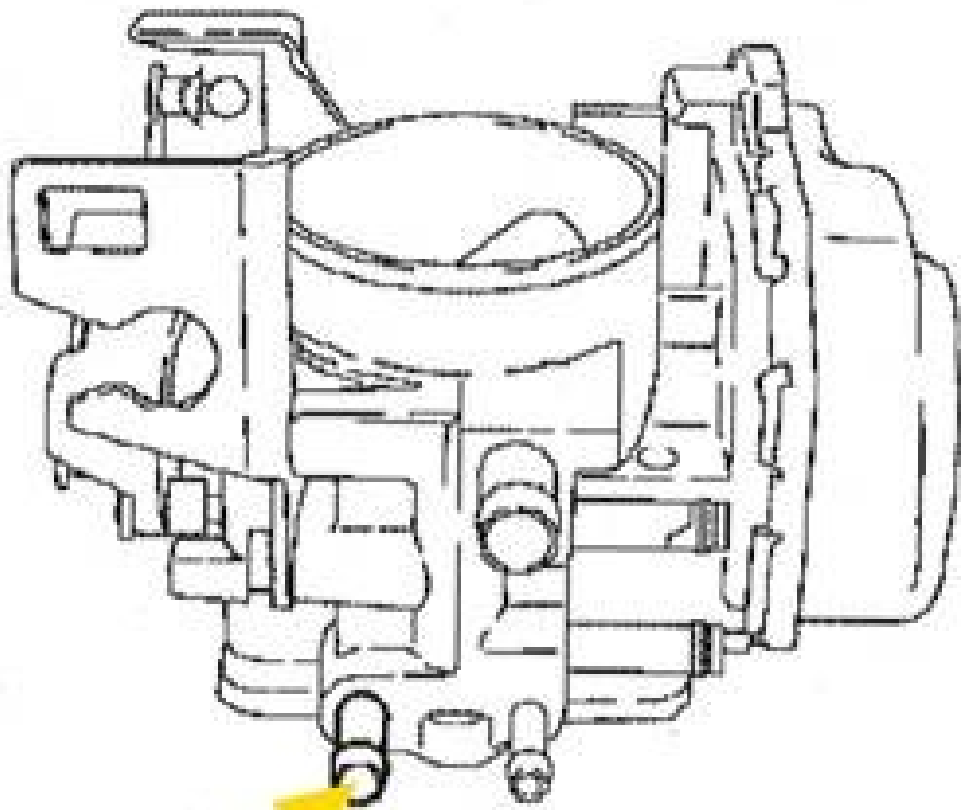
If the above-mentioned symptoms occur on these vehicles, this may be caused by a dirty throttle valve. In this case, check the blow-by hole and, if necessary, drill open to 2mm. Afterwards, the ECU must be reprogrammed with a software modified for this purpose. The ECU software can only be updated by an authorised dealer.

Note: If a white dot (1) is already on the throttle body, this measure has already been done.

- Remove the throttle body
- Secure the throttle body in a vice, protecting the contact faces from damage with a cloth rag.
- Drill blow-by connector (2) open and clean.

Make sure that no chips remain in the throttle body.

- Install the throttle body
- Mark throttle body with white dot at position (1)
- Program engine control unit
- Teach throttle adaptation using diagnostic tool. Be sure to follow the instructions from the car manufacturer.
