# Opel Astra K - Noises in vehicle interior / passenger compartment

## Data sheet

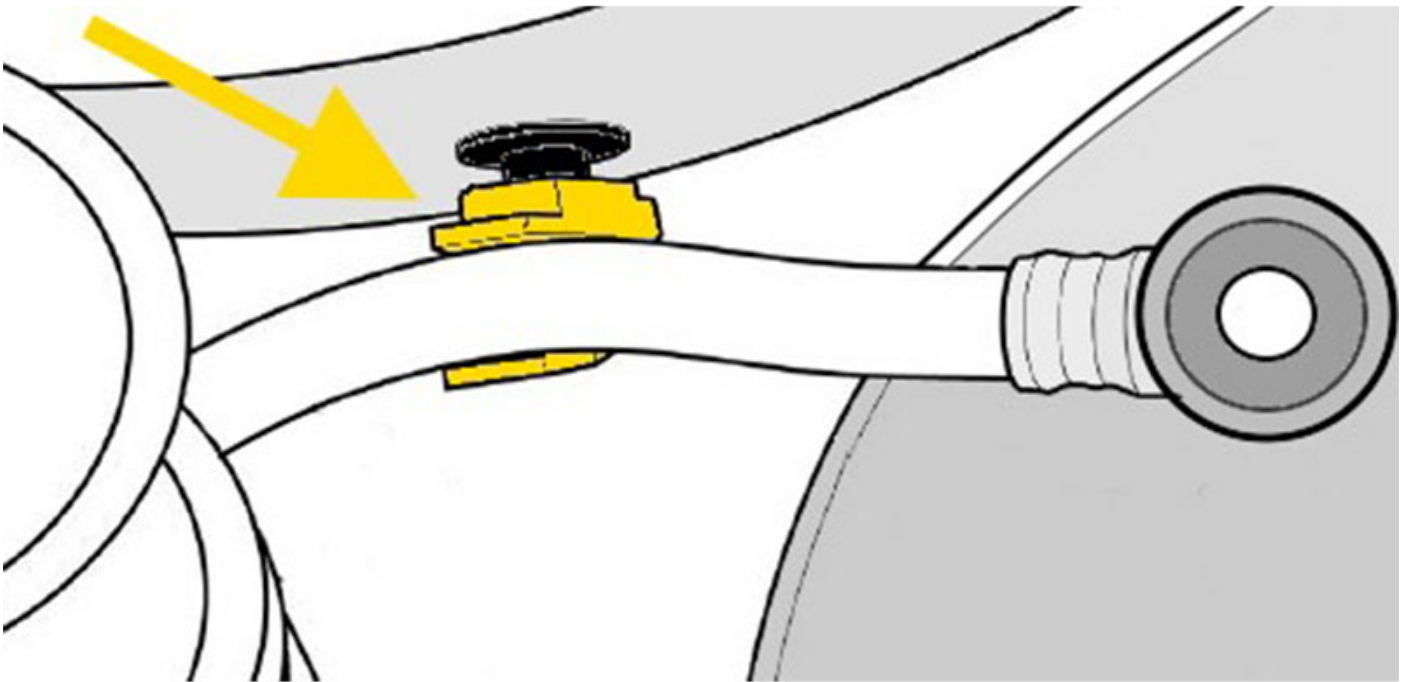
The cause of the noise is inadequate fastening of the brake booster vacuum line resulting from a faulty retaining clip (see picture).

Inadequate fastening of the brake booster vacuum line caused by a faulty retaining clip.

Remedy: Replace the old retaining clip with a new (modified) one. OE part number: 2073033
