## Peugeot 307cc- engine cuts out

| Vehicle model | 307cc |
| Engine | 2.0 16 V |

## Anti-lock braking system (ABS) error message present, engine switches off and cannot be restarted

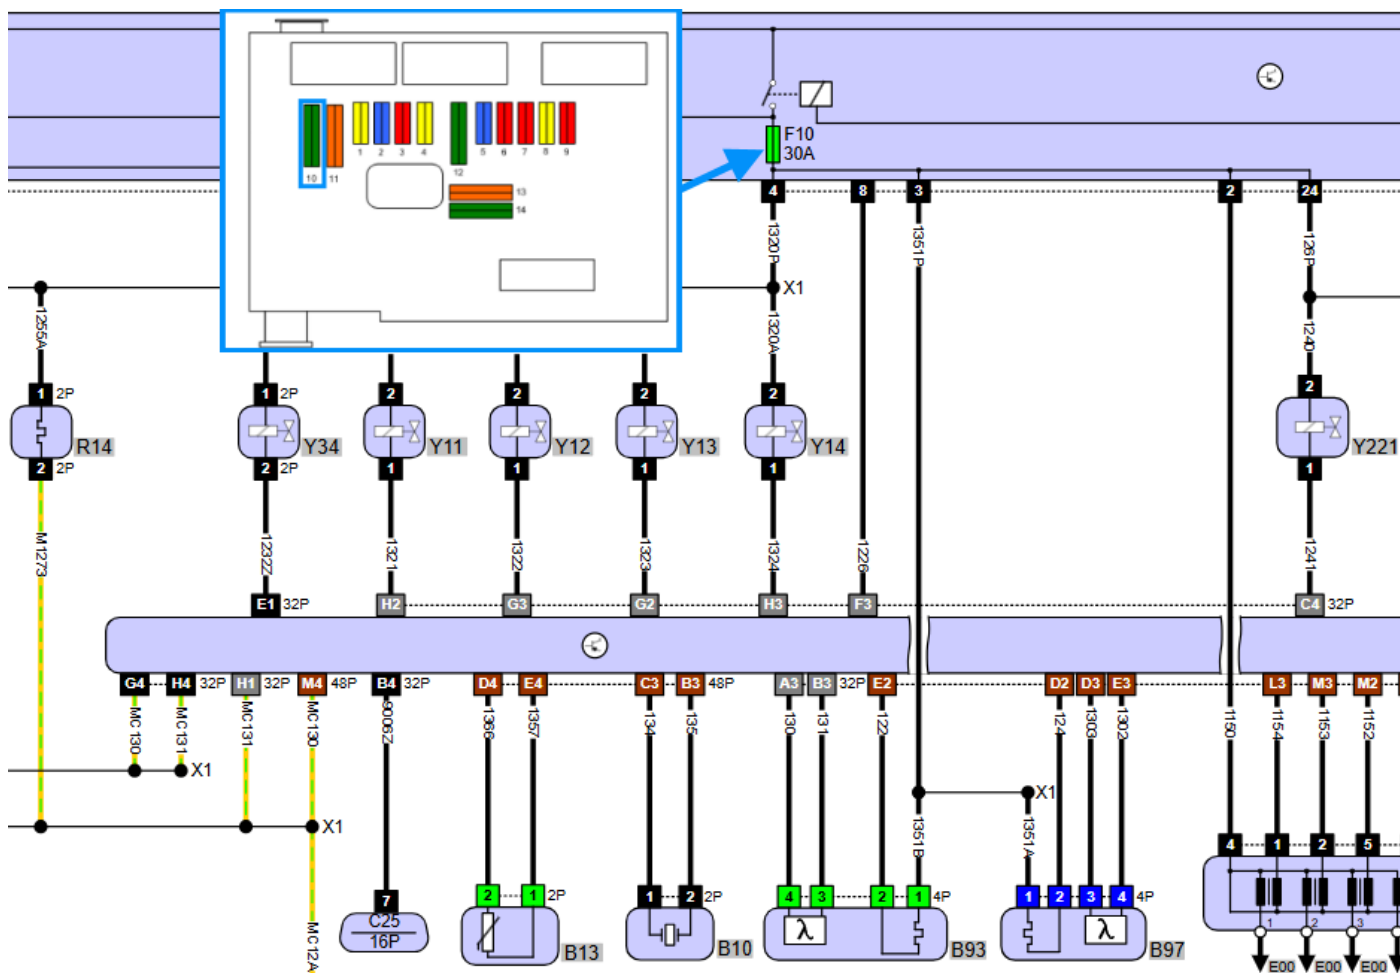
The fuses should be carefully checked as the first troubleshooting step. Pay particular attention to fuse F10 (30A) in the fuse and relay box in the engine compartment. The fuse must be removed and visually inspected for defects. If there are no obvious defects on the fusible wire, a continuity test can be carried out with a suitable measuring device for a more precise check. If the fuse is visually defective or measurements are out-of-spec, a possible cause may be a defective heating element on one of the two lambda sensors.

The fuse F10 (30A) not only protects the power supply to the lambda sensor heating elements, but also other components such as the crankcase ventilation heater or the ignition coils. This means that other components as well as the heating elements may also be a cause of the faults. It is therefore recommended to use the circuit diagram that matches the vehicle and the system so as to achieve precise troubleshooting.

In order to check whether the lambda sensors are responsible for tripping the fuse, a circuit breaker with 30 A can be temporarily inserted in the slot of fuse F10 for troubleshooting purposes. This circuit breaker trips in the event of a short circuit and can then be switched on again. After inserting the circuit breaker, the plug connections of the sensors are disconnected one after the other. Each time the plug connection is disconnected, the engine has to be started and, if necessary, a test drive carried out to check whether the short circuit is still present. If the circuit breaker no longer trips, the fault is in the previously disconnected component.

Once the cause of the fault has been rectified, delete the error memory and then carry out a test drive.
