# Seat Arona - noise from the front of the vehicle when manoeuvring

| Manufacturer | Seat |
| Vehicle model | Arona |
| Symptoms | Noises in the front area when manoeuvring |

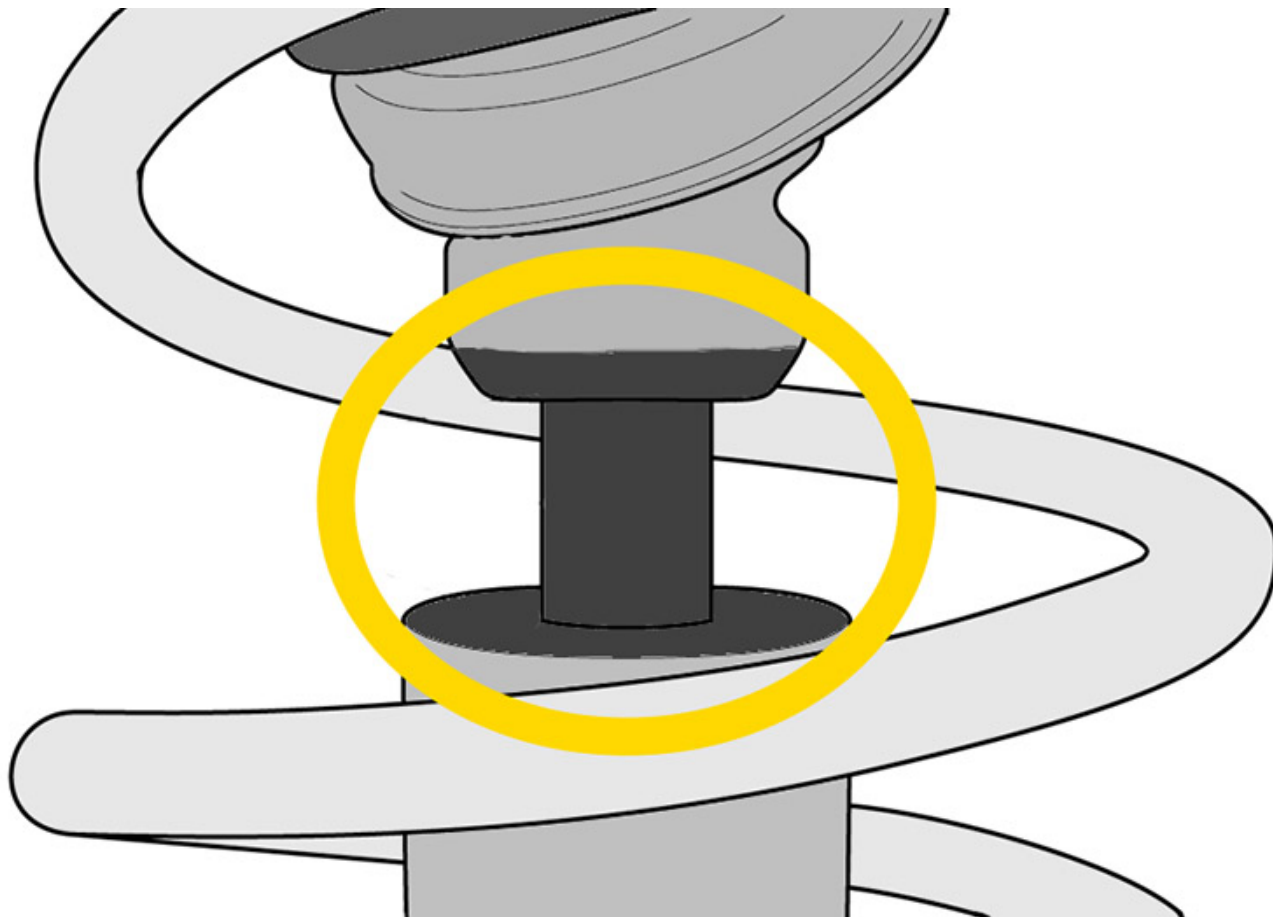
The cause was diagnosed as unwanted friction between the front suspension strut and the shock absorber bump stop.

- To access the shock absorber piston rod, lift the protective cover and bump stop upwards.
- Thoroughly clean all contact surfaces and coat them with

silicone grease article no. G 000 405 A2 (only use the specified type of silicone grease), as marked in the image, to the contact surfaces between the shock absorber piston rod and the shock absorber bump stop
