## Tesla Y - water ingress in interior fan

### Data sheet

## Water ingress on passenger side, interior fan noise

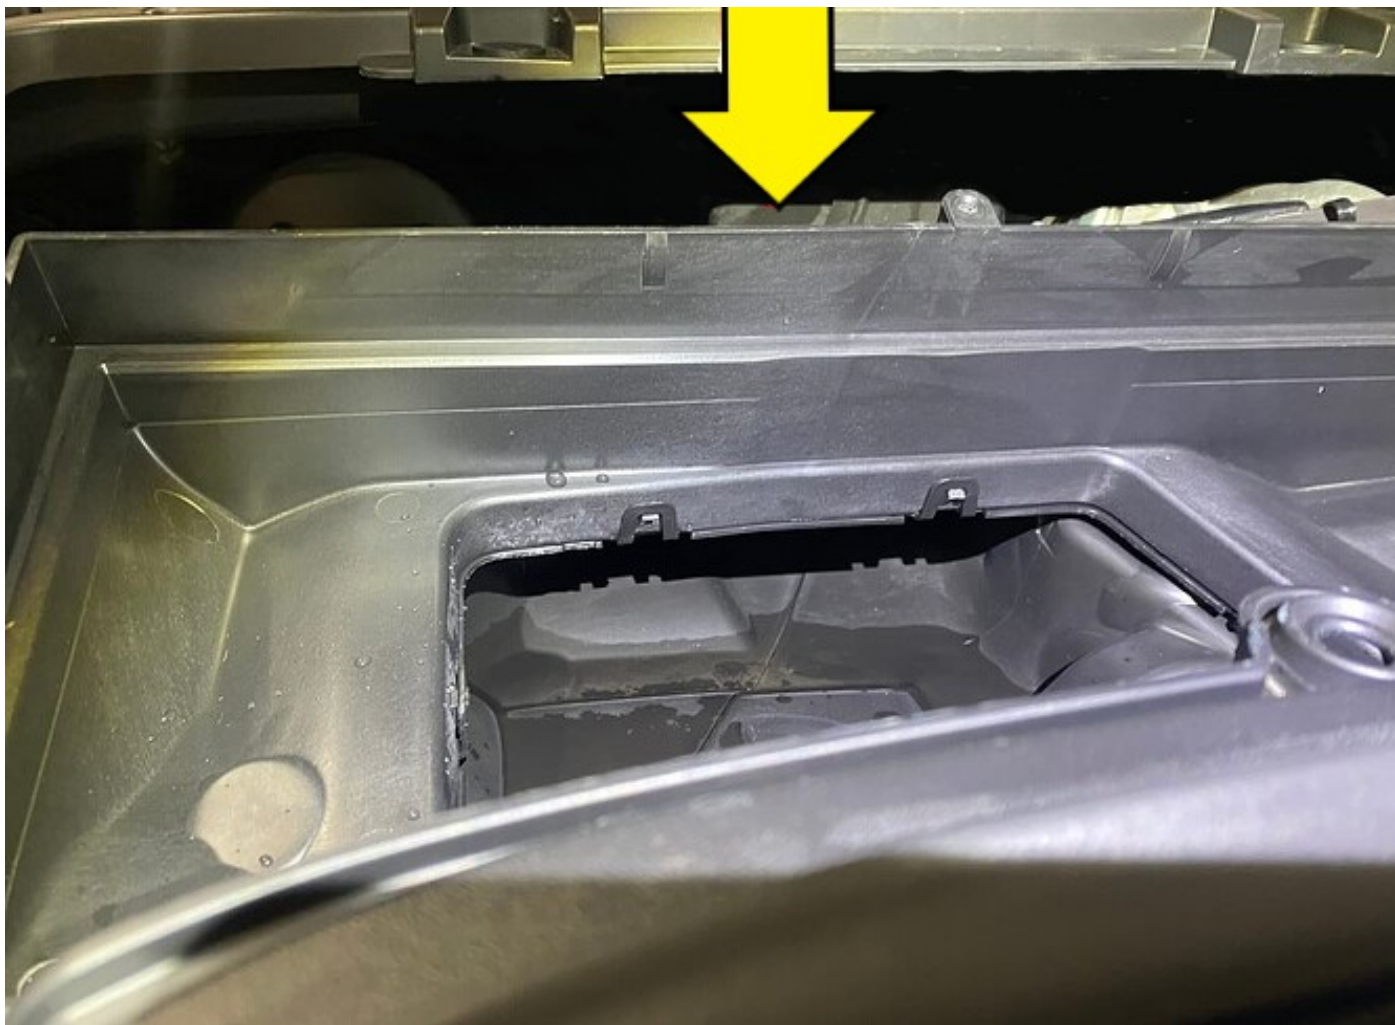
In the above-mentioned vehicle, water can enter the passenger footwell as a result of faulty sealing on the cabin air filter box. This is particularly noticeable during rapid acceleration. Car carpet and floor mats can then become quite wet. Water can also get into the interior fan, which leads to loud, squeaky noises being emitted from the fan.

In order to confirm the cause, the cabin air filters should be removed. These can be reached from the engine compartment (underneath the water box cover). A seal should be visible above the vent box. If it is only loosely attached or shows no real contact pressure, water will enter the vehicle interior via the ventilation housing and the ventilation shafts when it rains.

Sealing the ventilation box of the cabin air filter

Remedy or repair measures are to be carried out in accordance with the vehicle manufacturer's instructions.
