## VW Golf VII - loss of coolant

### Data sheet

| Manufacturer | VW |
| Vehicle model | Golf VII |

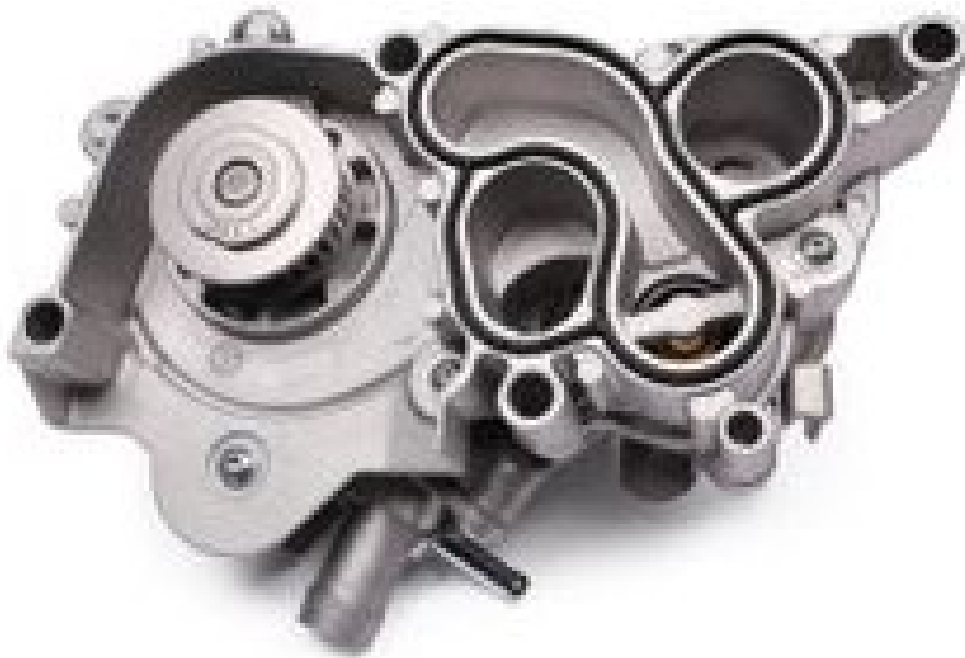
If a loss of coolant is detected in the vehicles mentioned above, the cooling system should be pressurised in accordance with the vehicle manufacturer's specifications and all components checked for damage/leakages. Paying particular attention to the coolant pump is advisable. Often the cause of coolant loss is a defective seal. To eliminate the problem, the seal and, if necessary, the entire coolant pump must be replaced. The cooling system must then be refilled and vented in accordance with the manufacturer's specifications. Ensure that the correct coolant additive is used and the correct mixing ratio is observed.
