# VW T6 - replacing the differential pressure sensor

| Vehicle model | Transporter T6 |
| Engine code | CXHA |

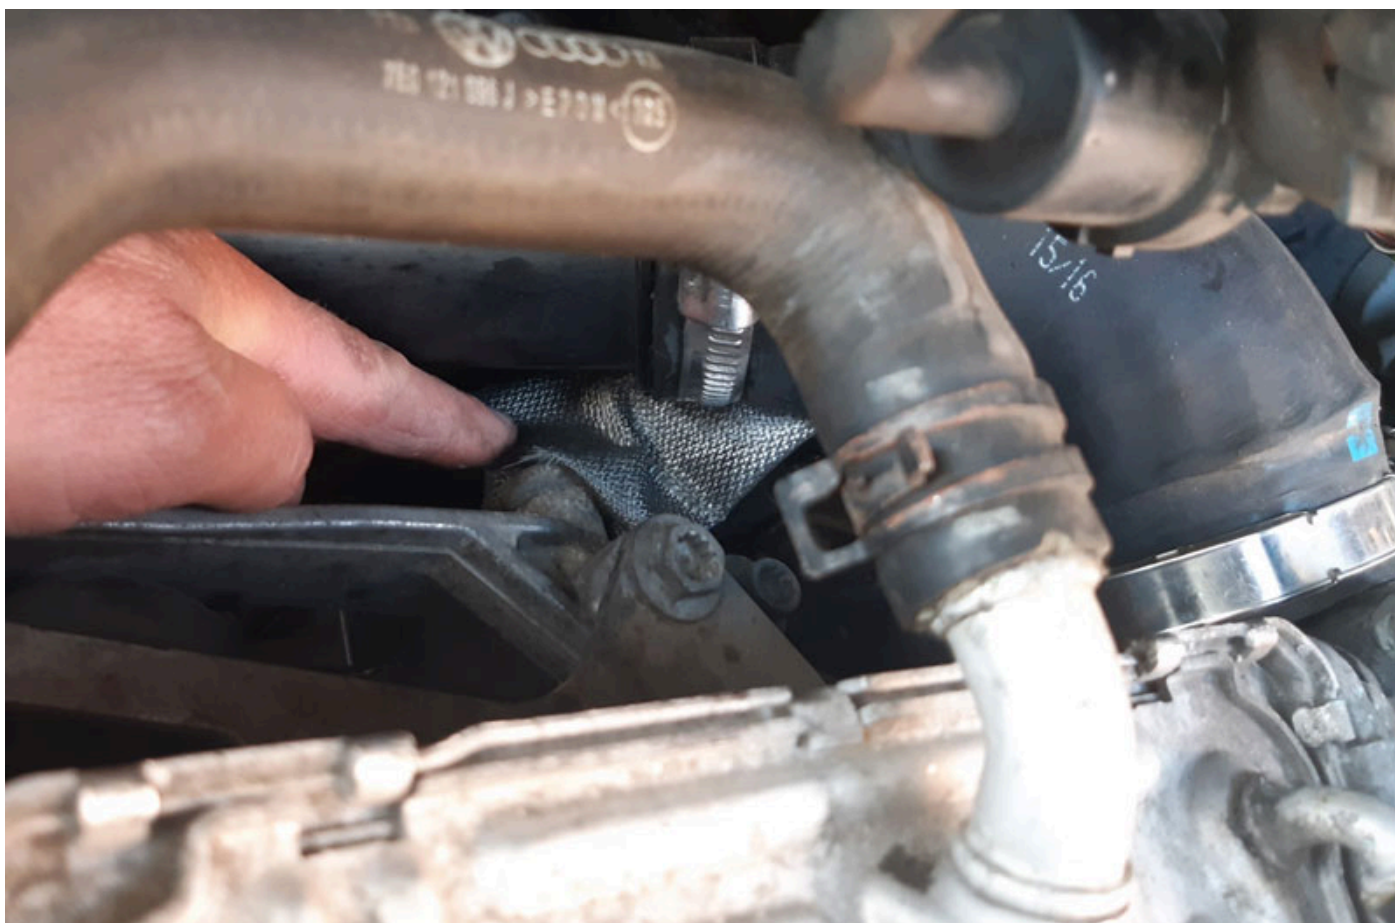
The sensor, wrapped in heat protection foil, is located behind the hose of the charge air cooler, as shown in ([Fig. 1](#)). In order to access the sensor, the charge air hose or the charge air pipe has to be removed as seen in ([Fig. 2](#)). This is done by removing 2 screws in the lower section. Loosen the hose clip at the top of the charge air cooler([Fig. 3](#)). Now it will be possible to remove the hose/pipe combination ([Fig. 4](#)). After opening/removing the heat protection foil, the sensor becomes visible. It can now be replaced with a sensor, for example, from HELLA (Part no: 6PP 009 403-221).
