## VW Touran - fault code 148C/148B and water ingress in the A-pillar area

| Vehicle model | Touran with panoramic sunroof |
| Year of manufacture | 2016 |

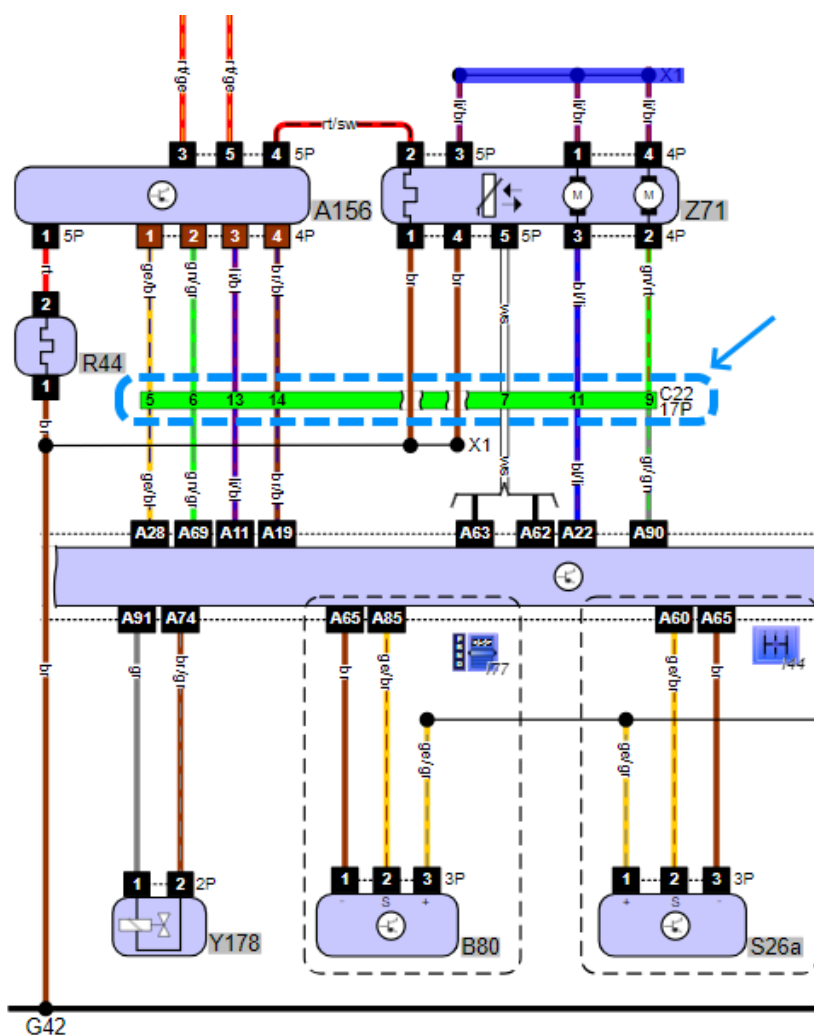
The engine control light in the above vehicle type may illuminate although there is no noticeable loss of power. If the above fault occurs and fault codes 148B and 148C (faulty auxiliary heating output stage) are stored in the fault memory, the connecting plugs in the footwell should be checked. They connect the electrical cables of the auxiliary heating, among other things, and are located behind the footwell panelling of the A-pillar on the driver's or passenger's side, depending on the equipment variant.

If moisture or corrosion is detected on the pins of these plug connections, special attention should be paid to the water drains of the panoramic sunroof.

These can become clogged with dirt. The water builds up, flows over the roof cassette into the passenger compartment of the vehicle and enters the plug connections, among other things. To

check this, open the glass roof and pour water directly into the drains. If water builds up in the sunroof cassette and does not drain away immediately, the drains should be cleaned. This can be done, for example, with a cleaning brush that is specially designed for cleaning the water drains.

Once the sunroof drains have been completely cleaned, the damaged pins of the plug connections should also be repaired in order to re-establish a perfect electrical connection.

Once the cause of the fault has been rectified, delete the error memory then carry out a test drive.
