## VW Up / Seat Mii / Skoda Citigo - poor engine performance

## Poor engine performance: Error codes P0010, P0016, P0088, P0341 stored in the control unit

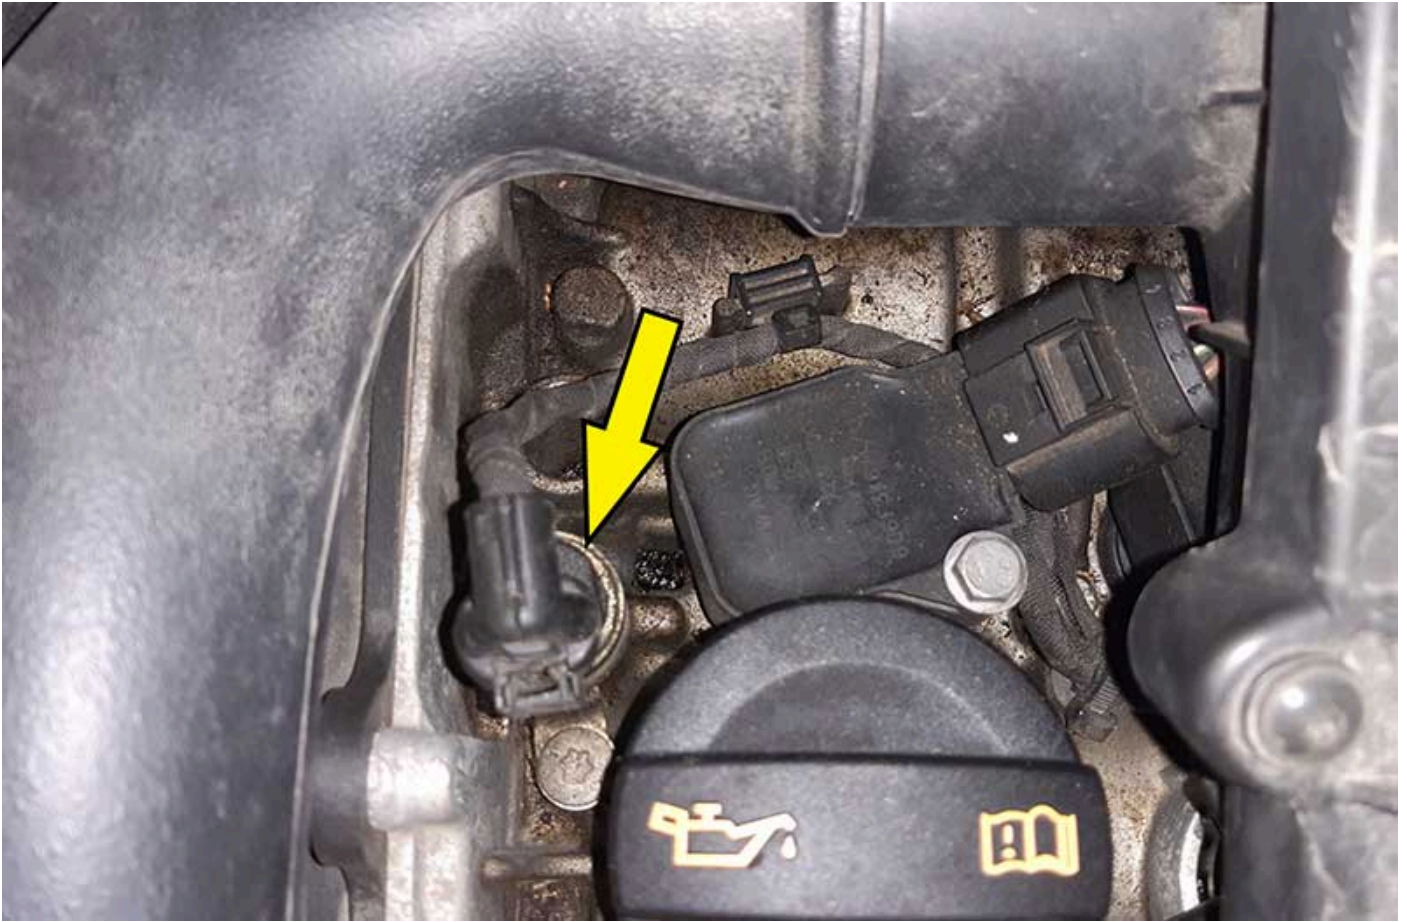
In addition to the classic sources of faults when it comes to the timing belt drive, particular attention should be paid to the oil pressure valve of the variable camshaft control (see picture). Blockages or coking of the oil bores can lead to the above-mentioned symptoms. These usually contribute to faulty camshaft adjustment.

In order to remedy this, the oil pressure valve of the camshaft control can be cleaned. In some cases, an immediate replacement is the best option. It is advisable to also inspect the area of the oil bore in the cylinder head and to check for contamination.

With the help of a diagnostic device (e.g. Hella Gutmann mega macs X), the error memory should then be deleted. Finally, a test drive has to be carried out.
