Kia Sportage - Error code P1820/1821/1822/1823/1824 and all-wheel drive not engaging

Data sheet	
Manufacturer	Kia
Vehicle model	Sportage
Engine	All models with all-wheel drive
Year of manufacture	2010-2016
Symptoms	All-wheel drive does not engage

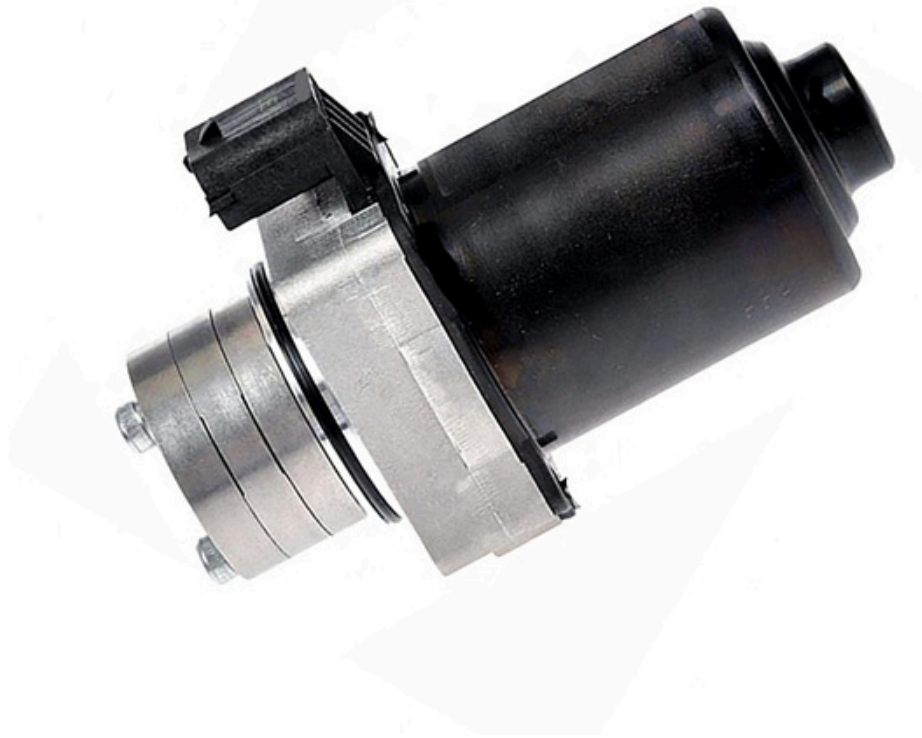
On the vehicles mentioned above, the all-wheel drive may no longer engage. The error memory may contain error codes that refer to the switch actuator or are brought about by a faulty wiring harness.

- If an all-wheel drive actuator from the manufacturer Keyang is installed, it is to be replaced (part no: 47810-3B520)
- If a Buhler actuator is installed, the actuator and its wiring harness (part no: 47891-3B310) should be changed
- After replacing the components, clearing the error memory and performing a test drive are advised.
