VW Up / Seat Mii / Skoda Citigo - poor engine performance

Data sheet	
Manufacturer	VW Seat Skoda
Vehicle model	Up Mii Citigo
Engine	1.0 MPI
Engine code	CHYA
Year of manufacture	2011 - 2016
Symptoms	Engine performance poor
Error codes	P0010 P0016 P0088 P0341

Poor engine performance: Error codes P0010, P0016, P0088, P0341 stored in the control unit

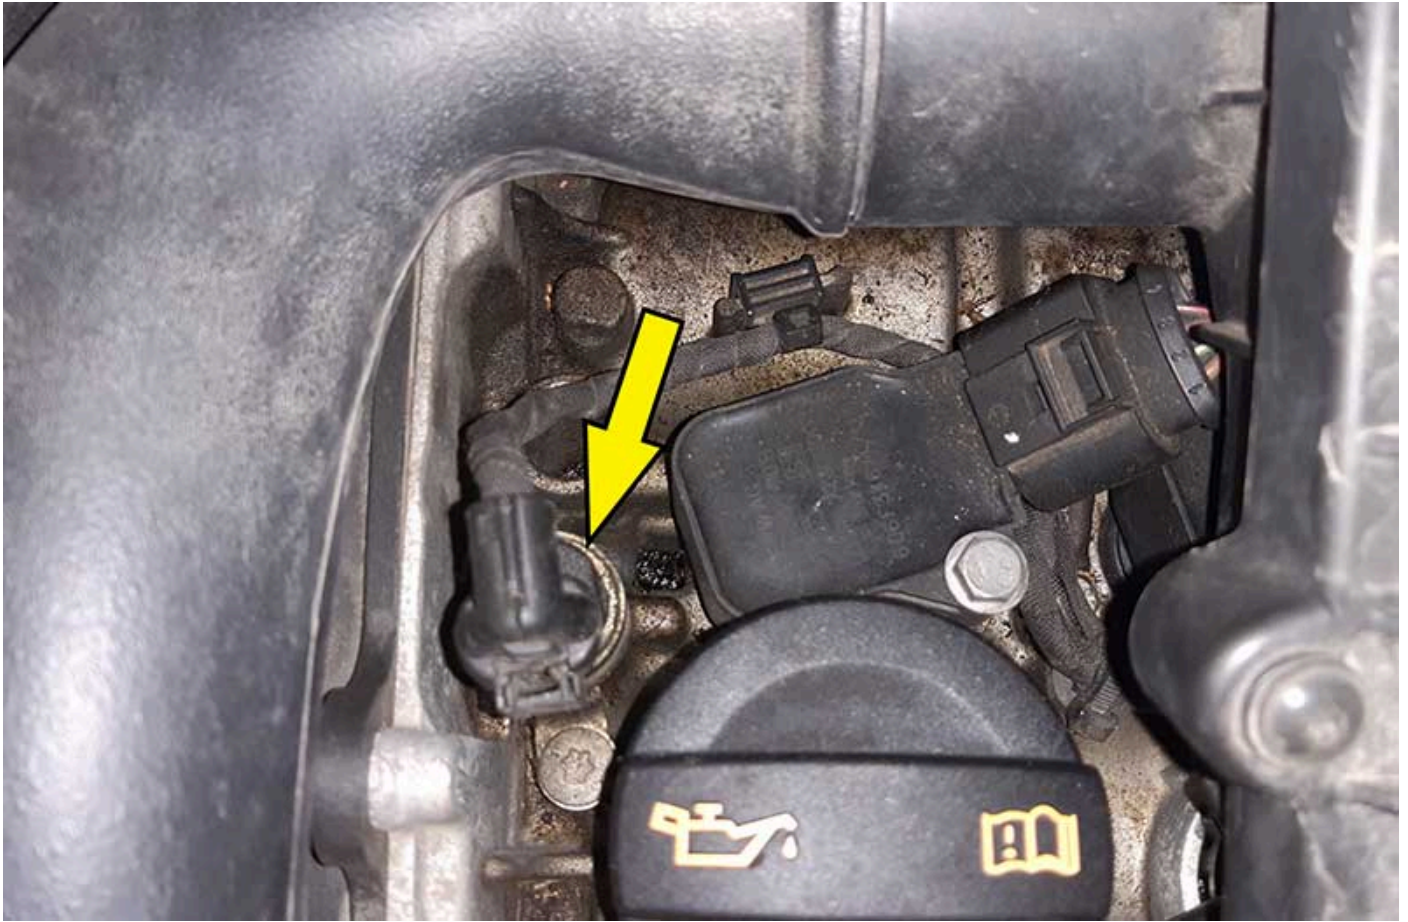
In the case of the above-mentioned vehicles, there can be a reduction of engine performance. The error codes P0010/P0016/P0088/P0341 are often stored in the error memory. These refer to the variable valve control or to the crankshaft/camshaft position.

In addition to the classic sources of faults when it comes to the timing belt drive, particular attention should be paid to the oil pressure valve of the variable camshaft control (see picture). Blockages or coking of the oil bores can lead to the above-mentioned symptoms. These usually contribute to faulty camshaft adjustment.

In order to remedy this, the oil pressure valve of the camshaft control can be cleaned. In some cases, an immediate replacement is the best option. It is advisable to also inspect the area of the oil bore in the cylinder head and to check for contamination.

With the help of a diagnostic device (e.g. Hella Gutmann mega macs X), the error memory should then be deleted. Finally, a test drive has to be carried out.
