Audi

A6, 2.4 I

Model year 1998

Car cuts out

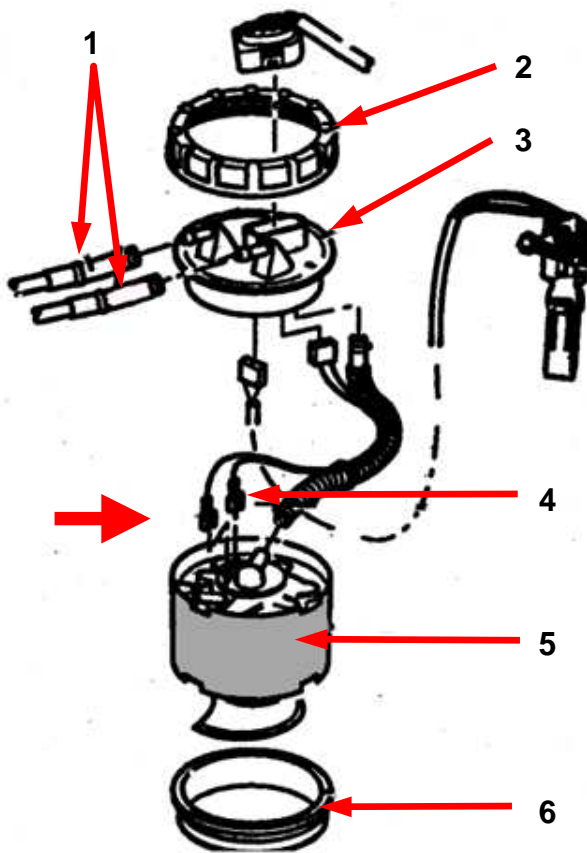
If there are complaints about the above-mentioned fault, the cause could be a chafed cable. Chafing of the insulation occurs in the case of the yellow positive cable for the fuel pump located in the fuel tank. Through subsequent contact with the cable plug of the earth cable, a short-circuit then arises and fuse 28 (electric fuel pump) blows. In order to eliminate this fault, a new harness with angled plugs is fitted. This harness is offered by the manufacturer.

- Pull out fuse 28 and allow the engine to crank over briefly, in order to reduce the fuel pressure.
- Switch off the ignition.
- Remove the rear seat bench and remove the plastic cover from the body floor.
- Remove both fuel hoses (1) from the flange (3) of the fuel pump.
- Unscrew the union nut (2) and remove.
- Remove the flange (3) upwards from the tank.
- Check the harness (4) to the fuel pump (5) for damage.
- If chafing points can be seen, replace the old harness with the repair harness with angled plugs.
- Following this, secure the harness with cable clips (included in the scope of supply) in such a way that renewed damage is not possible.

- The flange seal (6) should also be renewed. This must however be ordered separately.
- Insert the flange into the tank again in such a way that the arrow markings of the tank and the flange match.

Refit all removed parts in reverse order. After the repair, fuse 28 (15A) should be replaced with a new 20A fuse.
