## **BMW** **All models with M 42 engine**

### **Short-term poor performance**

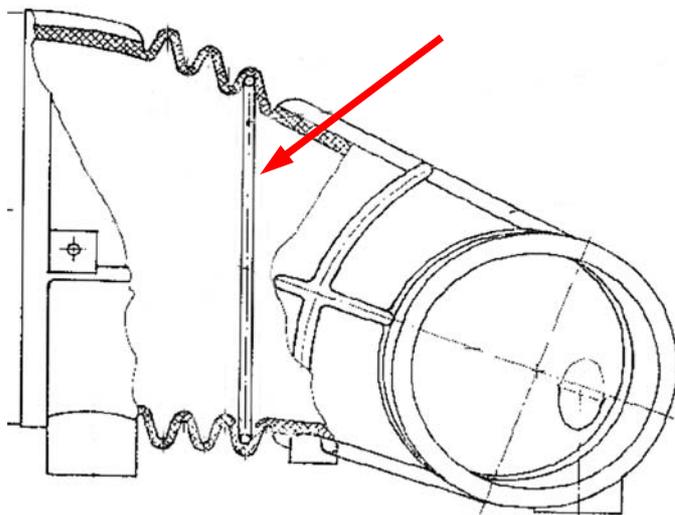
If there are complaints about the above-mentioned complaint, the bellows between the intake plenum and the air flow sensor could be the cause. With quick gear shifts, high engine speeds and high external and engine temperatures the bellows can contract on account of too much vacuum. This state and the poor performance connected with this can be particularly felt during gear shifting. For this reason the manufacturer supplies a spreader ring (see Fig.) which is inserted into the third fold of the bellows. This ring prevents the bellows from contracting.
