*Audi 80 7/89 – 6/96 Engine: NG*  
*Audi 90 7/89 – 6/92 Engine: NG*  
*Audi 100 7/85 – 6/91 Engine: NF*

## Knock sensor failure on the 2.3 Ltr. 5 cylinder engine

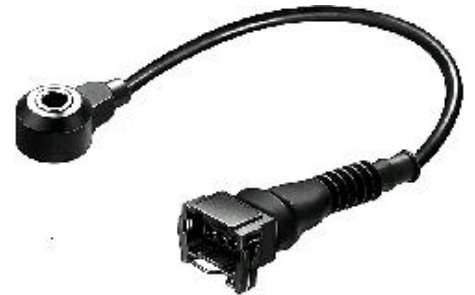
On the above-mentioned engine types a failure of the knock sensor can occur. This is often noticeable by an increased fuel consumption and a reduced engine performance. This is due to the ignition timing and the injection quantity, which are influenced by the ECU. An error code is stored in the ECU, however the warning light is not activated by the system. Checking the ignition timing or reading out the fault memory can indicate a failed or faulty knock sensor. You can find further notes in our technical information about the knock sensor.

Under the part no.: 6 PG 009 108-081 (blue plug, cable length 535 mm) and 6 PG 009 108-091 (green plug, cable length 740 mm) *Hella* offers now a replacement in OEM quality.

Make sure the torque setting is correct (20 +/-5Nm). Do not use spring any or plain washers.
