Mercedes Benz, E-Class (W124)

Idling speed is too high

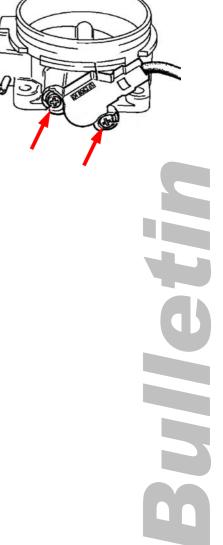
If there are complaints about the above-mentioned fault, a faulty or incorrectly set throttle valve switch and/or an incorrectly installed restoring spring on the shifting gate slide could be the causes. In this case proceed as follows:

- Check the position of the restoring spring and correct it if necessary (top diagram).
- Check the throttle valve switch.

- Press the throttle valve lever to the idling stop.
- Measure the resistance at the connector between contacts 1 und 2. Reference value: < 1 Ω .
- If the throttle valve is in the idling position but the throttle valve switch is not, this can be set. To do this loosen the two attachment screws (bottom diagram), turn the switch and then fasten the screws in place again.
- Activate the throttle valve lever until the switching point is exceeded. Reference value: $\infty \Omega$.

In the part load range the reference value has to be ∞ Ω . If the switch should no longer switch between the two values or if the measured values are not correct, the switch has to be replaced.
