Mercedes-Benz C-Class (W203) All models

Humidity in the fuse module box in the engine compartment.

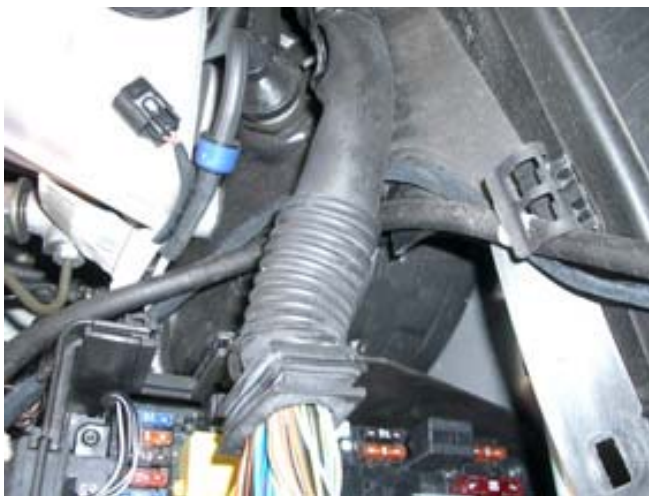
If there are complaints with these vehicles that humidity has penetrated the fuse module box in the engine compartment, this could be caused by a leak in the cable ducts. This fault sometimes manifests itself in the exterior lighting or the brake light illuminating on their own accord. To eliminate the fault proceed as follows:

- Remove the cover of the fuse module box.
- Pull the cable harnesses from the guides in the fuse module box (Fig.).
- Remove any humidity and dry all the plugs, cables, fuses and relays.
- Seal the cable duct (cable sleeve) additionally with insulating tape. Begin with the insulating tape on the cable sleeve and apply it to the cable harness as far as necessary for correct sealing to be achieved.
- Insert the cable harnesses back into the guides. Take care to ensure that they are seated correctly.
- Refit the cover.
